SODIUM LEAKAGE EXPERIENCE AT THE PROTOTYPE FBR MONJU

A. MIYAKAWA, H. MAEDA, Y. KANI, K. ITO
Monju Construction Office,
Japan Nuclear Cycle Development Institute,
Fukui-ken, Japan

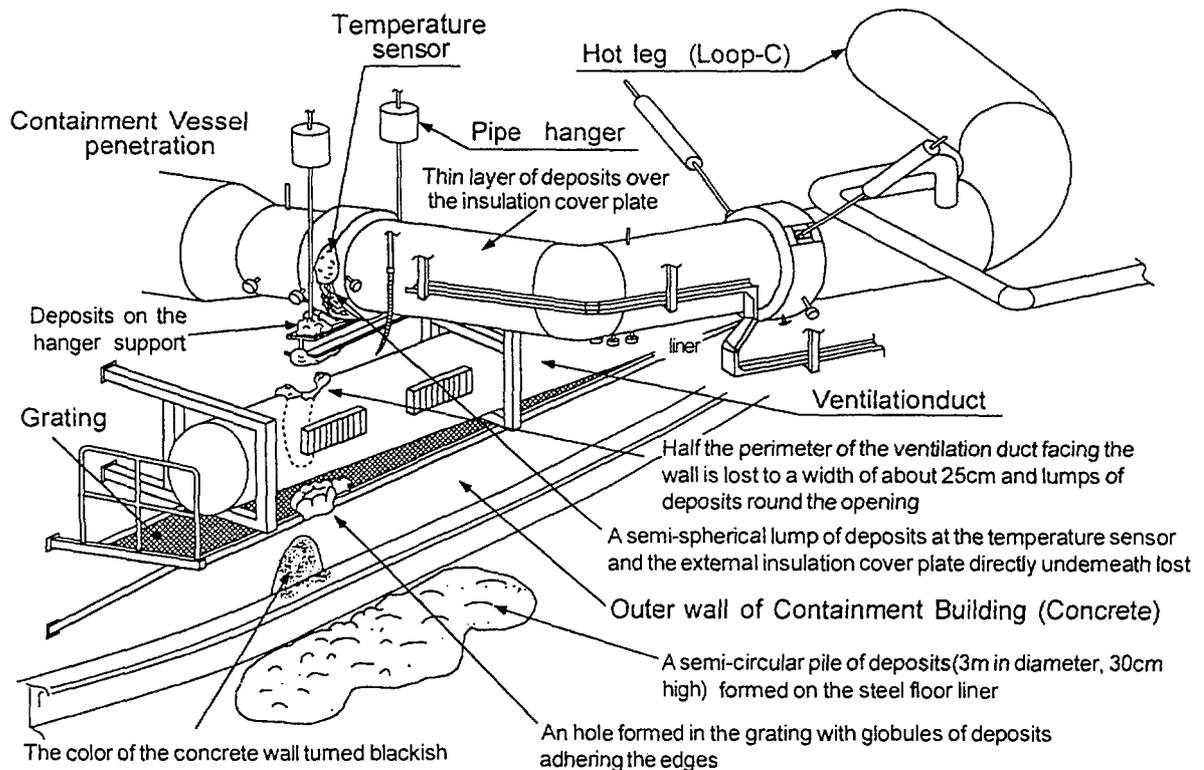
An inspection of the affected piping room on 9th December confirmed the presence of solidified materials associated with the sodium leak around and near the thermocouple well of the outlet of the secondary side of IHX. The state of the piping room after the sodium leak is shown in Fig.2. Approximately 1m³ of a sodium oxide on the 6 mm thick steel floor liner formed a semicircular mound, nearly 3 m in diameter and 30 cm high. Sodium aerosol was lightly diffused over and accumulated on the floor and walls of the room. The ventilation duct directly under the

Fig. 2. Sketch of the affected area.

thermocouple well developed a hole extending over half the perimeter facing the wall with lumps of deposits around the opening. On the steel walkway grating under the thermocouple well, an opening was formed with globules of deposits stuck around the edges. There were no further anomalies observed in the piping of the secondary circuit. Sodium compounds covered the entire floor of the loop C steam generator (SG) room adjacent to the piping room and the passages on the first and second floors.

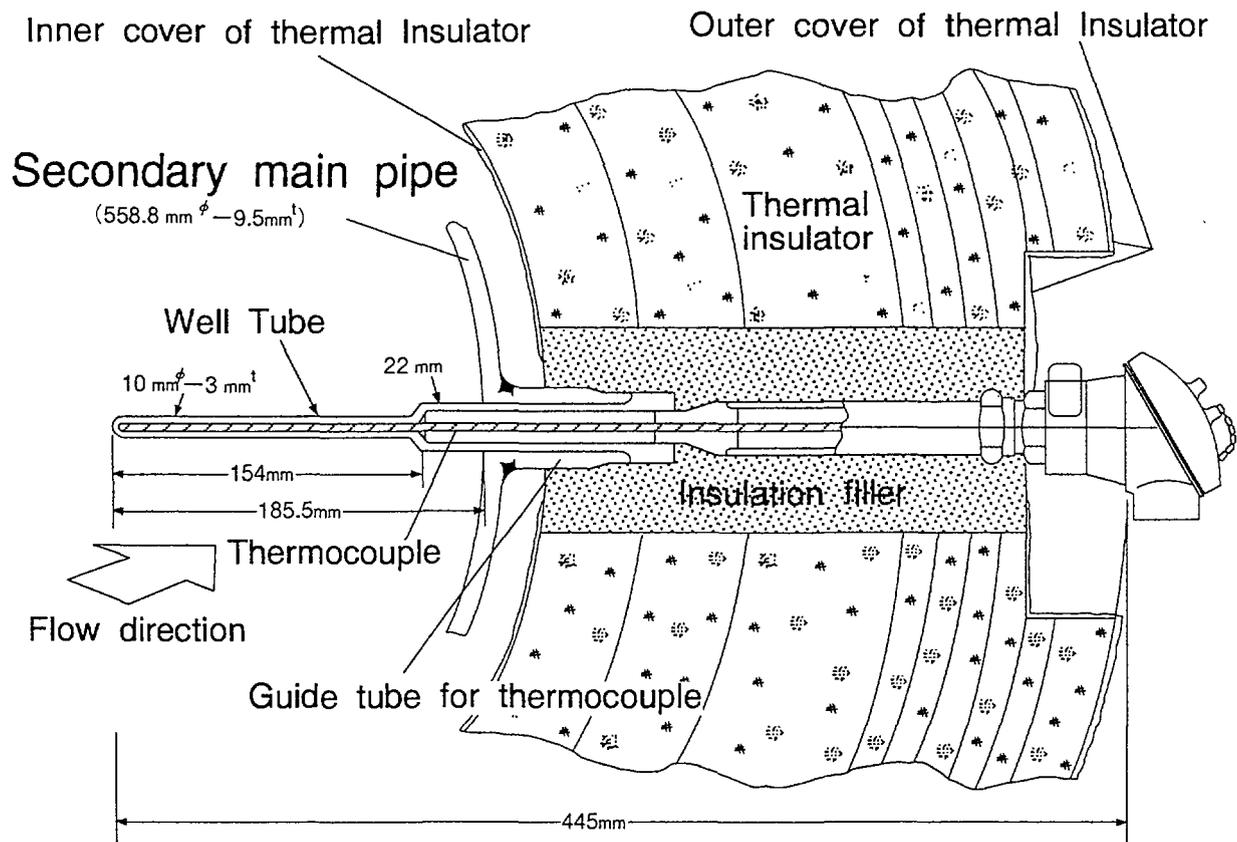
The thermocouple wires are enclosed by a sheath which is itself housed within the well tube. The tip of well tube is inserted horizontally into the center of the pipe. This tip (some 15 cm in length) is thinner in diameter than the base of the sensor. (Fig.3)

Fig. 3. The thermocouple well of the secondary circuit.

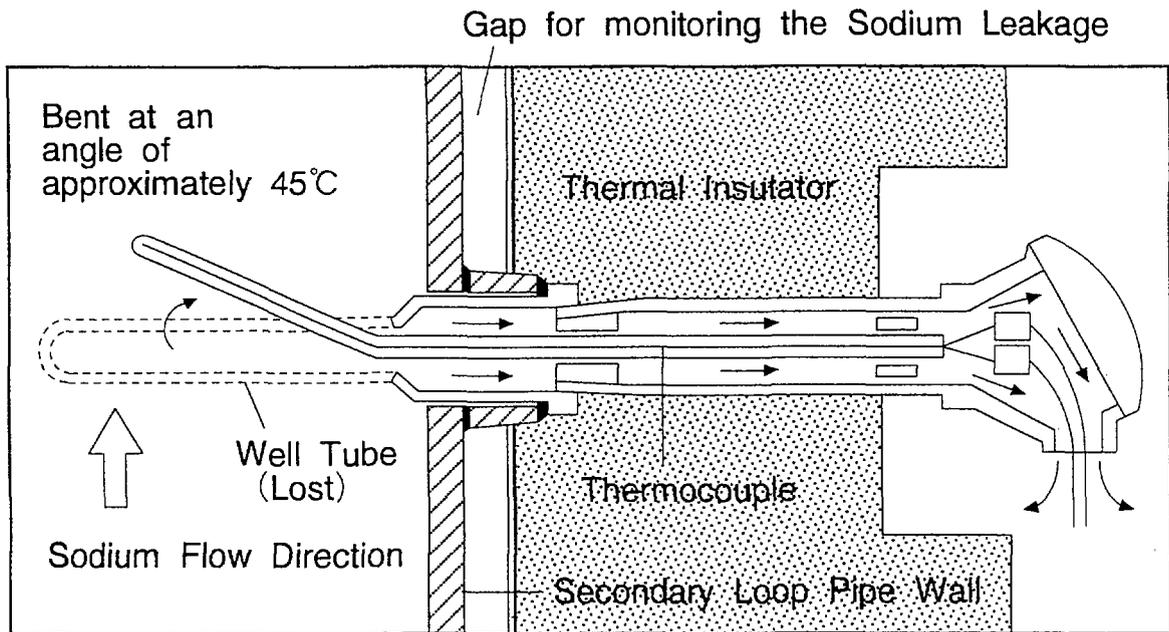
X-ray photographs were taken to estimate the extent of adherent sodium compounds around the temperature sensor and to assess structural condition. These revealed that the tip of the well tube was missing and the sheath containing the thermocouple wires was bent downstream. Other anomalies were not observed by the photographs. At that time, it was clear that the sodium leaked into the temperature sensor through the broken well tube. (Fig.4)

Fig. 4. The sodium leak flow path.

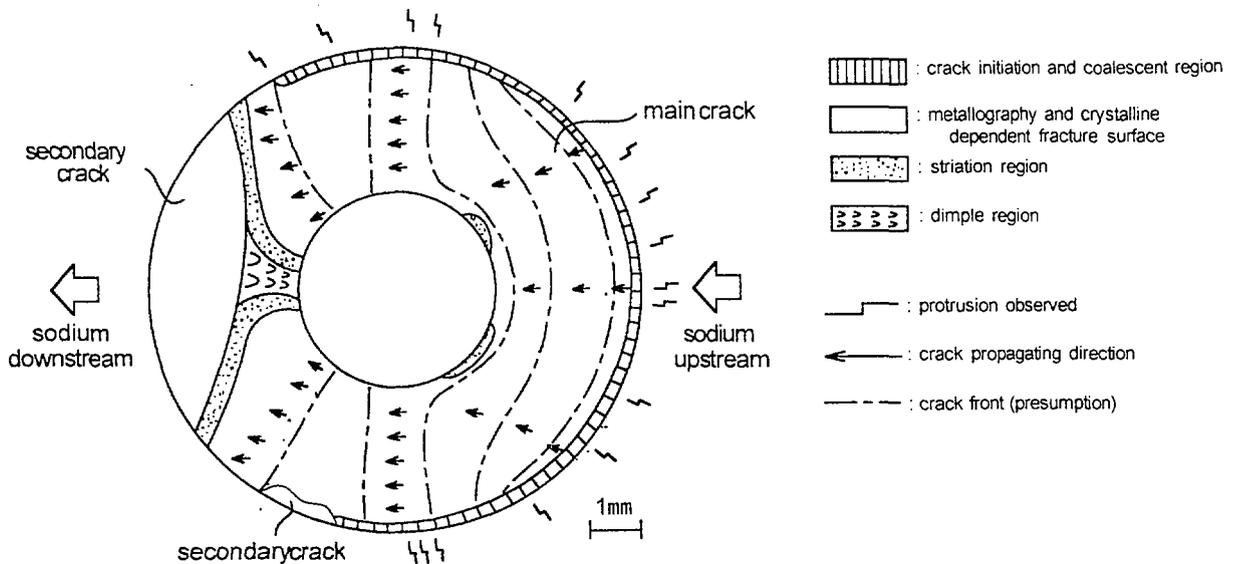
Detailed microscopic and metallographical examinations of the well tube and the fracture surface, examination of welded parts of the well, detailed examination of the sheathed thermocouple were carried out at JAERI and the National Research Institute of Metals (NRIM). The detailed measurement of the damaged part (fracture surface) was undertaken with microscopes and laser microscopes. As a result of these inspections, it was found that the fracture surface showed the typical features of high cycle fatigue with crack initiation, very slow propagation, and final ductile rupture, as shown in Fig.5. In parallel, flow-induced vibration analysis and mockup tests were conducted to identify the direct cause of the failure. These investigations confirmed that the breakage of the thermocouple well was caused by high cycle fatigue of the well tube tip due to flow-induced vibration. This vibration was not caused by well-known Von Karman vortex shedding, but a symmetric vortex shedding (Fig.6). According to fatigue crack analysis on the basis of the flow rate history, it was estimated that the cracks initiated at the early stage of the 100% flow operation, propagated in the subsequent operation, finally leading to the well tube failure in the last 40% flow operation. It was confirmed that the estimated breakage process agreed with the investigation results of the fractured surface and the full scale in-water experiment .

Fig. 5. Microscopic inspection of the fracture surface of the thermocouple wall.

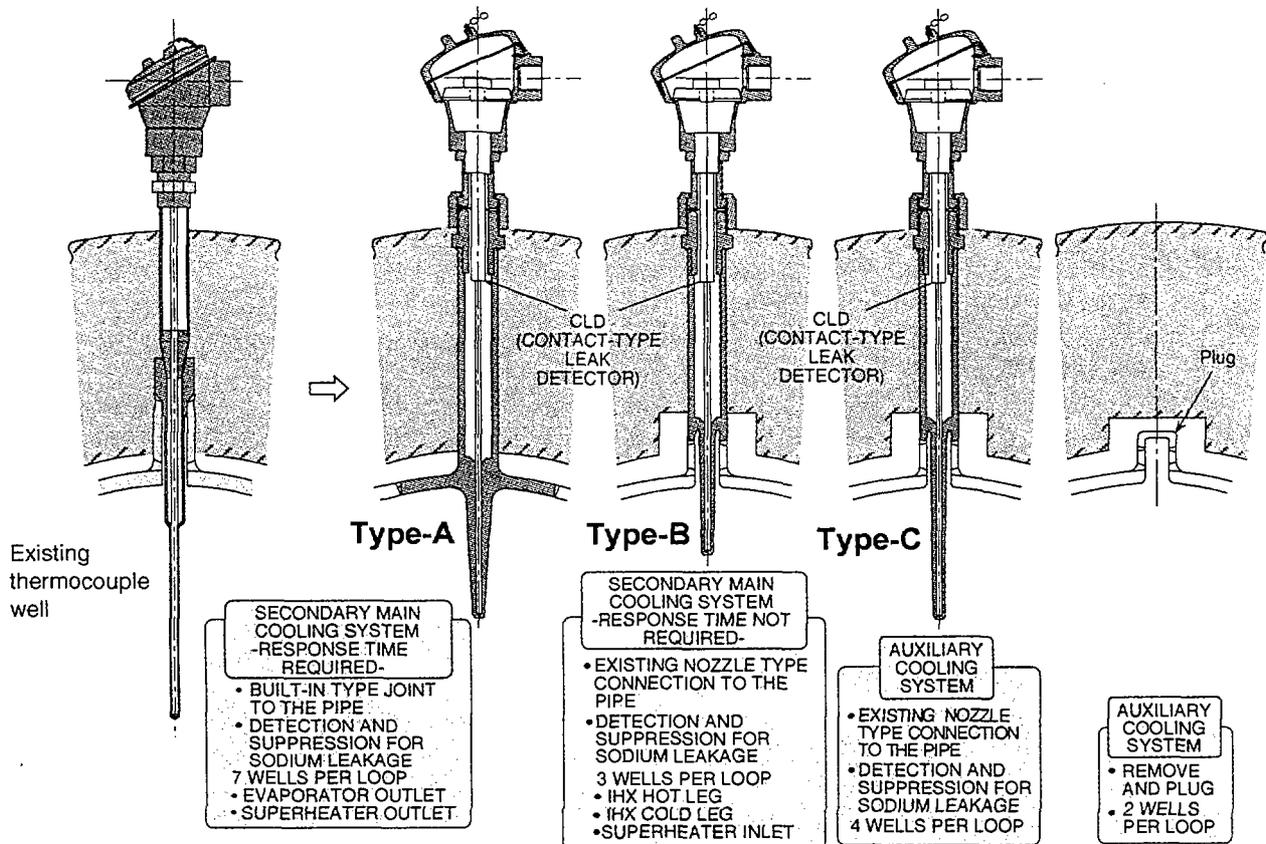
Fig. 7. Modified design concepts for the thermocouple wells on the secondary cooling system.

It was decided to replace all the thermocouple wells susceptible to vibration in the secondary circuit with modified designs. A new design guide against the flow-induced vibration was prepared by JNC. It is more comprehensive and definitive than the existing design guide "ASME N-1300".

Using this design guide, three new thermocouple well designs were developed, according to their functional requirements and locations. All the designs use a tapered well, instead of steep diameter change. A leak suppression mechanism is also incorporated into the new design. The three thermocouple designs, Type A, B, and C are shown in Fig. 7, along with the existing design. The "Type A" thermocouple well is directly welded to the pipe wall, while the "Type B" and "Type C" thermocouple wells are mounted on the existing nozzles. The three design types have different penetration designs and different insertion length into the flowing stream.

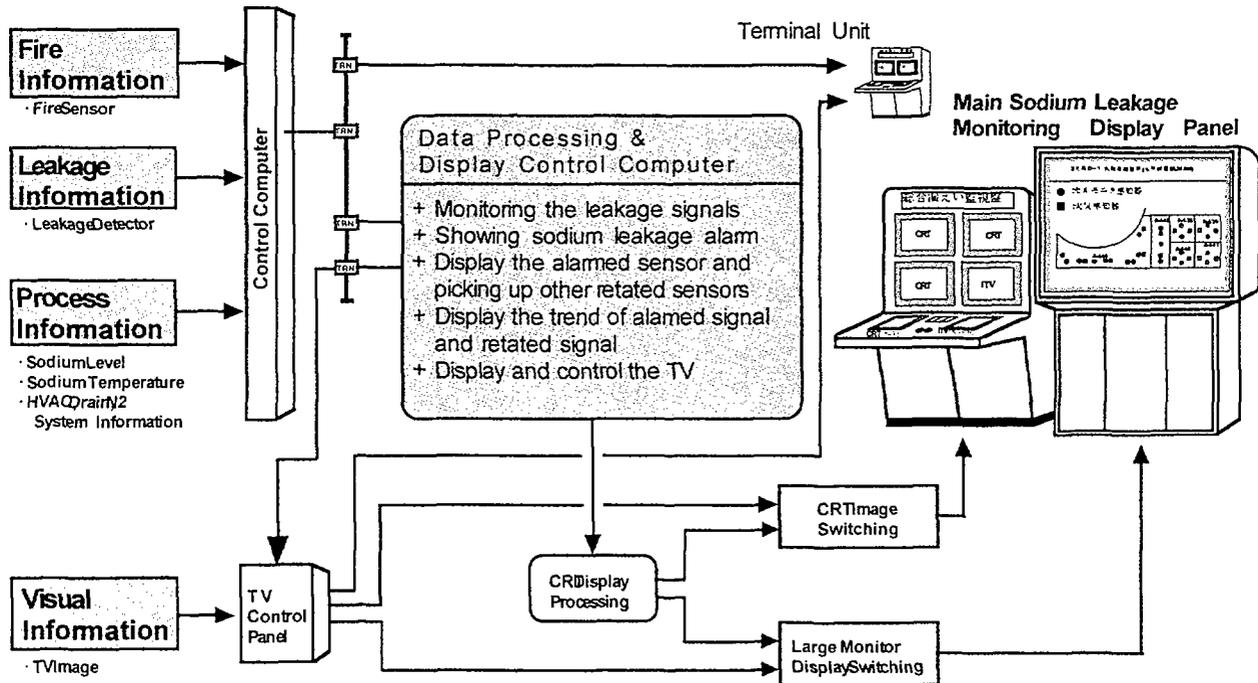
Fig. 8. Organization of integral leakage monitoring system.

A monitoring display panel will be installed in the main control room and information from the various sensors and TV cameras will be displayed. The new leakage monitoring system should enable the plant operators to take the necessary actions - such as a plant trip and loop drain - earlier, since they will be able better to understand the condition at the leak site without leaving in the main control room. A schematic of this system is shown in Fig.8.

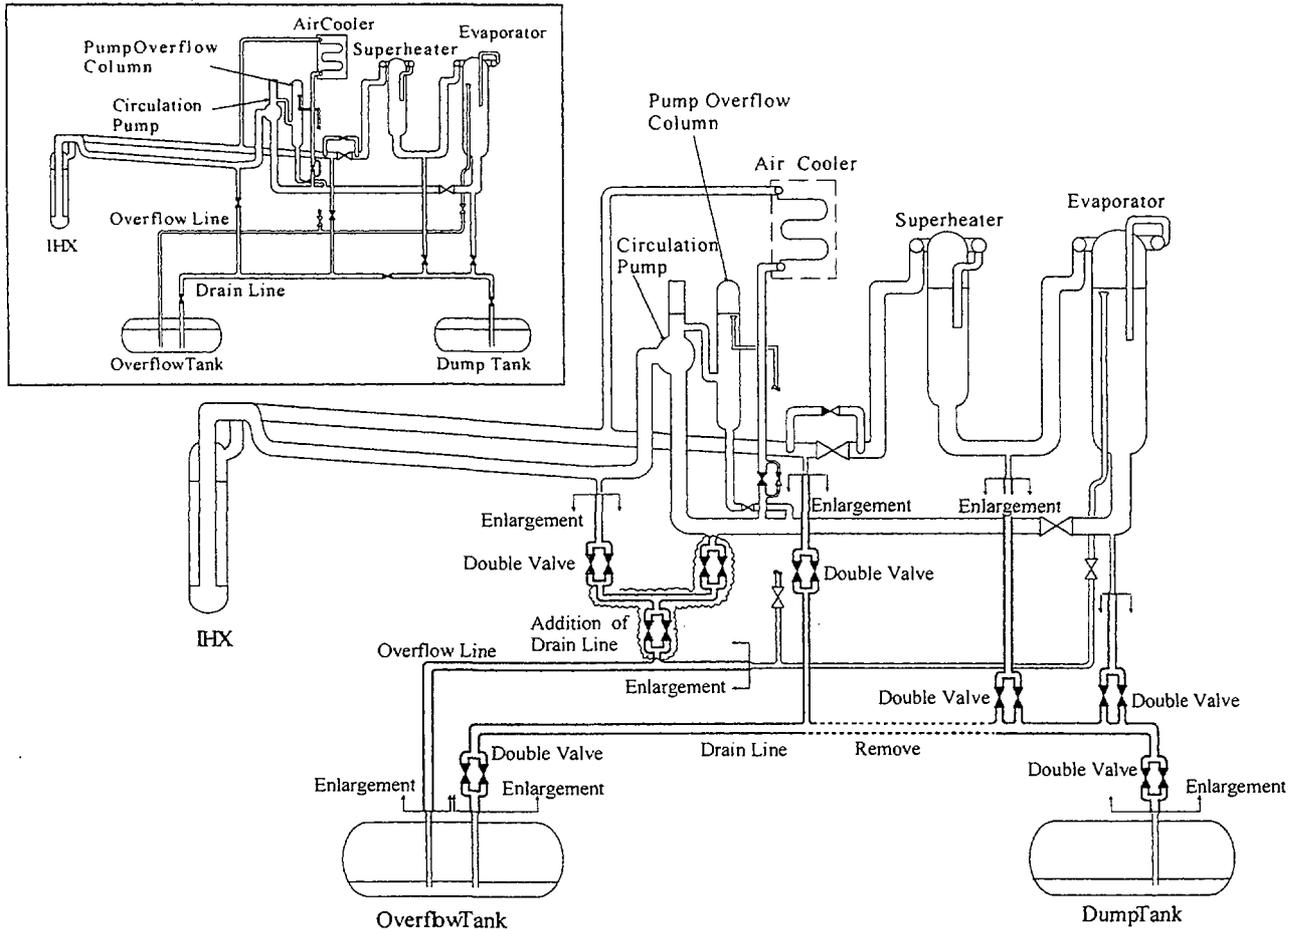
Fig. 9. Modified drain system.

To reduce the quantity of sodium leakage, the drain system was found to require two improvements. One is the addition of a new drain line pipe at the inlet of the secondary pump. The other is the replacement of all drain lines by pipes of larger diameter. In the existing system, each drain line has two drain valves in series to prevent accidental draining by single valve action error. In future so as to assure the draining, each drain line will have double drain valves in parallel. After these improvements, the drain time will be shortened from approximately 50 minutes to 20 minutes. It is estimated that it takes 40 minutes from the occurrence of sodium leakage to finish the drain for the secondary circuit. The modified drain system is shown in Fig.9.

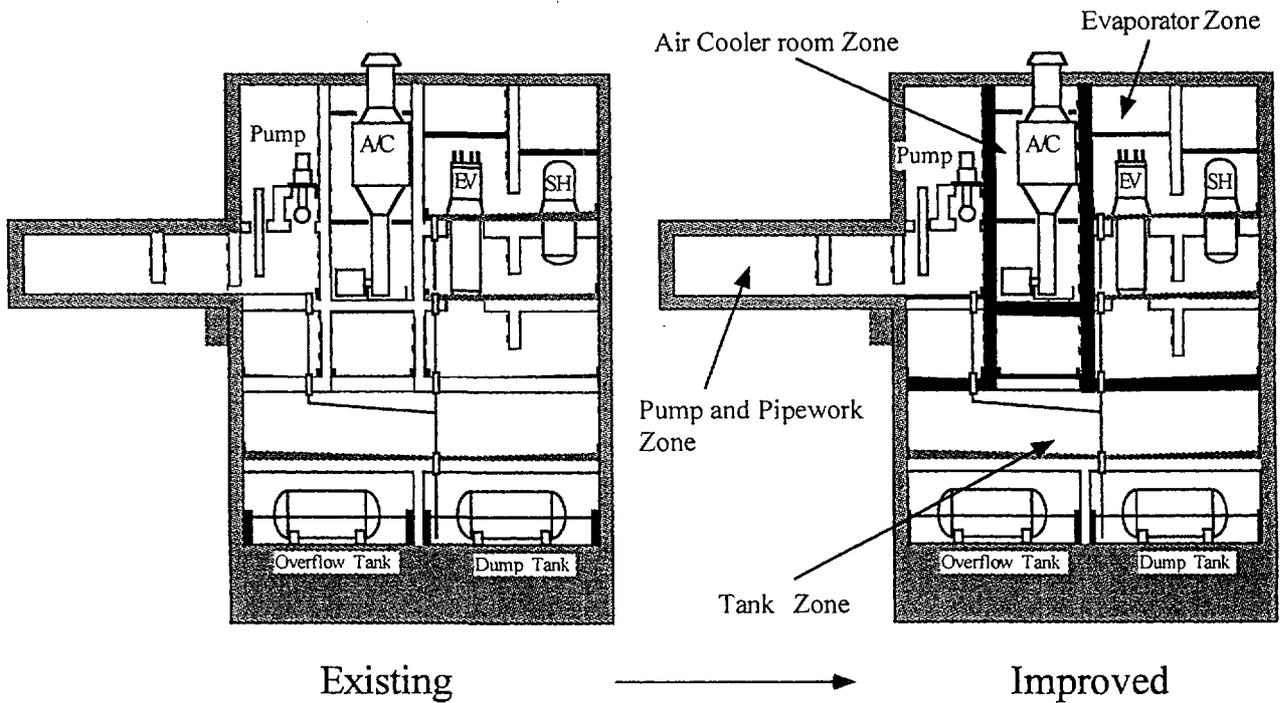
Fig. 10. Partition of the secondary circuit area.

To limit the diffusion of aerosol and the combustion of sodium more quickly, the area associated with each secondary circuit will be divided into four smaller zones. At first, more than four smaller zones were considered because partition is effective in controlling the diffusion of aerosol. However, it was found to be difficult to provide a dust-tight structure for some of the large openings between the proposed zones which allow air transfer. It was also difficult to prevent pressure in smaller zones from increasing and it is almost impossible to replace the existing ventilation ducts. Hence, four zones were adopted as the optimal solution. The openings for the cables or pipe penetrations through the wall between each zone will be improved to be almost airtight and additional isolation dampers will be fitted in the ventilation ducts between each zone. Pressure release lines will be installed to prevent an increase in internal pressure resulting from the smaller zones. The partition of the secondary circuit area is shown in Fig.10.

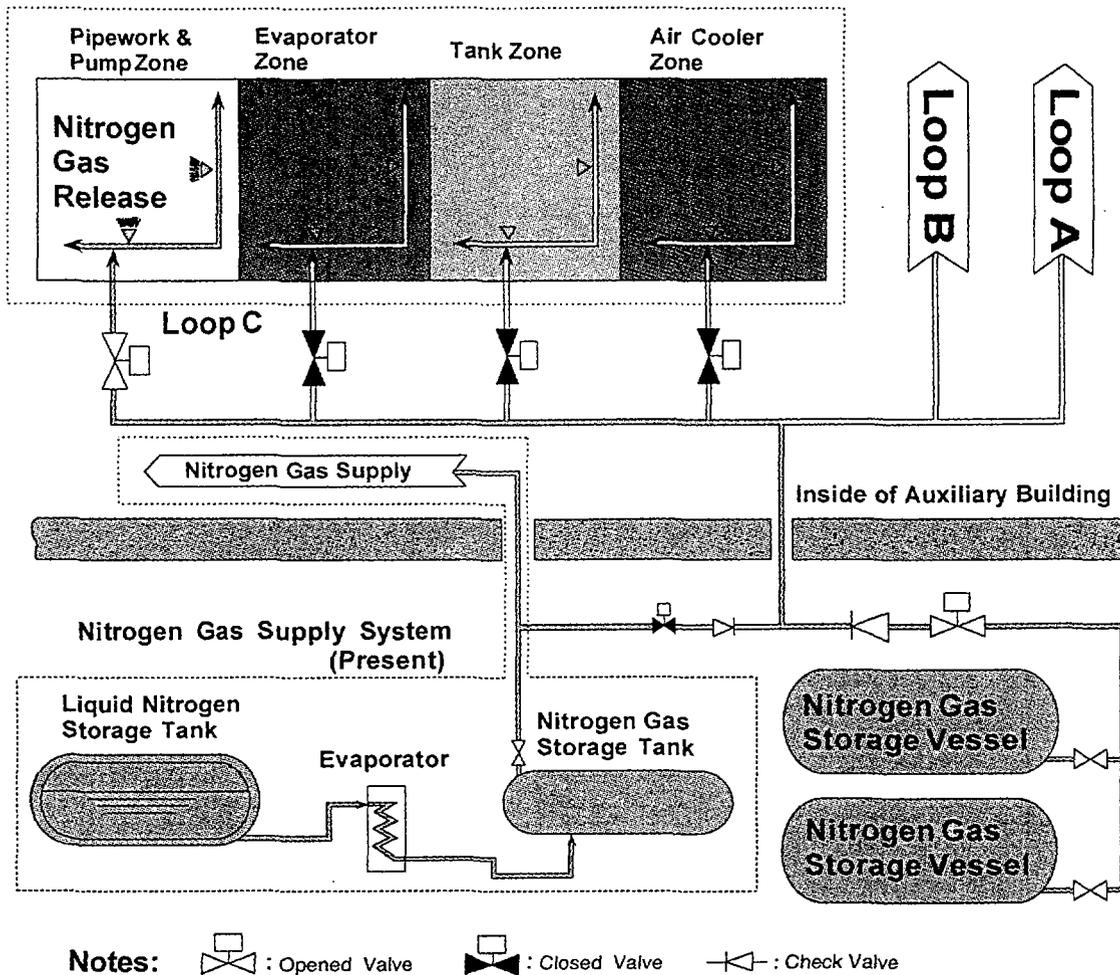
Fig. 11. Nitrogen injection system.

To extinguish the sodium fire more quickly and to prevent it from re-igniting in contact with oxygen, a nitrogen gas injection system will be installed to cut off the supply of oxygen. The nitrogen injection system is shown in Fig.11. The tanks are common to the entire system and the piping is connected to the each zone. After the personnel evacuation of the secondary circuit is confirmed, the operator will release nitrogen gas into the affected zone. According to an assessment of the relationship between nitrogen flow rate and extinguishing time, if more than 10,000 Nm³/h of nitrogen gas is injected, a sodium fire can be extinguished within 15 minutes for any sodium leak rate.

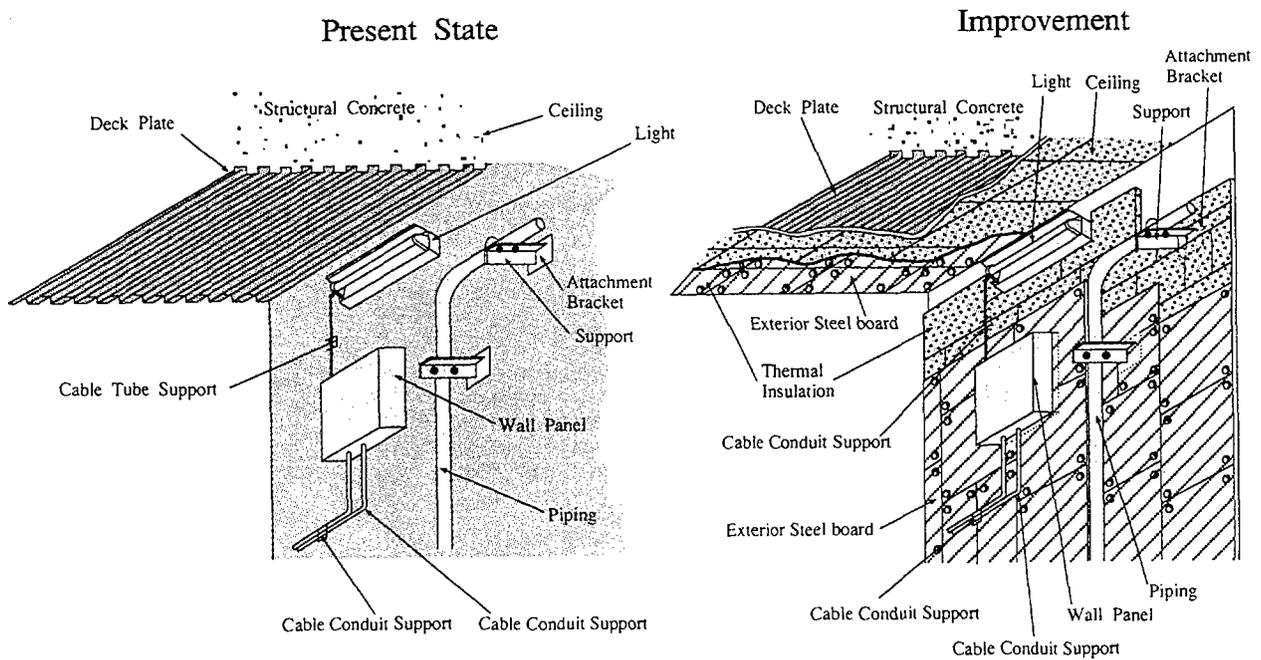
Fig. 12. Thermal insulation for walls and ceiling.

To reduce the water release from the structural concrete, thermal insulation will be fitted to the walls and ceilings. This is important because if a large amount of water vapor is released from the concrete during a sodium leak, there is an increased probability of generation of hydrogen and corrosive hydroxide in the chemical composition of the sodium debris. By using insulation, the temperature rise of the wall can be brought down to under approx. 100°C. The structure of thermal insulation is shown in Fig.12.
