UNUSUAL OCCURENCES IN FAST BREEDER TEST REACTOR

R.P. KAPOOR, G. SRINIVASAN, T.R. ELLAPPAN, P.V. RAMALINGAM,
A.T. VASUDEVAN, M.A.K. IYER, S.M. LEE, S.B. BHOJE
Indira Gandhi Centre for Atomic Research,
Kalpakkam, India

Abstract

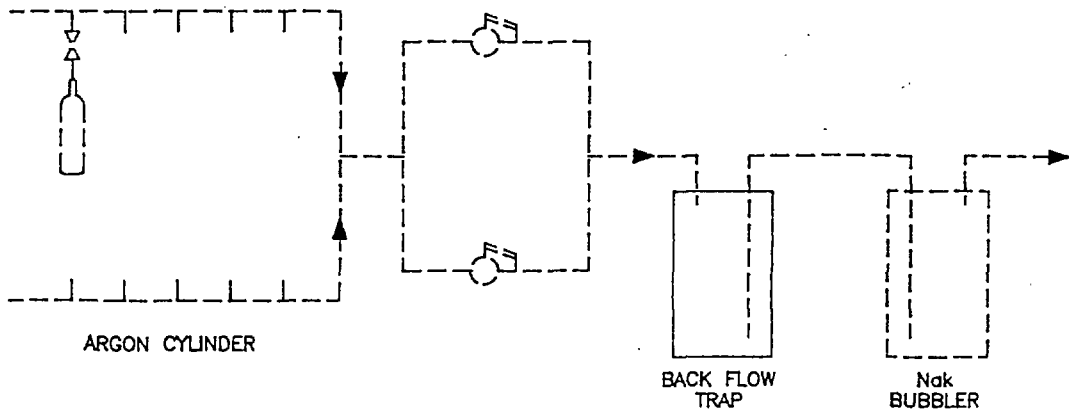
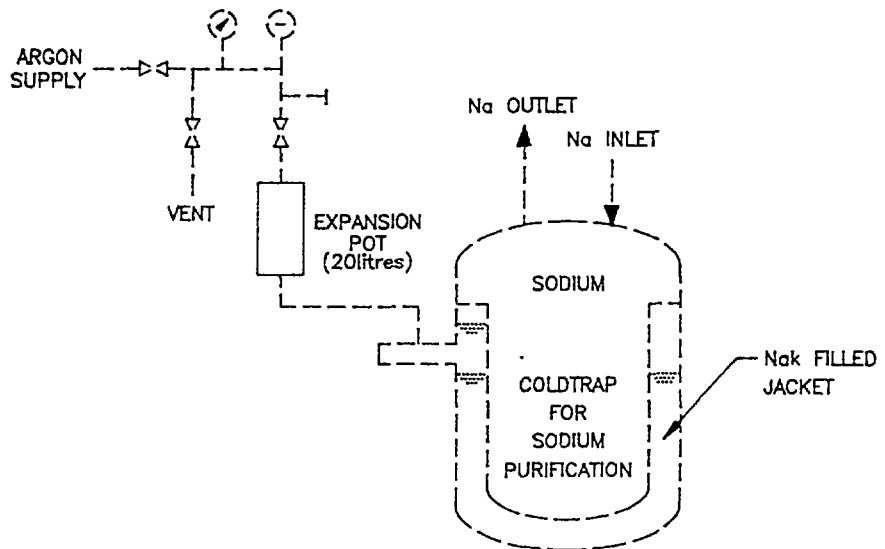
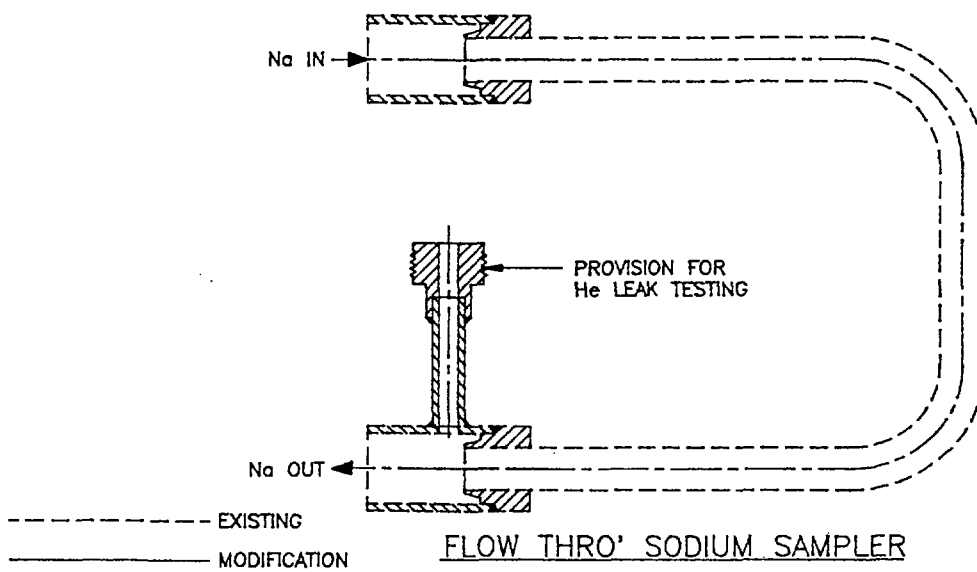
Fig.5

SODIUM/NaK LEAK INCIDENTS

3.1.2 Secondary sodium sample is required to be taken twice a year for chemical analysis. About one litre of sodium leaked out (Sept 87) through a swagelok coupling while putting in service the secondary sodium flow through nickel sampler. The fire was fought using DCP and CO₂ extinguishers and was put off in 30 min. To prevent recurrence, provision was made for helium leak testing of swagelok coupling joints after installation of the sampler. Over flow type sampler with conoseal joints for better leaktightness and more representative sampling was also installed in one of the secondary loops.

3.1.3 During adjustment of pressure setting of the regulating valve in supply argon system (May 88) about 2 l of NaK backed up and leaked out from the NaK bubblers provided for supply argon purification. The NaK leak was carefully collected in a tray covered with DCP and safely disposed off within 30 min. As a remedial measure, a backflow trap of 50 l capacity was introduced on the upstream side of bubbler and a pressure equalising valve was provided across it.

expansion of NaK during preheating phase. Surface thermocouples were also provided to follow NaK temperature during pre-heating.

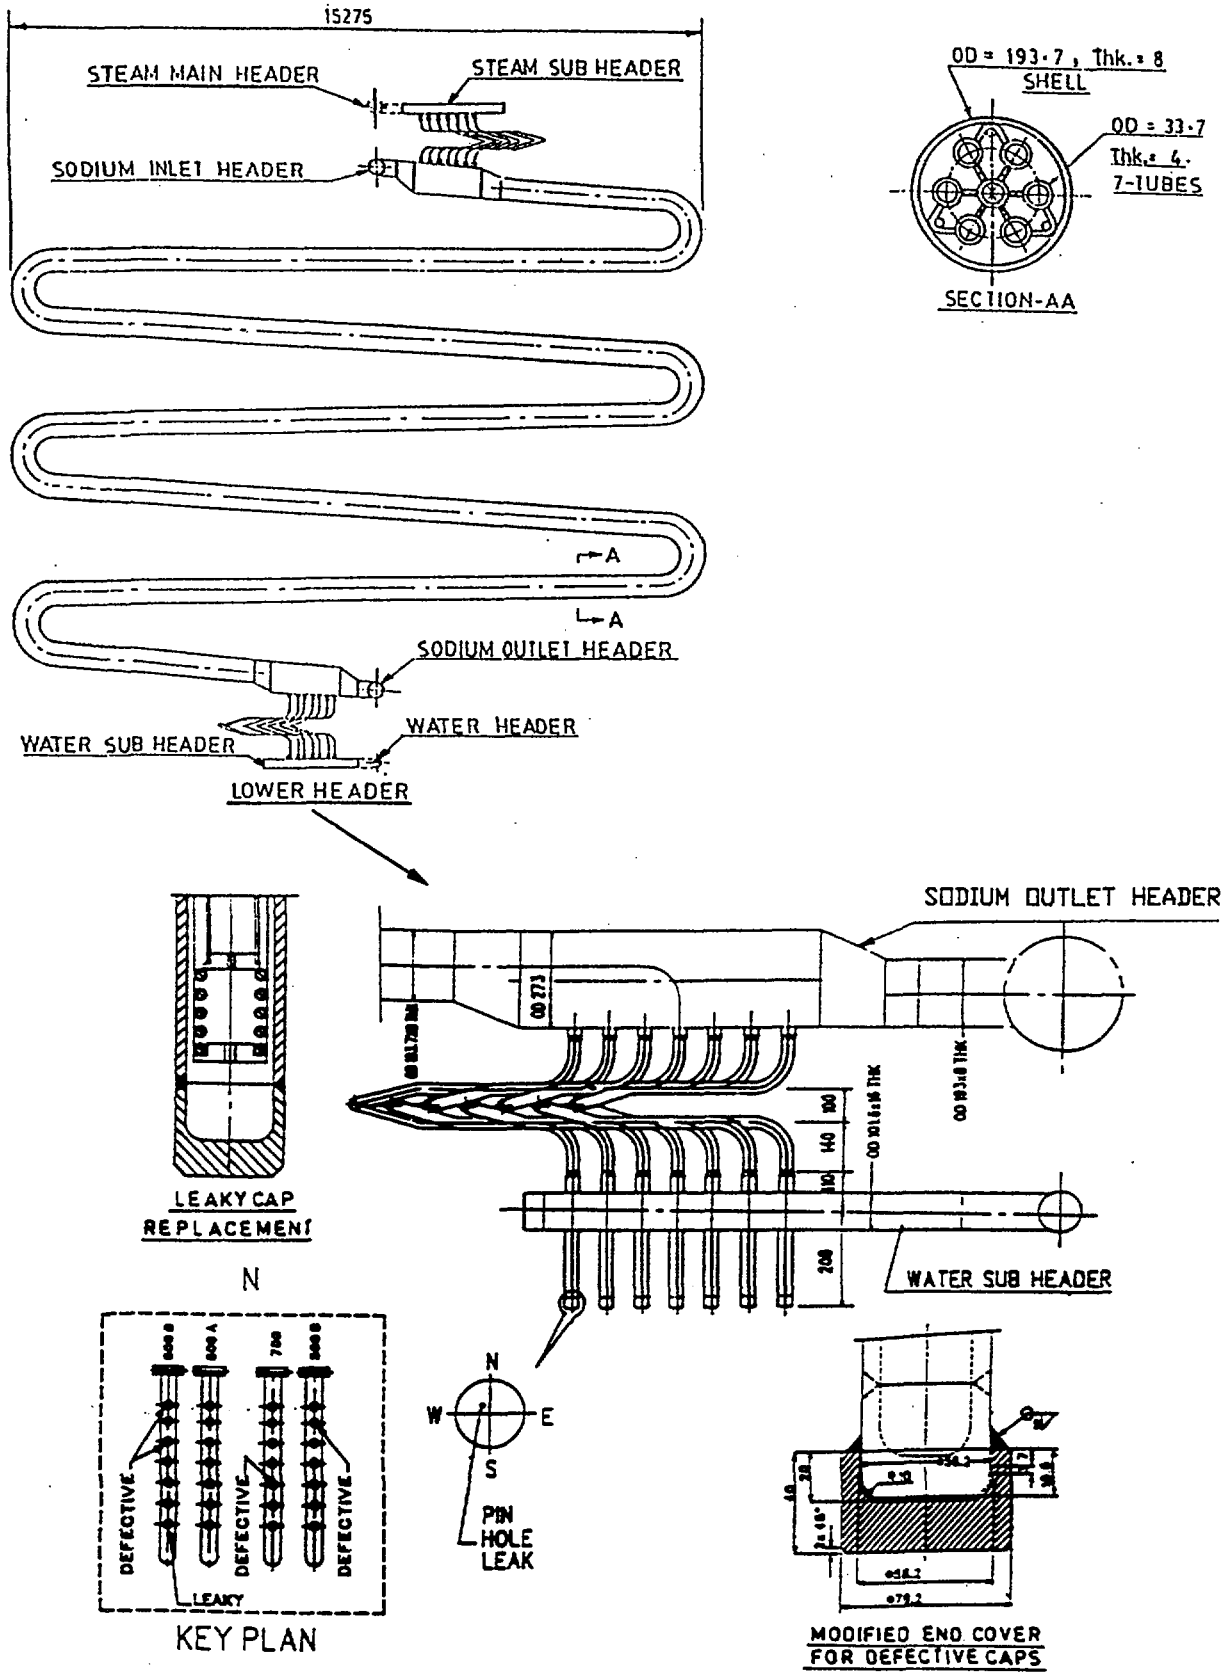
Fig. 6

3.2.1 In Jan 93 when SG was put in service for the first time, after 70 h of operation at 4 MWt, a water leak took place due to a linear pin hole defect in the end cap of one of the orifice assemblies at SG inlet. All similar caps (35 numbers) were ultrasonically inspected and four more were found having indication of linear defects. The leaking cap was replaced and additional covers were welded on the defective caps and SG modules requalified (Fig 6). This was attributed to inspection (having less capability to detect such defects) before accepting the material for fabrication of these caps.

3.2.2 Water subheaders of the 4 modules of the SG are provided with flanged orifices located inside the SG casing for flow measurement to study SG stability. In Aug 93, when reactor was operating at 8 MWt, feed water was found leaking through the orifice flanges. Investigation revealed that the leaktight orifice flanges under ambient conditions tend to develop leak under operating conditions as a result of differential thermal expansion between the water subheaders and the SG modules. All the orifice flanges were replaced with welded spools with integral orifices.

3.2.3 In Feb 98, when reactor was in shutdown state, while readjusting the settings of SG safety valves, water leak was observed in one of the bosses in experimental thermowell in the steam subheader of one of the SG modules. These thermowells are also provided for SG stability studies. The leaking thermowell boss and plug were replaced with a dummy piece of similar dimensions to have the same flow restriction in the path. Liquid penetrant inspection (LPI) was carried out on all similar welds in the four SG steam subheaders and no defective indications were noticed. Investigations revealed that this was due to lack of heat treatment of this part during fabrication.

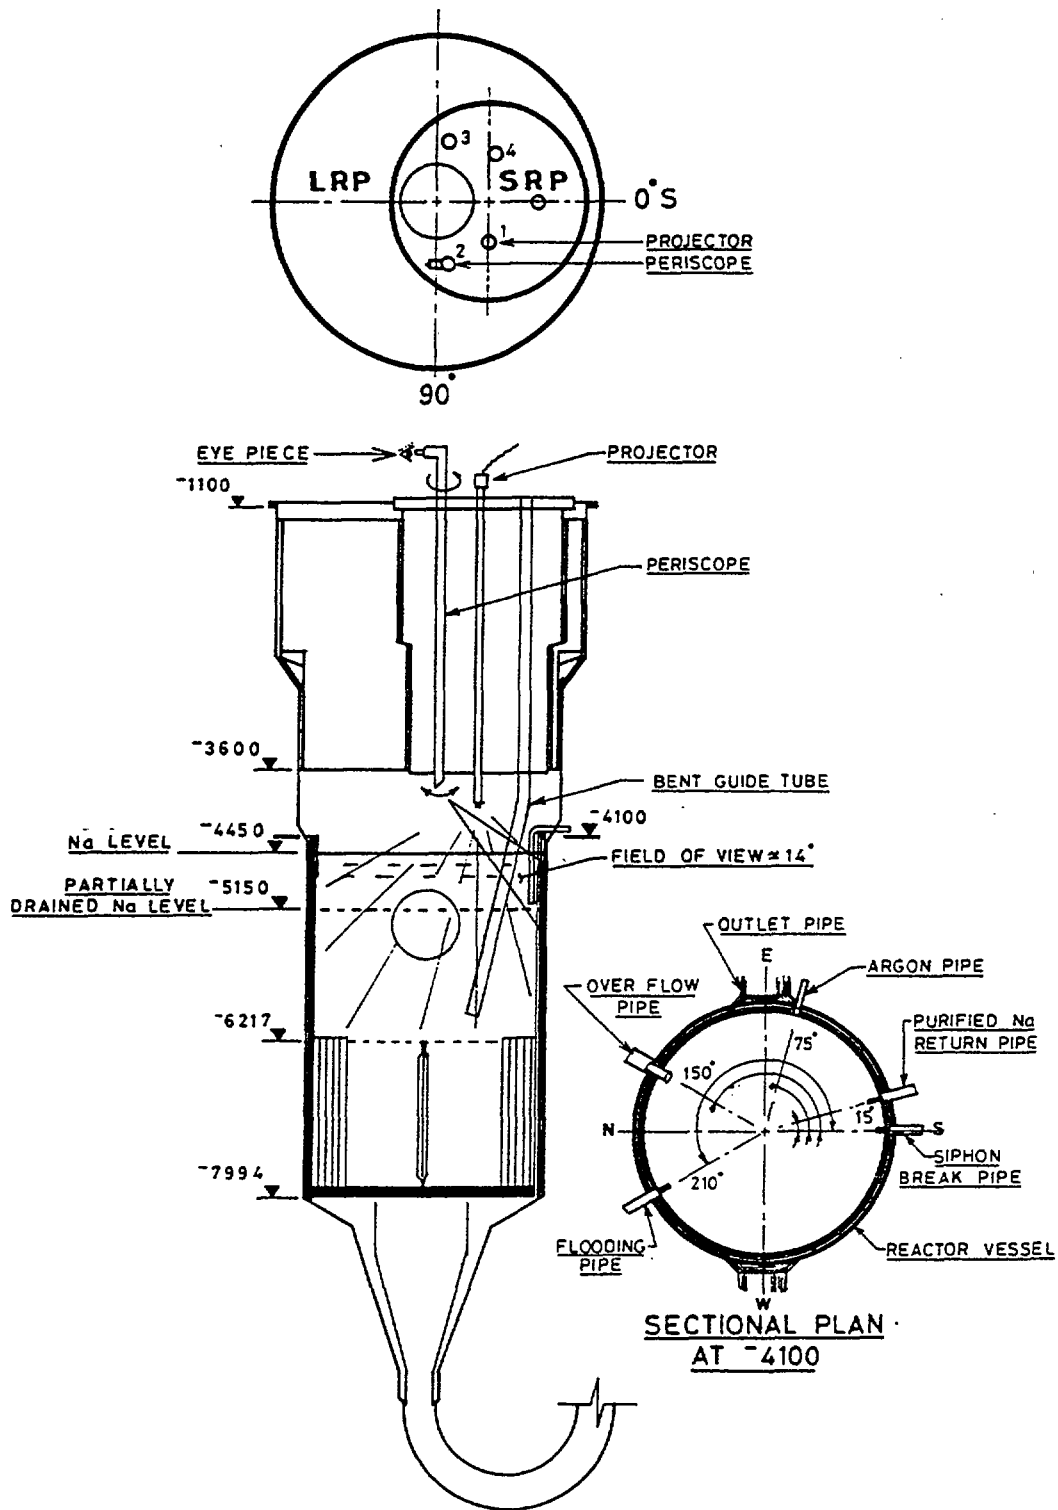
Fig.7

Three techniques were developed and utilised to assess the bend of the guide tube, viz., optical inspection, ultrasonic air gauging and mechanical disc gauging. Optical inspection was carried out with a periscope/projector system (Fig 7). Sodium was drained to expose the heads of SA and the bend of guide tube was measured by finding out the radius of sweep of its

bottom tip with reference to heads of SA when it is rotated on its own axis. This inspection also indicated a lifted SA at the periphery where manoeuvres to lower the fuel SA were earlier made. Slight deformations of the heads of some of the reflector subassemblies along two spiral paths were also seen (Fig 8). Ultrasonic air gauging method involved lowering of an

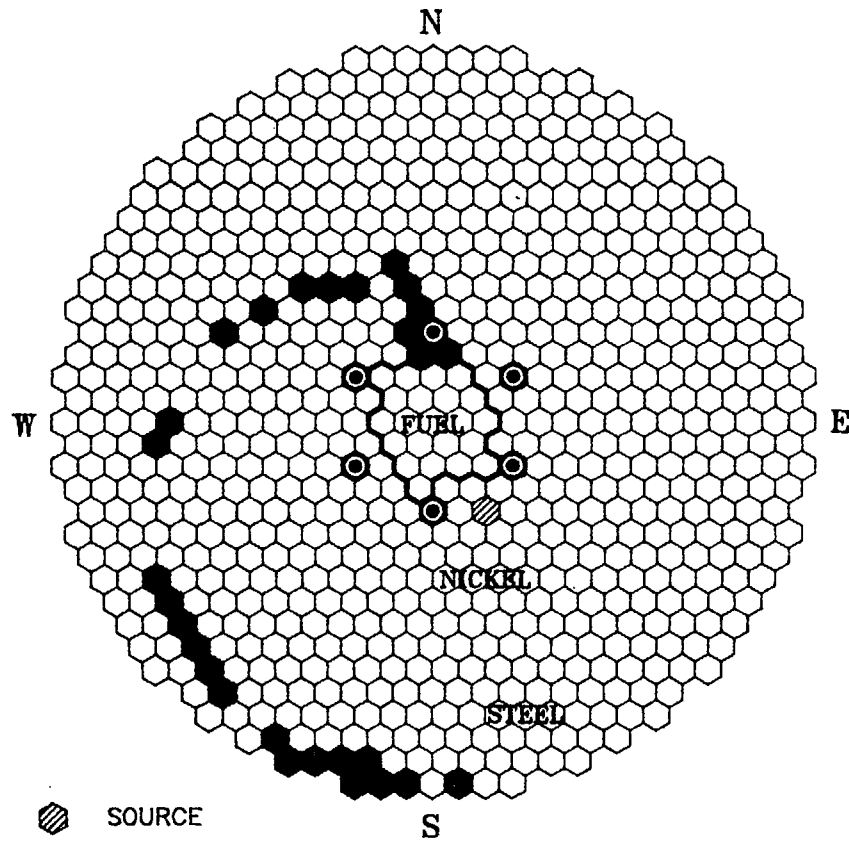
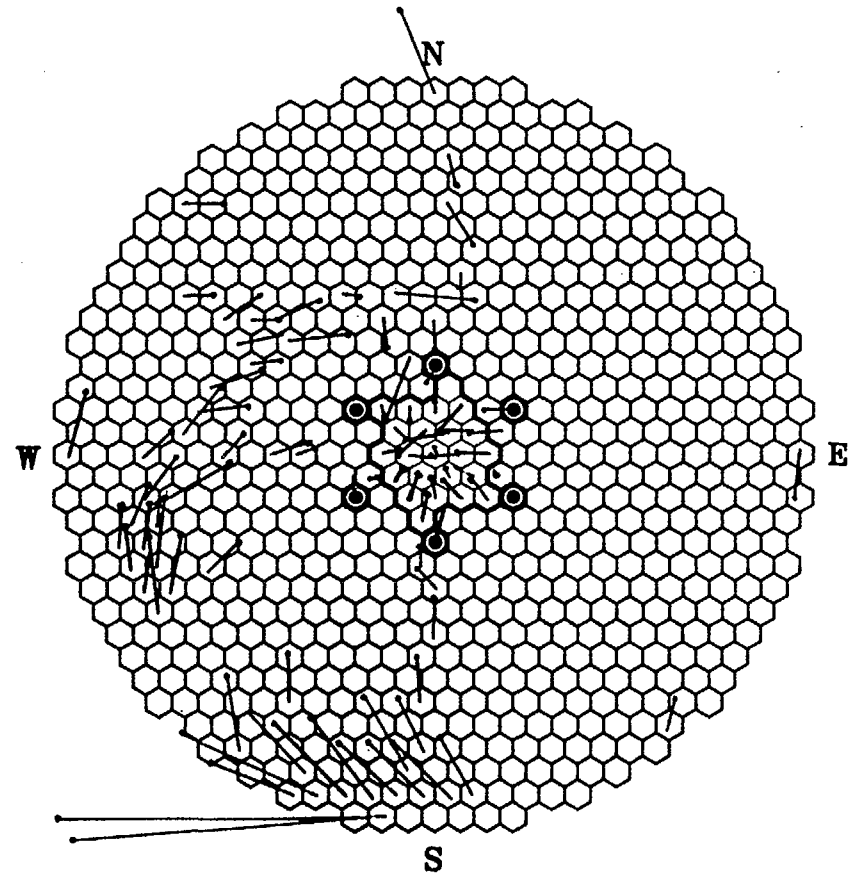
Fig.8

DAMAGED SUBASSEMBLIES DURING FUEL HANDLING INCIDENT

The retrieval of the damaged SA was another work successfully executed on the pile. Since the core was relatively new, radioactivity levels were very low. Hence all the SA were directly viewed and mapped through a transparent plate fixed on top of the fuel handling canal and 18 numbers of steel and nickel reflectors SA were identified for replacement. The retrieval operation was done using a two-finger gripper mechanism especially engineered for this purpose. Subsequently core coordinate measuring device (Tube de visee), received from France, was utilised to inspect 88 SA in the vicinity of the damaged path and 10 more reflector SA having minor bends in their heads were also replaced (Fig 8).

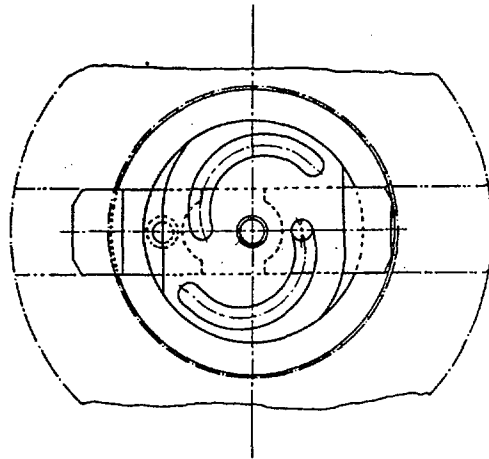
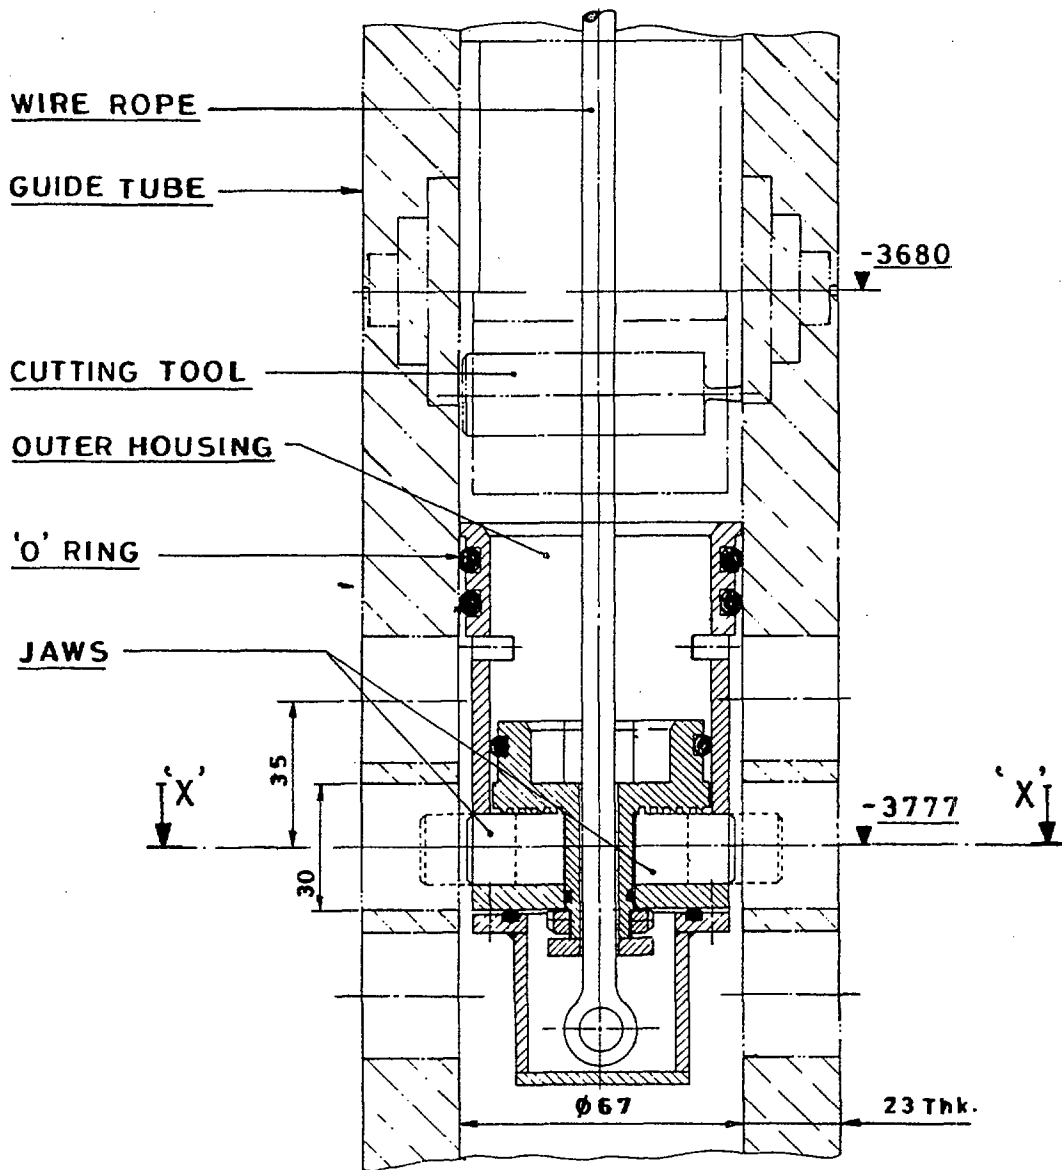
Fig.9

The design of leaktight remote cutting tool had the following special features; The cutting to be done at a depth of 3 m, the tool to be accommodated within the guide tube bore of 67 mm and provide a depth of cut of 23 mm without tool chatter, the bottom portion of the cut guide tube to be held in position till the top part is removed, no cutting chips should fall into the reactor and leak tightness should be maintained during the cutting operation. An elegant remote cutting tool having these features was developed and it consisted of assembly of telescopic tubes for transmitting the rotational movement to the tool and controlling and monitoring the axial travel and depth of cut from the top. No lubricant was used and special features were provided to recover all the chips generated. This tool also employed a leaktight plug anchored to the bottom part of the guide tube to maintain leaktightness w.r.t. reactor cover gas, to collect the chips generated and to hold the bottom part during complete process of cutting and retrieval (Fig 9). The cutting sequence was carefully chosen to permit radial entry of the tool holder along the guide tube thickness during the last stages of cutting, thus avoiding tool chatter. After successful mockups, the tool was perfected and with microprecision the in-situ cutting and retrieval of the damaged guide tube was successfully completed in May 88. Measurement of the profile of the cut guide tube indicated a deformation of 350 mm, bearing full testimony to the reliability of the various remote methods employed to measure the bend.

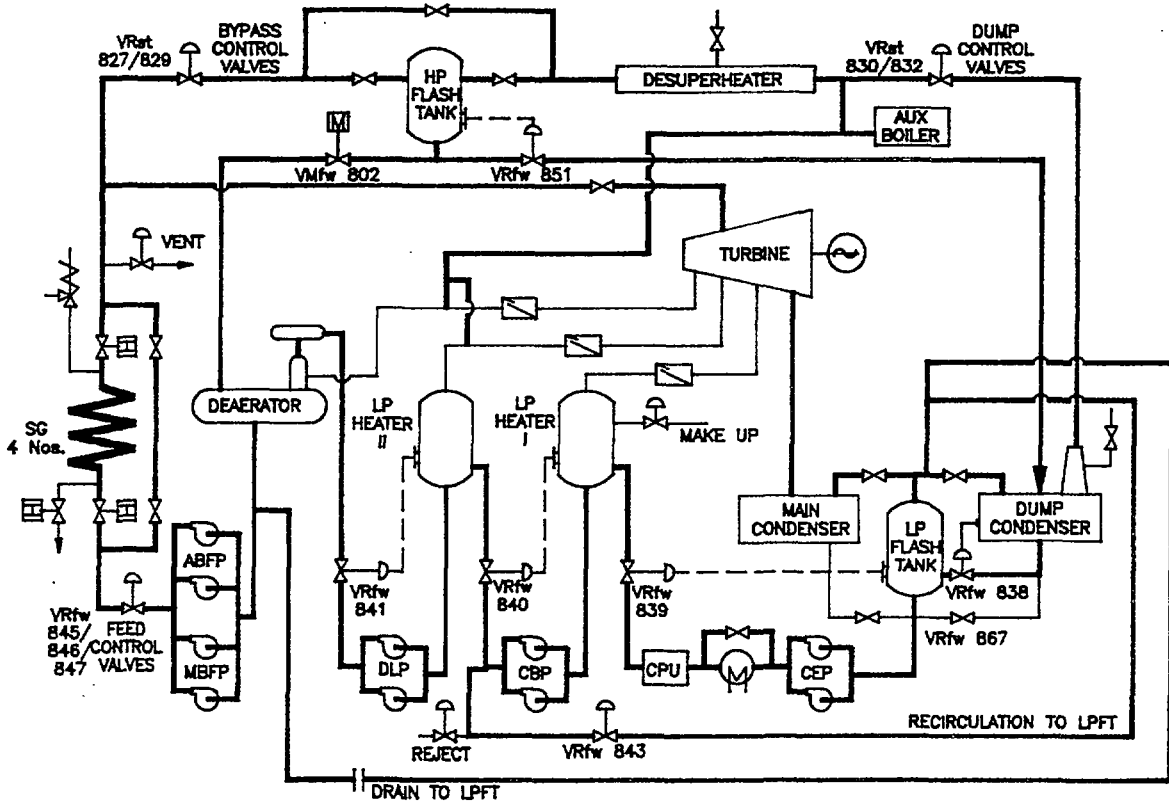
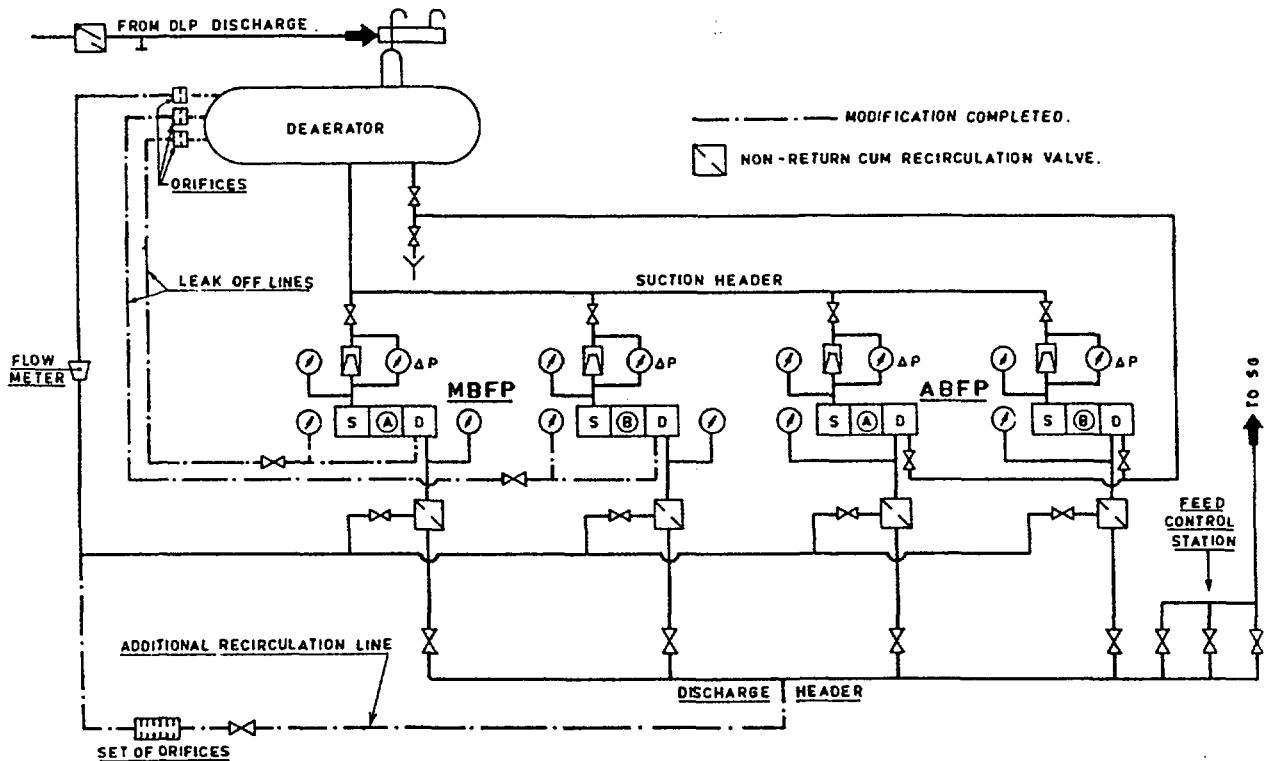
Fig.10

In Apr 92, this pump was being used at a flow of around 17 m³/h for preheating feed water by its own power for putting SG in service. At 165°C feed water temperature, abnormal noise was heard from the pump with large fluctuations (110 to 170 kg/cm²) in its discharge pressure gauge. The motor current crossed full scale of 75 A and there was reduction in feed water flow. The pump was immediately stopped and on inspection motor drive end thrust pads and most of the stages of impellers, were found damaged. Water lubricated hydrostatic bearing sleeve was found seized. Balancing piston and sleeve had scoring marks.

With the site location of deaerator from which the pump takes suction, the available NPSH varies from 8.69 to 8.52 mlc, which under normal operating condition for full flow is adequate. During investigation, it was found that prior to the incident condensate system had to be shutdown to attend to some instrumentation problem. MBFP was kept in recirculation mode and system preheating was continued. Restoration of condensate system later on resulted in admission of cold condensate to deaerator causing collapse in deaerator pressure and hence reduction in available NPSH resulting in severe cavitation and flashing at the pump inlet and causing damage.

Modifications to improve available NPSH at pump suction were carried out viz.; balancing leak off line which was earlier heating the suction was routed to the deaerator, continuous cold injection was ensured at pump suction to improve transient performance, additional recirculation line was added to avoid pump operation at low flows. Operating procedures were modified and feed water heating by package boiler steam was strictly adhered to. This resulted in a delay of 8 months to put the SG in service.

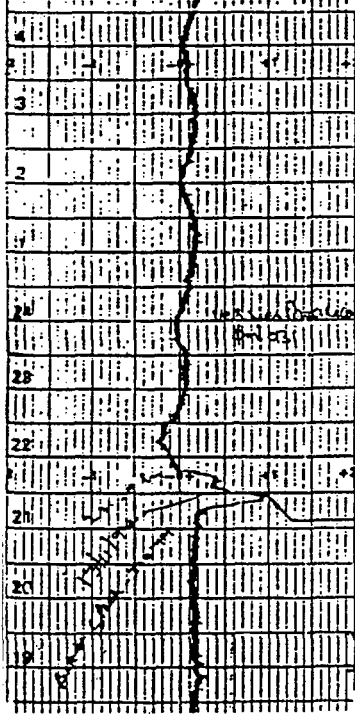
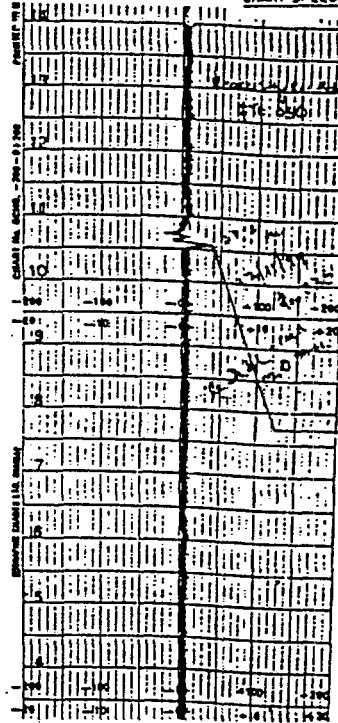
REACTIVITY TRANSIENT OF 13.11.94

In Nov 94, when the reactor was operating at 10.1 MWt, power was found to be slowly increasing. Though the control rods were lowered one by one, the power continued to rise and reached 10.4 MWt in about a minute. The control rods were cumulatively lowered by 7.6 mm and the power was brought down to 10.1 MWt. The reactivity meter registered a spike of 3 pcm during the incident. Reactivity before and after the incident did not reveal any measurable permanent reactivity gain.

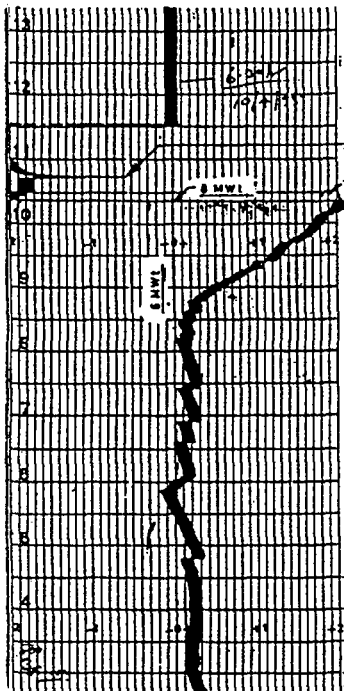
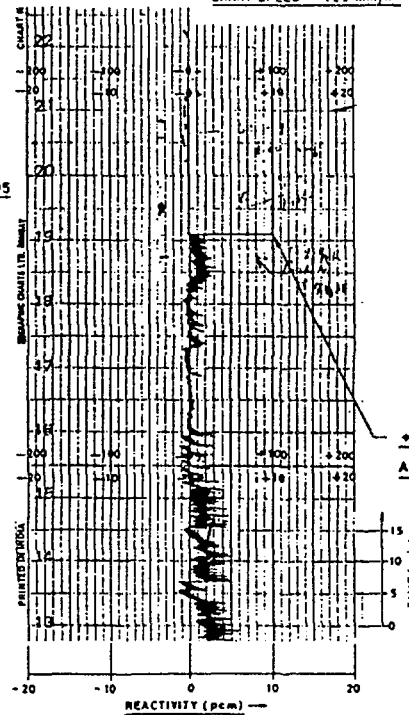
REACTIVITY TRANSIENT OF 10.04.95

In Apr 95, during a startup, when the reactor was at 7.1 MWt, power increased sharply by 450 kWt in 7 s. No control rod movement was made at this time. Reactor underwent a scram on high positive reactivity and the recorder indicated a spike of + 10 pcm. Criticality measurements before and immediately after the incident revealed a reactivity gain of about 24 pcm. However, a reduction of this value to 14 pcm was observed upon subsequent measurements. The measurement error itself is of the order of ± 10 pcm.

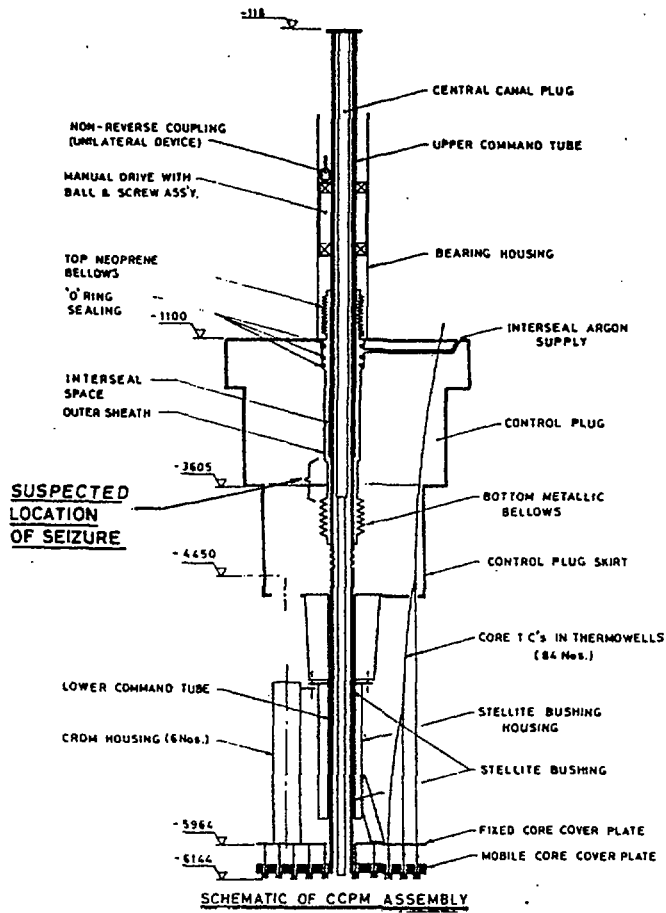
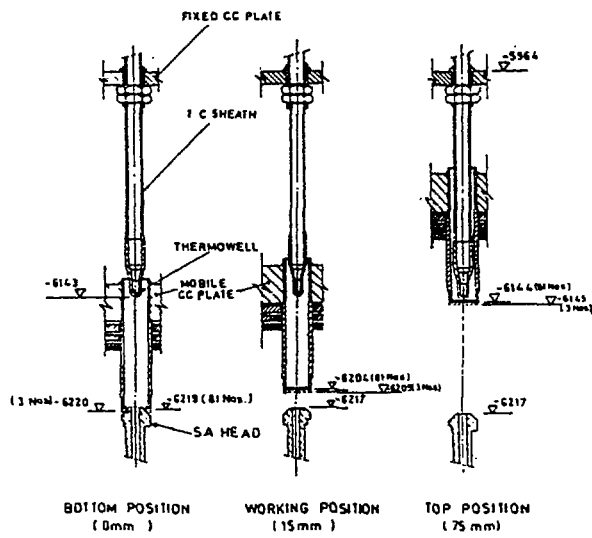
Fig.12

During normalisation of pile after fuel handling operations in Jul 95, CCPM could not be lowered to normal working position from fuel handling position. Various operations resulted in its getting stuck at 81 mm position above the top of SA heads. The likely causes were attributed to mechanical obstruction at the top, below the core cover plate or within the mechanism. Based on systematic investigations viz., checking for obstruction by dismantling the ball screw mechanism, scanning the space below the core cover plate and above the top of SA heads by ultrasonic under sodium scanner, ensuring leaktightness of bottom metallic bellows and checking for free movement of CCPM at the stellite guide bushes fixed to the control plug, it was confirmed that the sticking is in the interseal space having an annular gap of 1 mm between the command tube and the outer sheath. Based on safe load analysis, a jacking down force of 780 kg was applied to release the sticking and make the CCPM functional. Precise cause for malfunctioning could not be identified⁽⁸⁾.

During normalising of pile after next fuel handling operation in Jul 96, CCPM again could not be lowered from 80 mm position to its normal working position.

No smear of sodium oxide or any other foreign matter could be found by these three techniques. Load deflection measurement in the horizontal direction indicated the possible area of seizure to be below the step in the outer sheath and above the SS bellows (Fig 12) and the most likely reason could be mechanical interference. Further investigations are pursued. Cumulatively, about 8 months were spent for various investigations.

Experiments were carried out on power to measure the fuel SA outlet temperature with CCPM stuck at 80 mm position and a temperature attenuation of 7% average was found in Mark I SA. However this attenuation is large for SA having lesser flows than the Mark I fuel. Proper monitoring of likely entry of cold slugs of Na causing reactivity transients is also affected with CCPM at 80 mm position. 3 D analysis of outlet plenum thermal hydraulic, although being a complex subject, was carried out to establish the level of plugging that can be detected viz. a viz. allowable plugging for fuel clad integrity. PSA studies based on available data for plugging of any SA during operation has also been carried out. Based on these studies, clearance was obtained for reactor operation with suitable lowering of scram thresholds generated by CDPS on fuel SA outlet thermocouples.

- Development of an eddy current flowmeter which can be lowered through the fuel handling canal during shutdown to measure flow at the outlet of a SA as a periodic surveillance.
- Fabrication of a longer central canal plug for positioning it at 15 mm normal working position to accurately measure the outlet temperature of central fuel SA.
