EVALUATION OF ALUMINIUM-CLAD SPENT FUEL CORROSION IN ARGENTINE BASINS.

Div. Corrosión, Unidad de Actividad Materiales

Comisión Nacional de Energía Atómica, Av. Gral Paz 1499, (1650) San Martín (Buenos Aires) - Argentina

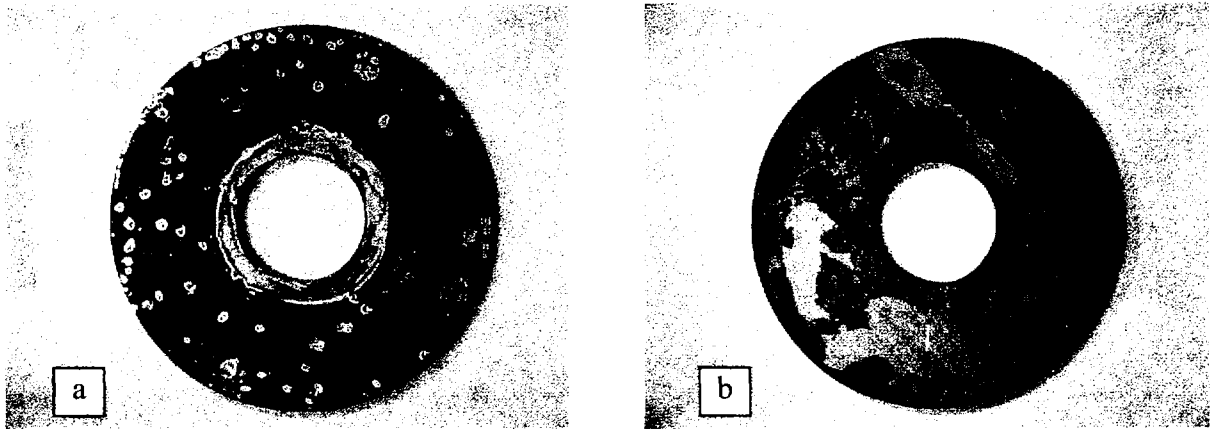
Figures 2 (a) and (b) show the typical aspect of outer and inner faces of crevice sandwiches or galvanic couples. As it can be seen, the inner surfaces are stained by uneven oxidation, that probably depends on the remaining gap after coupling; depending on site and time, there may be an extended shallow attack with pitting. The outer faces, instead, bear an even oxide and sometimes are pitted. The thickness of all oxides depends mostly on water quality, specially on its conductivity. The amount of pitting strongly depends on which conditions of points (2) and (3) are fulfilled. The fact that surfaces pointing upwards of samples located at the top of the racks are the most pitted suggests that this is related with the sedimentation of particles that may fall on the racks. In fact, brown-reddish deposits have been encountered in some occasions; deep pits associated with these particles became evident after the cleaning-decontamination procedure.

Fig. 2: Aspects of (a) outer surface of a coupon at the top and (b) inner surface of a sandwich.

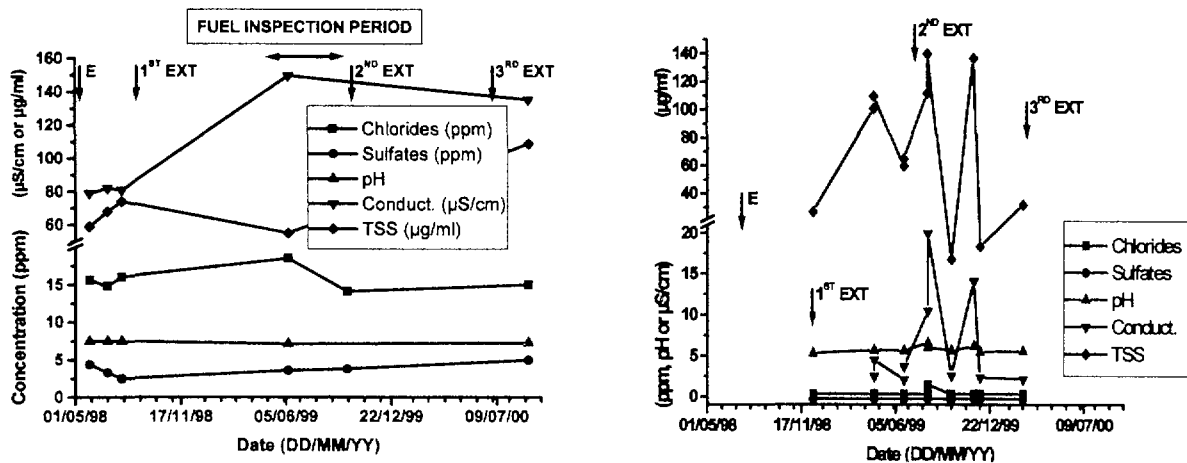
As an example, figures 3 (a) and (b) illustrate the variation of chemical parameters with time in channel #46 of CSF and RA6 DP, respectively; the times of sample extraction are indicated.

Fig. 3: Evolution of chemical variables in (a-left) channel #46 of CSF and (b-right) RA6 DP. “E” and “EXT” indicate Entry and Extraction time of racks

In CSF, a notable increment in water conductivity, accompanied by alterations in other variables, is verified in coincidence with a period of fuel inspection in which major movements of water were made. Also, in RA6 DP there was a period in which important increases in conductivity and total soluble solids were measured, possible related to some civil work carried out in the vicinity of the pool. As a result, the samples extracted in second term show an increased degree of corrosion. This effect is strong in CSF due to its higher chloride content; in samples extracted from RA6 DP right after the onset of an excursion was noticed, very localised pitting attack was encountered on the upper free surface of the top coupon, as seen in figure 4.
