## WHAT CAUSED THE FAILURES OF THE SOLENOID VALVE SCREWS

North Atlantic Energy Service Corporation, Seabrook Station, Box 300 Seabrook New Hampshire,  
03874 USA

**KEYWORDS:** Corrosion, Failure, Materials

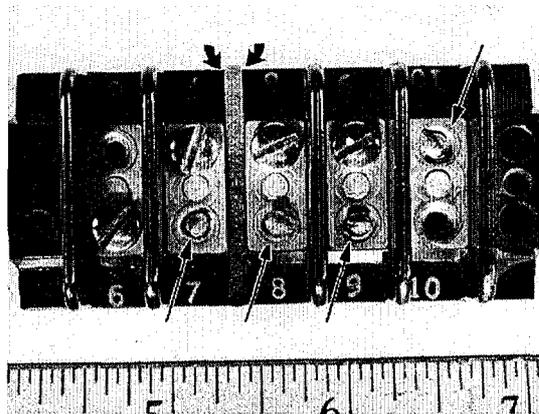
The as-received solenoid valve position switch terminal block showing failed screws and fractured piece of the phenolic terminal block is shown in Figure 1. The visual and binocular microscope examinations performed on the failed screws revealed that they all failed in a similar location, in the shank/bearing surface radius. The fracture surfaces revealed various hues of green, and yellow. These are indicative of oxides, suggesting environmental interaction. The fracture surfaces revealed multiple crack initiation sites. No significant deformation was observed at the fracture initiation areas. One representative view is shown in Figure 2.

**Figure 1:** Solenoid valve position switch terminal block showing failed screws (thin arrows) and fractured piece of phenolic terminal block (heavy, curved arrows). Mag. 0.6X

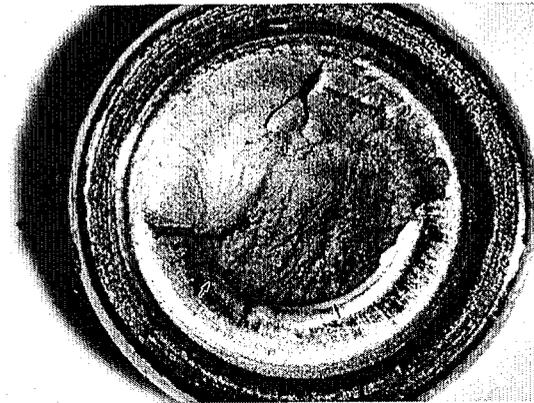
**Figure 2:** Fracture surface on terminal block screw head. Mag. 25X

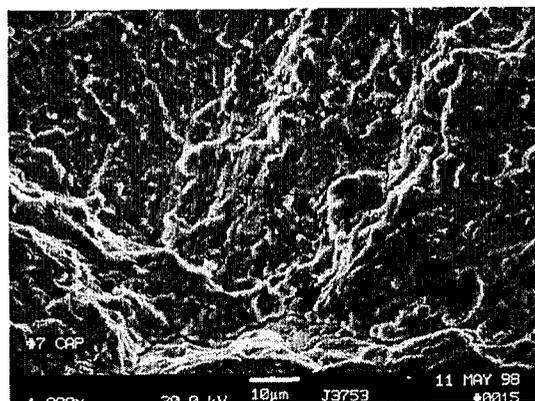
Scanning electron microscope (SEM) analysis of the fracture surfaces revealed planar, brittle, and feathery features, Figure 3. The initiation area, mid-fracture area and the final fracture all revealed similar features. No evidence of fatigue was detected on the surfaces.

**Figure 3:** Fracture surface of origin of cracking on failed screw head. Mag. 630X

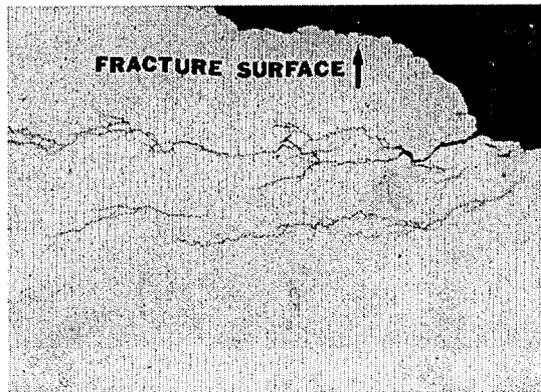
Different failed and unfailed brass screw samples were cross-sectioned and prepared for optical microscope examination of the metallurgical structure (Figure 4). All the failed screws revealed secondary cracking parallel to the fracture surface (Figure 5). The primary and secondary cracks were predominantly transgranular and branched, showing the typical appearance of stress corrosion cracking (SCC) of copper-zinc alloys at mildly acidic or mildly alkaline pH (Ref. 2). The fracture progressed along the cold worked interface present in the head as a result of the cold heading process used in the screw manufacture (Figure 6).

**Figure 5:** Secondary branched cracks parallel to primary fracture plane on fractured screw. Mag. 300X

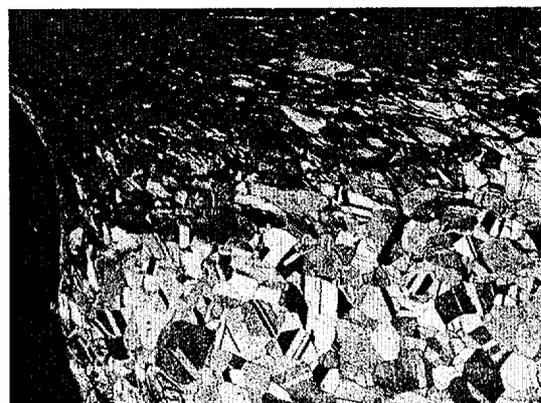
**Figure 6:** Part-through cracked terminal block screw showing crack propagation path at interface between cold worked and non-cold worked material. Mag. 60X
