## Assessment of Cracking in Dissimilar Metal Welds

Paper presented at the 10<sup>th</sup> International Symposium on Environmental Degradation of Materials in Nuclear Power Systems – Water Reactors, August 2001, Lake Tahoe, Nevada, USA

During the refueling in 2000, indications were observed by non-destructive testing at four locations in the reactor pressure vessel (RPV) nozzle to safe end weld in Ringhals 4. All indications were confined to the outlet nozzle (hot-leg) oriented at 25°, a nozzle with documented repair welding. Six boat samples were removed from the four locations, and the samples were subsequently subjected to a metallographic examination. The objectives were to establish the fracture morphology, and if possible the root cause for cracking. The examination revealed that cracks were present at all four boat sample locations and that they all were confined to the weld metal, alloy 182. Cracking extended in the axial direction of the safe-end. There was no evidence of any cracks extending into the RPV-steel or the stainless steel safe-end. All cracking was interdendritic and significantly branched. Among others, these observations strongly suggested crack propagatio

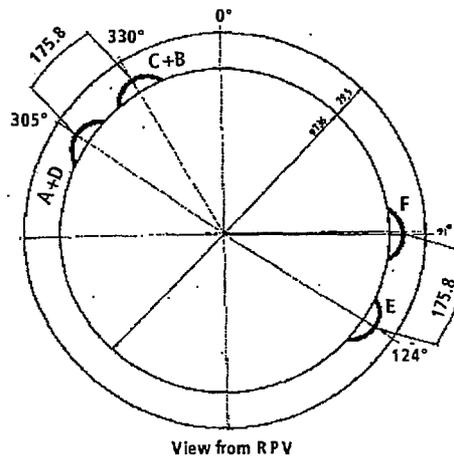
In all, six boat samples were removed from four locations of the weld, see Figure 2 for positions and denominations of the samples. In order to remove one surface breaking defect and one defect which ISI had indicated was just below the surface, two boat samples were taken out in positions 305° and 330°, respectively. Based on the results from the metallographic examination of the defect located at 330° (Boat Samples B and C), it was decided to remove two other defects (91° and 124°, Boat Samples F and E, respectively).

As indicated in Figure 2, two boat samples were removed from each of the locations at 305° and 330°. At the location 305°, two boat samples were required to remove all of the crack, i. e. the first sample (A) did not cover

the entire depth of the crack. Regarding the location at 330°, a second sample had to be removed since the location of the first sample (B) was not properly positioned in relation to the indication.

Figure 2. Cross section of nozzle to safe end weld. 0° is in the direction of the RPV head. Letters denote location of boat samples.

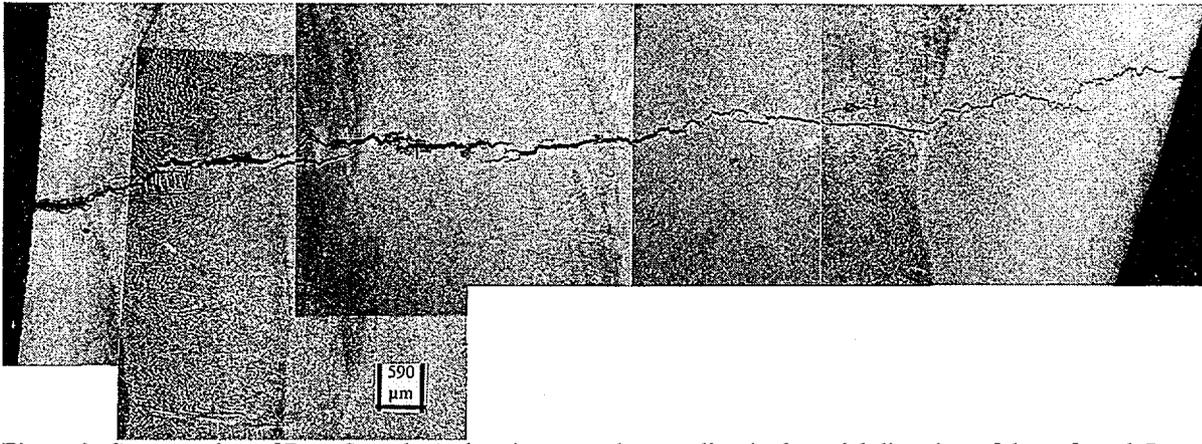
The crack in this boat sample is oriented in the axial direction of the safe end. Figure 3 shows a crack in Boat Sample A extending through the entire thickness of the boat sample. This means that the crack is deeper than 16.1 mm, which is the thickness of the boat sample in this cross section. In order to determine the crack depth, as well as to verify that no part of the crack remained in the plant, Boat Sample D was examined. Examination of this sample revealed the presence of thin, short crack tips on the surface facing Boat Sample A. These crack tips are in the order of 1 mm deep, and they disappeared after light polishing. Considering that about 5 mm of the material is removed during the EDM process, and provided that the crack tips observed in Boat Sample D are continuations of the main crack in Boat Sample A, this means that the total crack depth is approximately 22 mm (16 +5 +1 mm).

Both the cross section of Boat Sample A (Figures 3 through 5), and examination by SEM of the fracture surface (Figure 6), reveal that the crack morphology is interdendritic. Evidence of repair welding was observed, see Figure 4. Cracking is significantly branched, and the crack extends in the dendrite as well as recrystallized boundaries, see Figure 5. Examination of Boat Samples A and D verified that no cracks extend into the RPV steel or the stainless steel safe end. Analysis by EDS of Boat Sample A showed some areas of the fracture surface with high silicon levels.

Figure 3. Cross section of Boat Sample A showing a crack extending in the axial direction of the safe end. In this cross section the crack exceeds the thickness of the boat sample. The surface in contact with primary water is to the left.

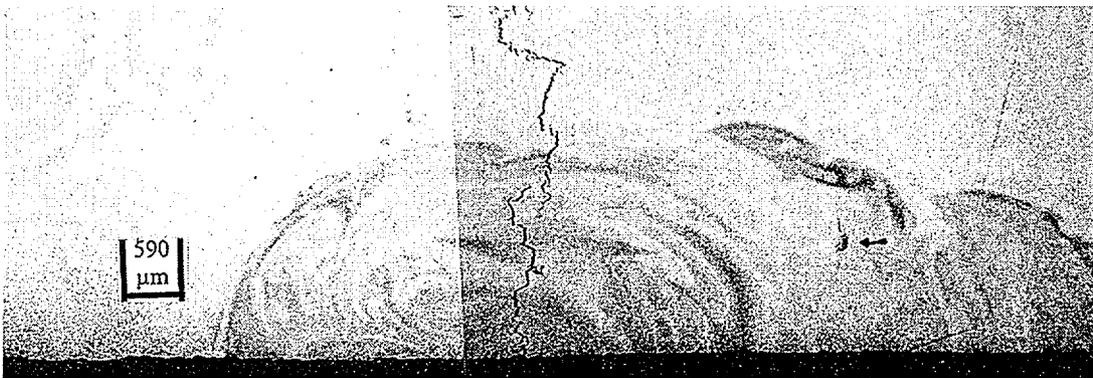
The reason for, or location of, crack initiation can not be established based on the boat samples examined. According to documentation from the fabrication, repair welding was performed at the cracked regions. Evidence of this is observed in Boat Sample A. This may increase stress levels adjacent to repair welds. In addition, there is evidence of cold work at the surface of Boat Sample E, which may stem from grinding after repair welding. Grinding has the possibility to induce local tensile stresses, although compressive stresses may also be produced. Another factor that may have played a role in the crack initiation process of Boat Sample C is the defect caused by incomplete penetration. There is also a possibility that hot cracks not detected during the original inspection assisted crack initiation. All these factors, alone or in combination, may have contributed to the crack initiation process.

Figure 4. Cross section of Boat Sample A showing the same crack as in Figure 3 after repolishing and etching in 10% chromic acid. Part of the repair weld is visible. Note the short crack indicated by the arrow.

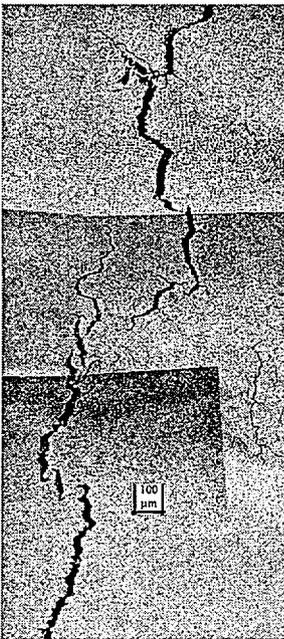
Figure 5. Detail of crack in Boat Sample A. Etched in 10% chromic acid

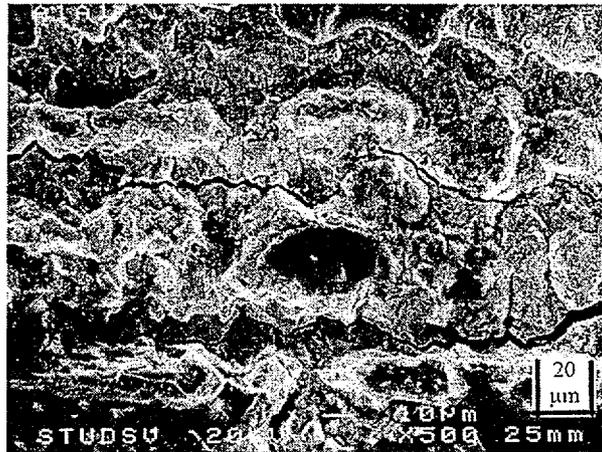
Figure 6. Detail of fracture surface in Boat Sample A showing interdendritic cracking. Note the transverse cracking.

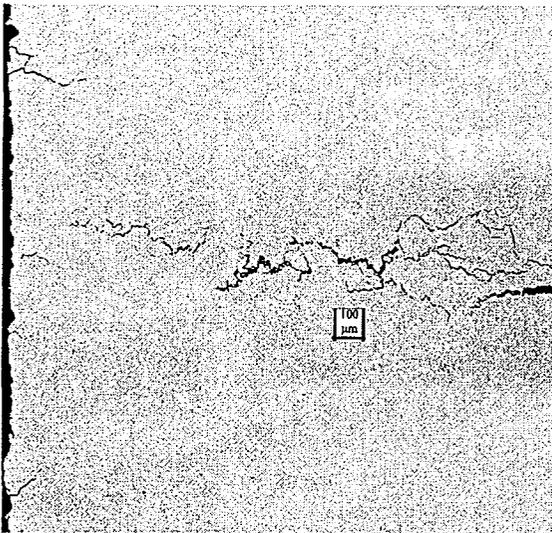
No cracks could be observed in Boat Sample B. The crack in Boat Sample C is oriented in the axial direction of the safe end, and all cracking is confined to the weld metal alloy 182. Examination by LOM of Boat Sample C shows that the crack morphology is interdendritic, see Figure 7. The crack depth in this section is 22 mm. As in Boat Sample A, the crack is heavily branched. Adjacent to the main crack shown in Figure 7, at least four other, shallow, cracks have initiated at the surface in contact with primary water. No attempts have been made to investigate if other areas of Boat Sample C, or any other boat sample, contain additional cracks of similar kind.

An insight into the crack initiation mechanism may be gained by more detailed examination of the shallow cracks adjacent to the main crack in Boat Sample C. An examination to establish if further, similar cracks, are present in Boat Sample C (as well as the other boat samples), might present additional information as regards crack initiation.

Figure 7. Cross section of Boat Sample C showing a crack extending in the axial direction of the safe end. Note the shallow cracks adjacent to the main crack. The surface in contact with primary water is to the left.

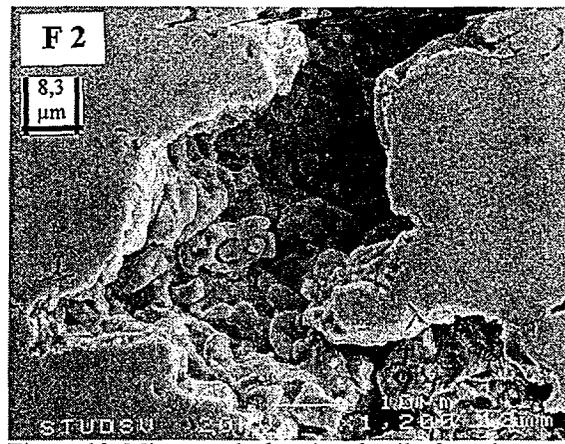
Another crack found in Boat Sample F is entirely enclosed in the weld, i. e. it is not in contact with primary water. It runs almost parallel to the surface in contact with primary water, at a distance of 8.2 to 9.6 mm from the same, see Figure 10. The length of the crack is 4.4 mm. Analysis by EDS shows enrichment in silicon. Several other non-surface breaking defects exist in this sample.

The interdendritic surfaces examined are probably not entirely caused by IDSCC, as areas indicating hot cracking have been observed. These defects represent cracking occurring during fabrication, caused by the formation of a low melting liquid eutectic during cooling between the solidifying dendrites. Some regions of the fracture surfaces of Boat Sample A, and to a lesser extent Boat Sample C, were rich in silicon. In addition, several non surface breaking crack-like defects are present in Boat Sample F. Silicon enrichment was observed in one of these non surface breaking defects. These silicon rich regions and defects probably cracked during welding as a result of hot cracking. It has been noted that silicon is particularly damaging to the hot cracking resistance of chromium bearing high-nickel alloys [3]. In addition, it has been shown that fracture surfaces resulting from hot cracking reveal enrichment in niobium, manganese and silicon [4]. Thus, this may suggest that cracking of those areas high in silicon occurred during fabrication.

Figure 10. Micrograph showing detail of crack entirely enclosed in the weld, i. e. it was not in contact with primary water. The surface of the crack is high in silicon.

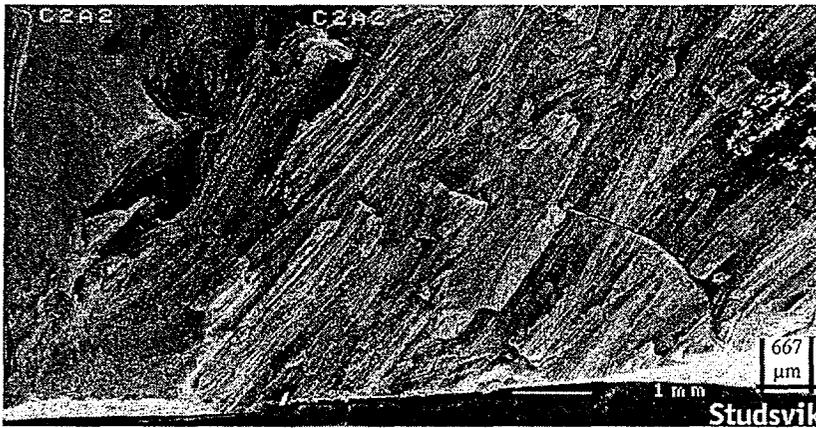
The interdendritic nature of the cracking is also evident from the fractographic examination, see Figure 8. Similar to Boat Sample A, the fracture surface is uneven, and shows that the crack extends in different planes. Ductile fracture (dimples) were observed in some areas where the dendrites protrude from the fracture surface, which is a further indication that the cracks extend in different planes. The fracture surfaces are covered by a brownish oxide, except the few areas where ductile fracture occurred. A defect caused by incomplete penetration during welding exists in Boat Sample C at the surface in contact with primary water, see Figure 8. As in Boat Sample A, areas with elevated silicon content were detected on the fracture surface of Boat Sample C. However, the silicon rich areas are less in extent in the latter sample.

Figure 8. SEM micrograph of fracture surface in Boat Sample C. The lower edge of the fracture was in contact with primary water. Note the incomplete penetration in the lower right-hand corner

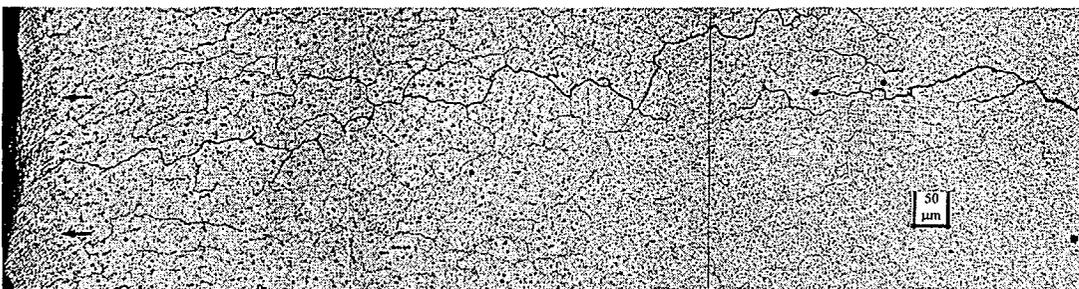
Cracking in Boat Sample E is oriented in the axial direction of the safe end, and is confined to alloy 182. Examinations by LOM reveal that the crack morphology is interdendritic, see Figure 9. The crack depth in this cross section is 6.1 mm. As in the other samples, cracking in Boat Sample E is significantly branched. At the surface in contact with primary water, there is clear evidence of cold work, see Figure 9. The depth of the cold worked layer is in the order of 0.1 mm. Examination of the fracture surface confirms that cracking is interdendritic and oxidized. No silicon rich areas were detected in this sample.

Figure 9. Cross section of Boat Sample E showing a crack extending in the axial direction of the safe end. Surface cold work is indicated by arrows. Electrolytically etched in Chromic acid.
