THE EBR-II STEAM GENERATING SYSTEM —  
OPERATION, MAINTENANCE, AND INSPECTION

For presentation at the IAED-IWGFR Specialists' Meeting on MAINTENANCE AND REPAIR OF LMFBR STEAM GENERATORS, June 1984, Oarai, Japan.

EBR-II PROJECT

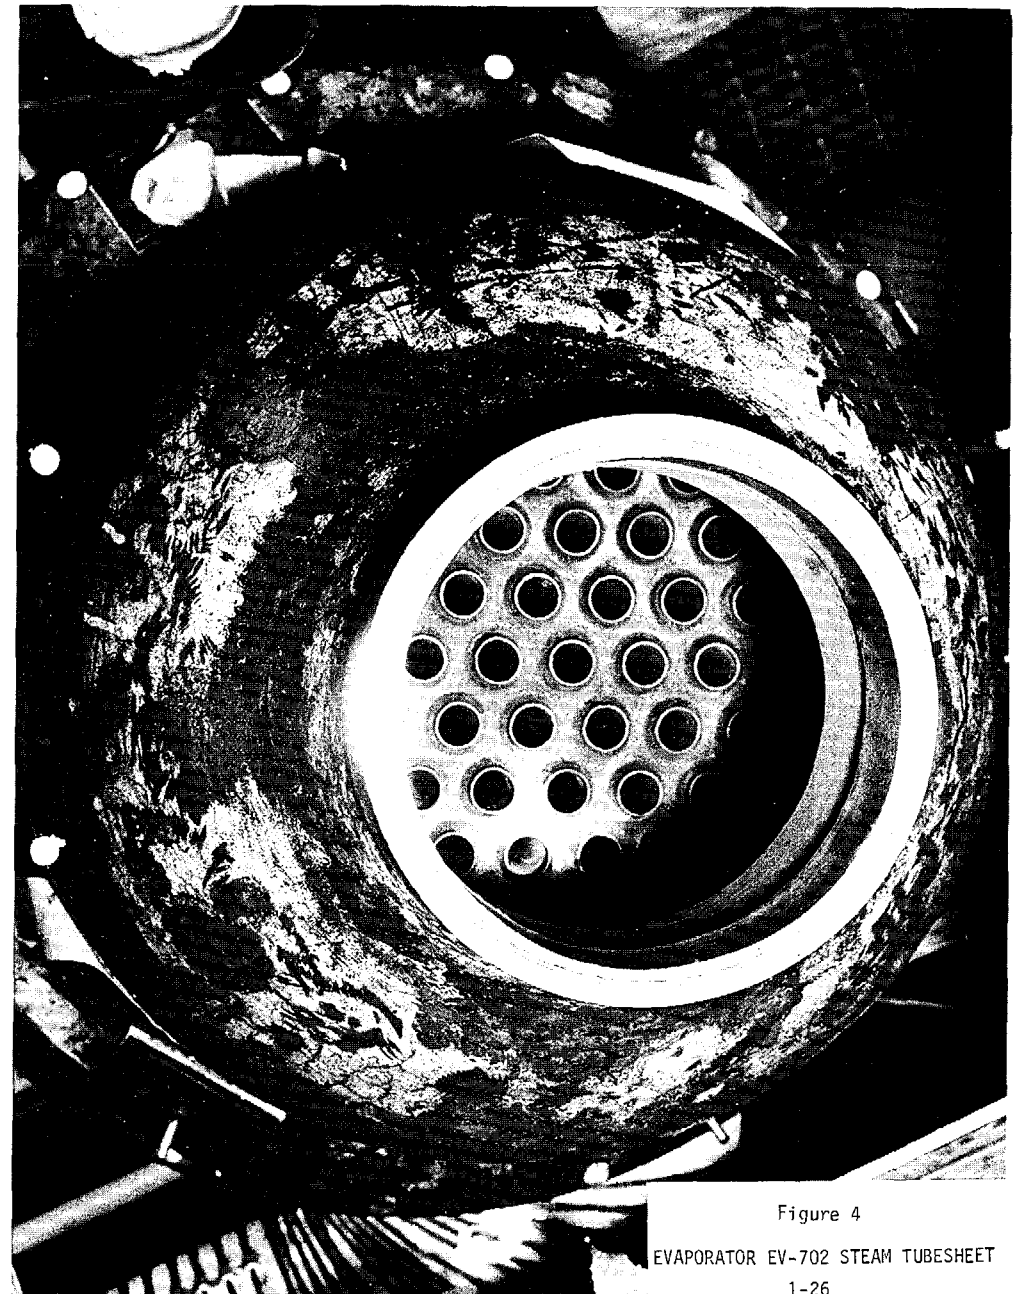
Figure 4  
EVAPORATOR EV-702 STEAM TUBESHEET  
1-26

The surface of the metal in the system is covered with a deposit of brown magnetic (magnetite) material. Some of it is readily removed with a brush or cloth and some is rather firmly attached. The thickness ranges from zero to about 1-1/2 mm. No obvious pits or metal loss have been detected when the deposits were removed. Deeper accumulations of the loose material are found on top of the tubesheet.

No appreciable change has been detected in the metal surfaces of the steam tubesheet or tube interiors from one inspection to another.

Samples of the loose dark brown deposits that cover the top of the tubesheet were collected for chemical analysis. The powder is magnetic, and is believed to be primarily magnetite,  $Fe_3O_4$ . Analysis of two of the corrosion samples is presented in Table 5.

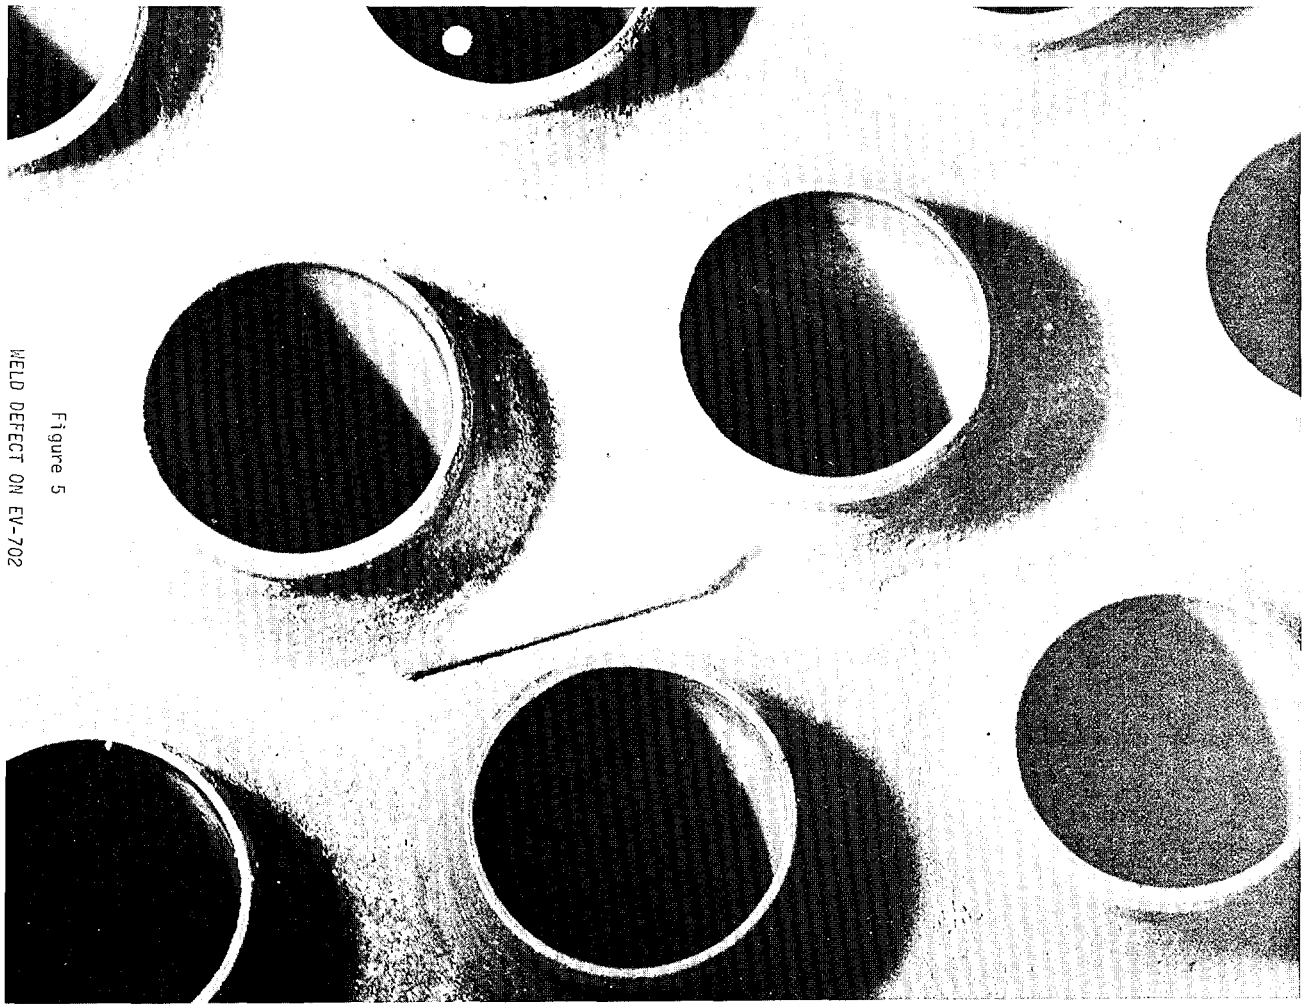
Figure 5  
WELD DEFECT ON EV-702

On February 7, 1965, during a shutdown period with the steam system at ambient temperature, the operating crew reported that liquid water could be observed in the space between the steam and sodium tubesheets at the upper end of EV-702. The source of water was traced to a crater crack in one of the tube-to-tubesheet welds. Figure 4 is a photograph looking down through the outlet nozzle of the evaporator. Figure 5 is a closeup view of the defect after the surface was slightly ground. Liquid penetrant has been applied to assist in locating the precise leak site. The leak was obviously due to a birth defect that was not detected by the original helium leak test because it was at least partially plugged with slag. The defect was repaired by manual welding. Access was through the outlet nozzle shown in Figure 4. The steam riser from EV-702 to the steam drum had been removed for the repair. During the subsequent 20 years of operation, no additional leaks have been detected in any of the steam-generating equipment.

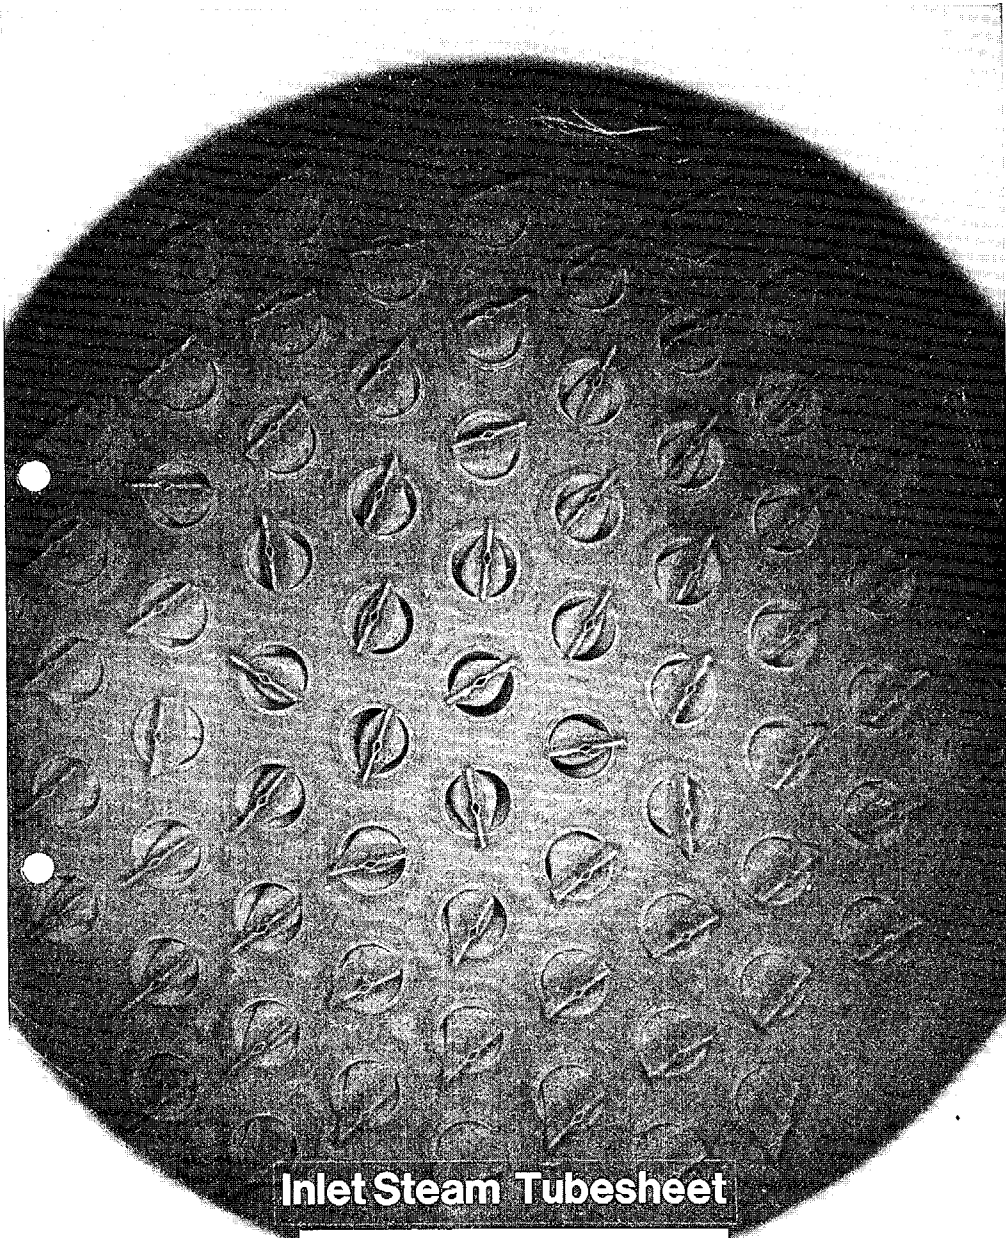
The anomalous behavior of SU-712 discussed above prompted the 1979 inspection of SU-712 to determine the potential for continued degradation and failure. The steam side of the superheater was examined by visual, dimensional, ultrasonic, and weld-inspection methods. Three core tubes were removed to provide access to the inside of the heat transfer tubes for examination. The core tubes were replaced with new ones, leaving the originals available for destructive examination. To gain access for the examinations, the steam piping was cut at the inlet and outlet reducers and moved aside. This provided straight direct viewing of the central seven tubes. Figure 9 shows a view of the tubesheet in the inlet steam chest.

Visual examinations of the inlet and outlet steam chest did not reveal any unusual conditions. Horizontal surfaces were covered with a dark rust-red thin film of magnetite ( $Fe_3O_4$ ). Vertical surfaces were covered with a thin layer that presented a silvery, crystalline effect.
