STRENGTH, DURABILITY AND STABILITY OF MATERIALS
Proceedings of the 3rd international conference SDSMS'03, Klaipeda, 2003

INTER GRANULAR STRESS CORROSION CRACKING OF IGNALINA NPP AUSTENITIC PIPING OF OUTSIDE DIAMETER 325 MM

Linus Nedzinskas, Artūras Klimašauskas

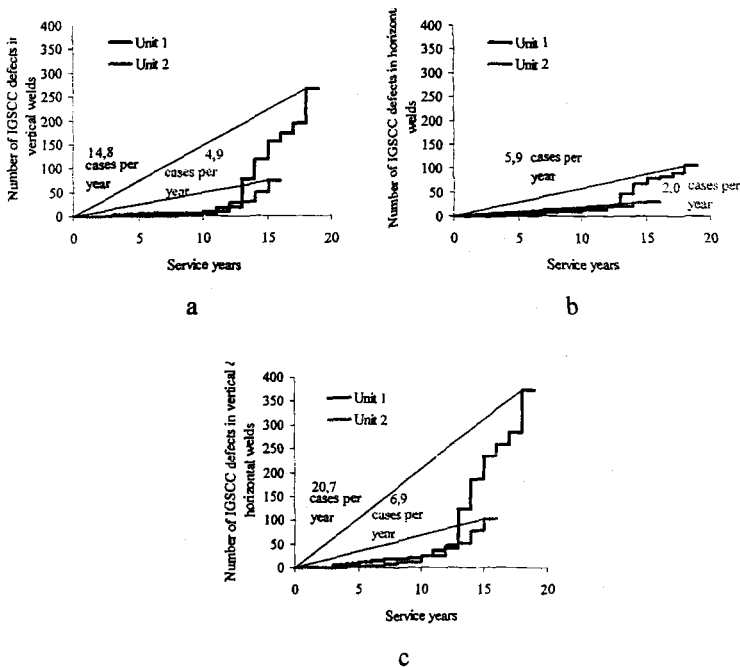
Fig. 2 Cumulative number of IGSCC cases in Ignalina NPP after repair in 2002: a in vertical welds, b in horizontal welds, c in vertical & horizontal welds

Comparing numbers of IGSCC cases in vertical and horizontal welds (Fig. 2a and Fig. 2b) is important to notice, that vertical welds has more defects than horizontal welds, however quantity of vertical welds is larger than horizontal welds. In Fig. 2c could be noticed significant increment of IGSCC defects in the latest 6 years. The reasons of such noticeable increment are implementation of more advanced inspection methods and increased ISI volume.

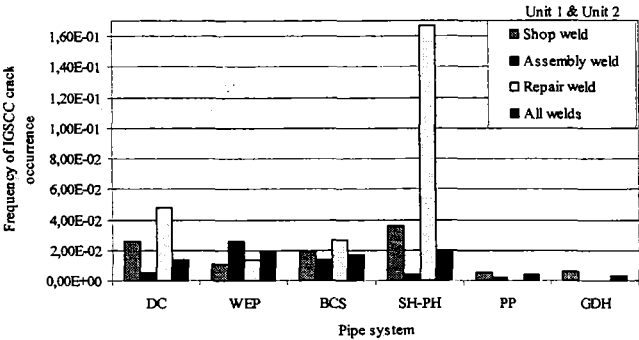
Fig. 3 Frequencies of IGSCC crack occurrence in 325 mm outside diameter austenitic piping systems in year 2002

Fig. 3. In Fig. 3 could be noticed, that exists significant difference in IGSCC defect occurrence frequencies between suction part (DC, WEP, BCS) and pressure part (PP, GDH). Comparing frequencies of IGSCC defect occurrence of shop, assembly and repair welds, the highest frequencies are observed in shop and repair welds of majority systems; especially repair welds of SH-PH system are standout. Analysing all systems together, the highest frequency of IGSCC crack occurrence has repair welds, the lowest – assembly welds.

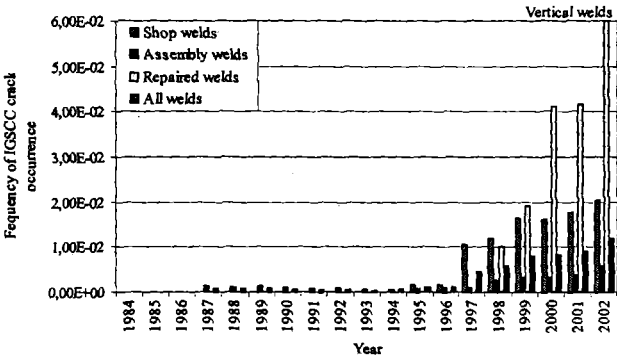
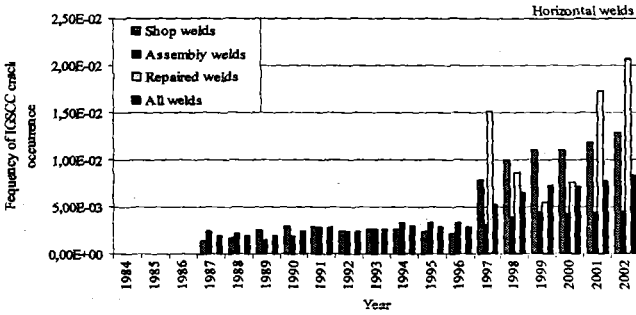
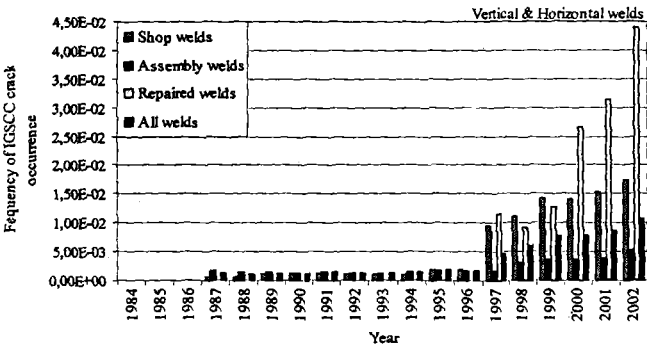
Fig. 4 Frequencies of IGSCC crack occurrence: a in vertical welds, b in horizontal welds, c in vertical & horizontal welds

Variation of IGSCC crack occurrence frequencies during period from start of operation until 2002 is presented in Fig. 4. Comparing IGSCC defect occurrence frequencies of vertical and horizontal welds one can see, that from 1997 until 2002 (after starting to use UT inspection technique) frequencies of vertical welds are about twice higher than frequencies of horizontal welds. The reasons of such difference can be a fact, that vertical

welds are welded using higher heat input than horizontal welds, because of specifics of welding. The higher heat input cause higher sensitization of HAZ and higher weld residual stresses.

Variation of IGSCC crack occurrence frequencies of vertical & horizontal welds together (Fig. 4c) shows, that until 1997 a frequency is almost constant, however from 1997 it increases from year to year. It shows that actions on IGSCC mitigation are not sufficient. Especially huge increase of IGSCC defect occurrence frequency for repair welds is observed. This indicates that welds repair technique is inadequate.

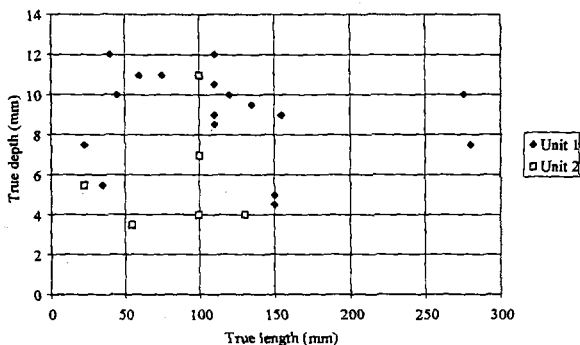
Fig. 5 True length and depth (measured in destructive examinations) of IGSCC cracks in Ignalina NPP austenitic steel pipelines with outside diameter of 325 mm

In Fig. 5 comparison of cut out defect sizes, measured during destructive examinations is presented. Comparison of defect sizes showed that IGSCC crack length to depth ratio is not constant, but scattered and varies from 3 up to 38 mm. Depth of the deepest cracks reaches up to 12 mm, i.e. 75% of wall thickness. Length of the longest cracks reaches up to 280 mm, i.e. approximately 27% of circumference. Through-wall cracks were not detected in austenitic 325 mm outside diameter piping.

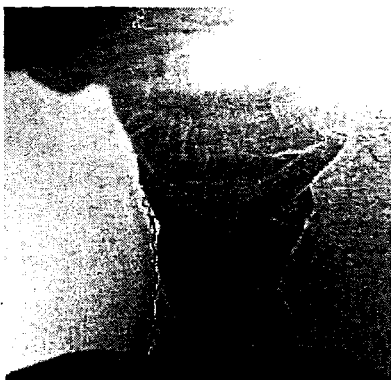
It should be mentioned, that all IGSCC cracks detected in MCC austenitic piping of Ignalina NPP appear at the inner surface in heat affected zone (HAZ) near to weld root and grow to outside close to fusion line. Typical IGSCC crack is shown in Fig. 6.

Fig. 6 Typical IGSCC crack
