4th Meeting of the International Group of Research Reactors (IGORR-IV)
Gatlinburg, TN, USA, May 24-25, 1995

SURVEILLANCE PROGRAMME AND UPGRADING OF THE HIGH FLUX REACTOR PETTEN

Michel BIETH

Commission of the European Communities
Joint Research Centre

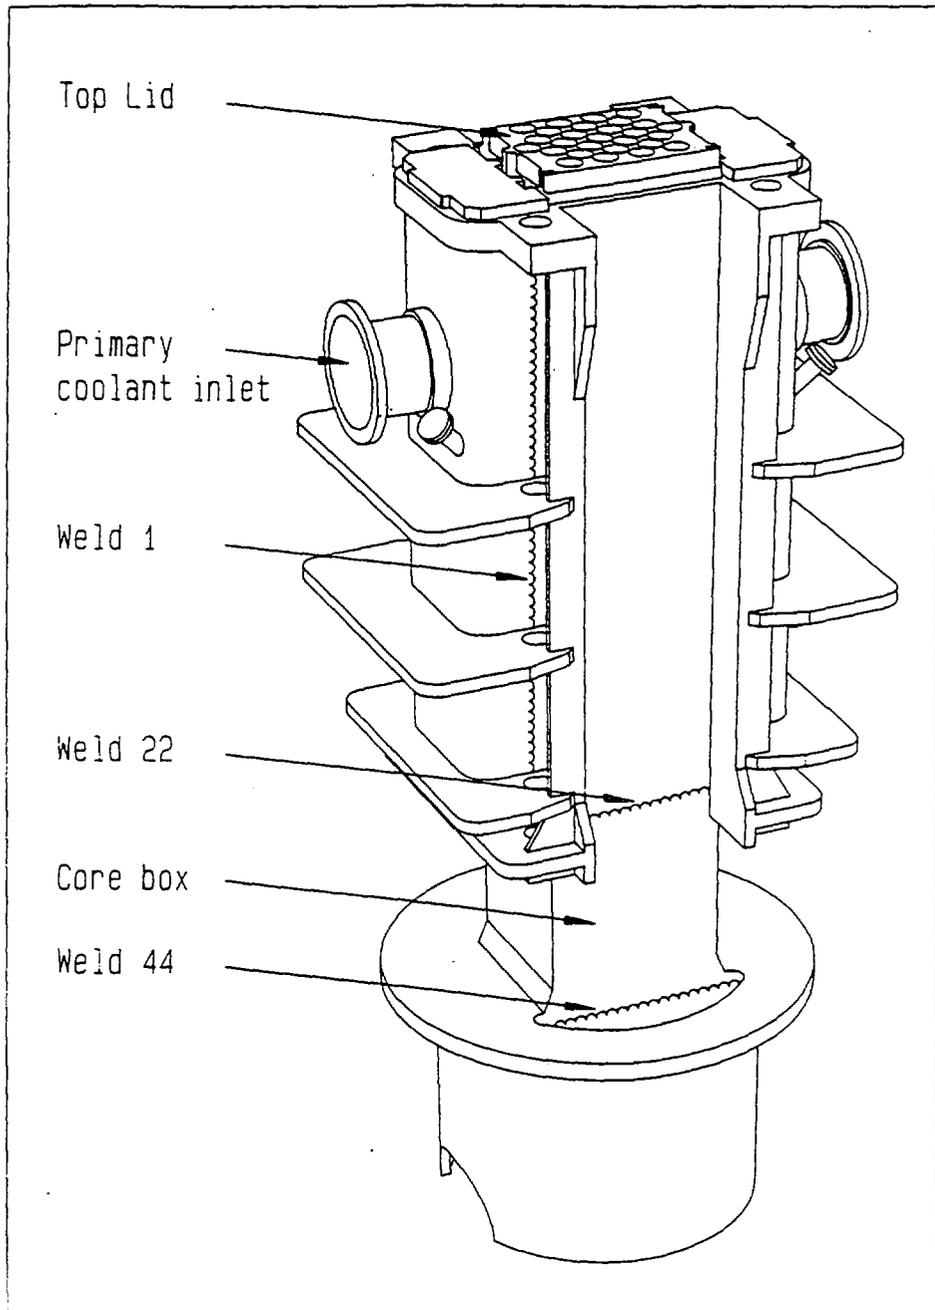
Fig. 1 : HFR Reactor Vessel

The reactor vessel is an all welded aluminium structure about 5 m high which includes the core box, the core box support structure and the cooling water inlet plenum (see fig. 1). The core box is a rectangular shaped construction fabricated from 50 mm thick forged material joined by electron beam welding. The other vessel areas use 40 mm thick plate material with MIG welds. The goal of the in-service inspection of the HFR vessel is to demonstrate that all parts assuring the core geometry and the control rod alignment will not fail in service. Ultrasonic examination is then required for a selection of welds and for the most highly exposed core box walls. An eddy current testing is also conducted on core box walls and corners for surface and near surface defects. The ISI also includes dimensional checks for the control rod alignment, visual inspection using t.v.- cameras for the general condition of the vessel and any surface flaw and penetrant testing of primary coolant inlet.
