IMPLEMENTATION OF IN-SERVICE INSPECTION PROGRAM FOR HANARO

J.S. WU, Y.C. PARK , Y.G. CHO and B.J. JUN

*Reactor System Management Department
HANARO Center, Korea Atomic Energy Research Institute
P.O.Box 105, Yusong Taejon, KOREA*

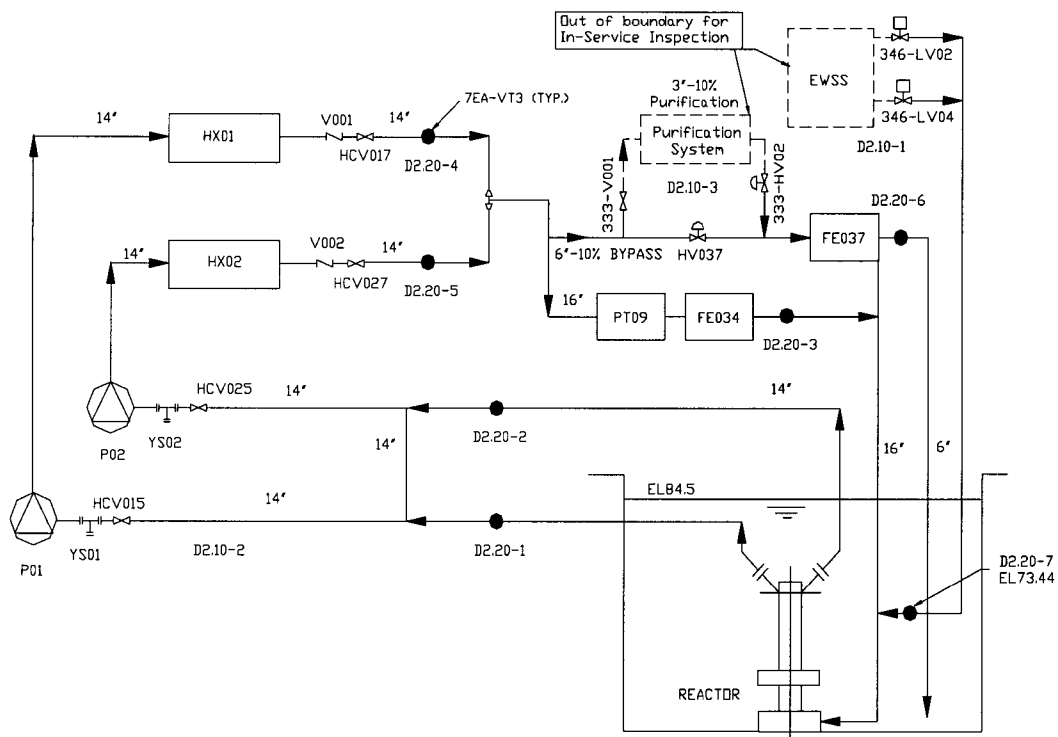
Figure 2. Visual inspection points of SC-3 boundary piping

Figure 2 indicates the visual inspection points of SC-3 piping.

Using the VT-3 procedure, the mechanical and structural status of the components and their supports, such as clearances, physical displacements, loose or missing parts, debris, corrosion, wear, erosion or the loss of integrity at bolted or welded connections was checked out. The four examination points are the anchor support (D2.20-1) for 16-inch pipe at common discharge, the anchor supports (D2.20-2 & D2.20-3) for 14-inch pipe at each discharge of primary pumps, and the under-support (D2.20-4) for 14-inch pipe. Qualified inspectors according to the LEVEL II requirements of ASME section V carried out a VT-3 visual examination for the PCS piping. It was verified that all components and welding joints are maintaining their mechanical and structural integrity without any remarkable defect.
