THE EFFECTS OF THE RULISON EVENT
ON BUILDINGS AND OTHER SURFACE STRUCTURES

Lloyd A. Lee and Roger E. Skjei
John A. Blume & Associates Research Division
San Francisco, California

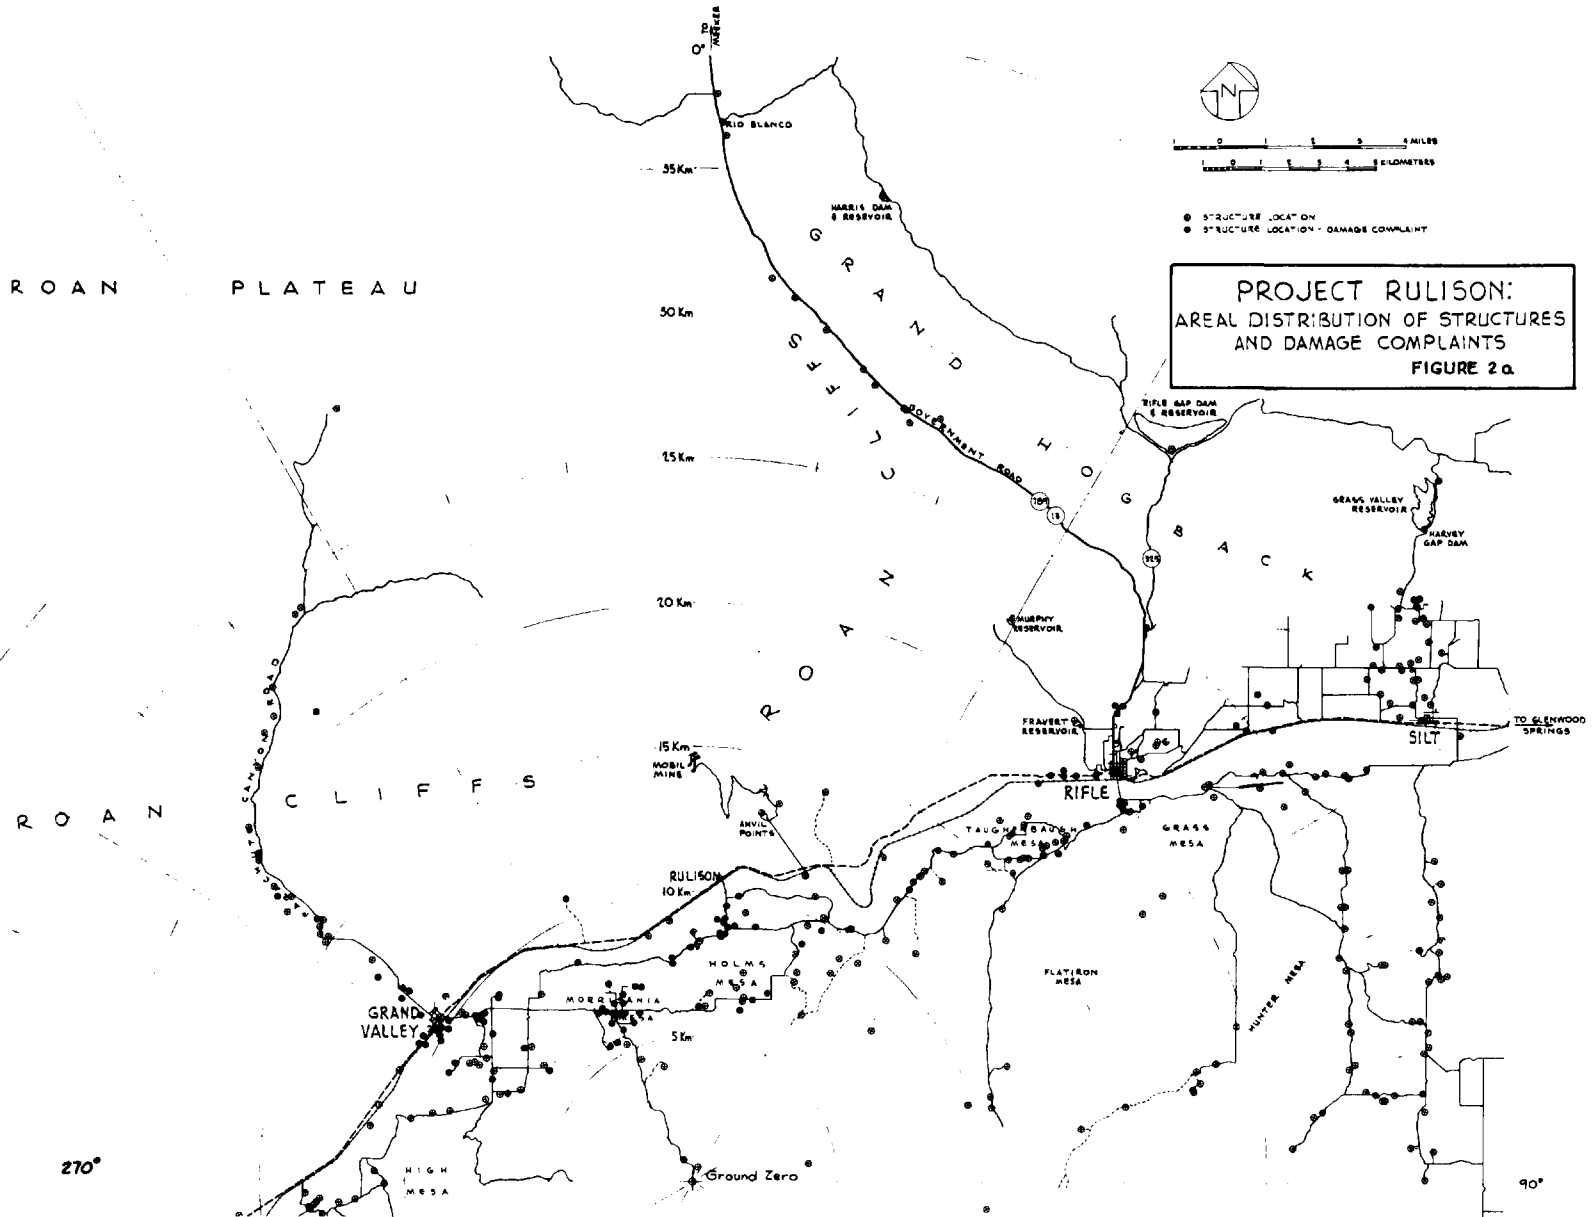
PROJECT RULISON:
AREAL DISTRIBUTION OF STRUCTURES
AND DAMAGE COMPLAINTS
FIGURE 2a.

Table IV presents a breakdown, again by 5-kilometer increments, of the total number of structure locations versus damage complaints. A structure location as used here is a house or cabin location with or without outbuildings. Thus, a ranch is a structure location and a house in Grand Valley is also a structure location. The areal distribution of structure locations and damage complaints outside of the towns is shown in Figure 2. The 69 complaints in Grand Valley and the 74 complaints in Rifle are not shown in this Figure.
