Monitoring of Primary Circuit and Reactor of NPP A-1

M. Prazska, D. Majersky, J. Rezbarik, S. Sekely, , P. Vozarik
(AllDeco, 919 31 Jaslovske Bohunice)
R. Walthery (Belgoprocess, 2480 Dessel, Belgium)
P. Stuller (SE-VYZ, 919 31 Jaslovske Bohunice)

The work is described that has been carried out by the Consortium (AllDeco & Belgoprocess) for the Phare project EUROPEAID/116059/D/SV/SK.

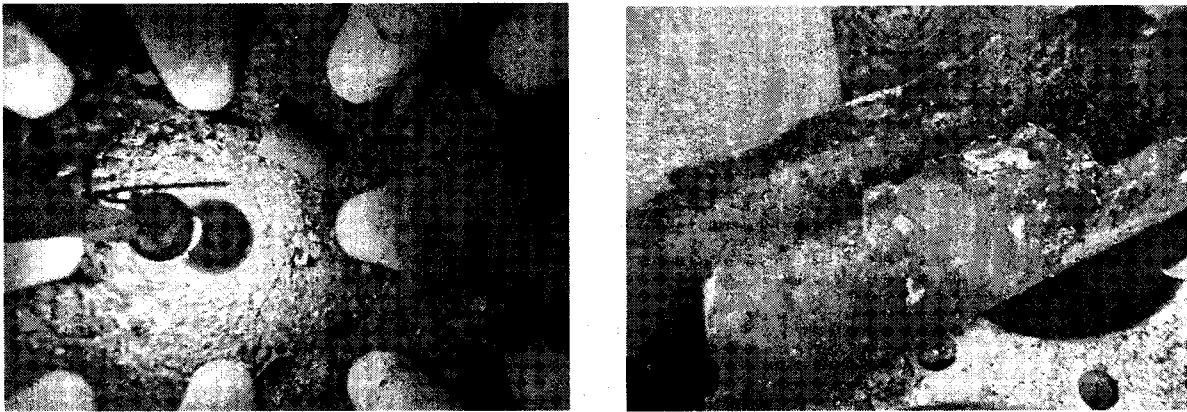
TV inspection of channels, hot gas chamber and avial vessel was accomplished via channels H08, D04 and C05. Fig. 2 and Fig. 3 are typical pictures to illustrate the state and characteristics of radioactive waste in the reactor.

Figure 2: State of the reactor equipment recorded via the technological channel C-05 at the level -12 m showing pipe fragments and deposits at the bottom of the avial vessel

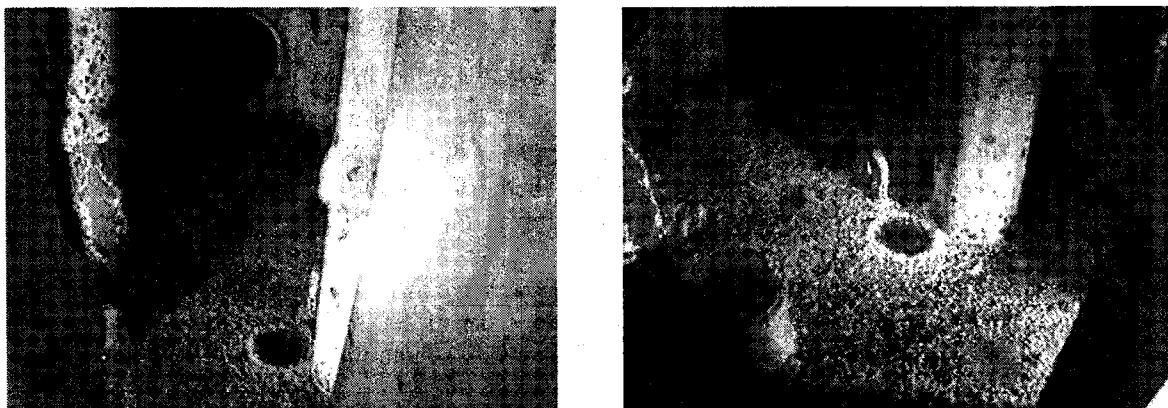
Figure 3: Typical look of sediments and deposits on the pipes and at the bottom of the hot gas chamber in the reactor

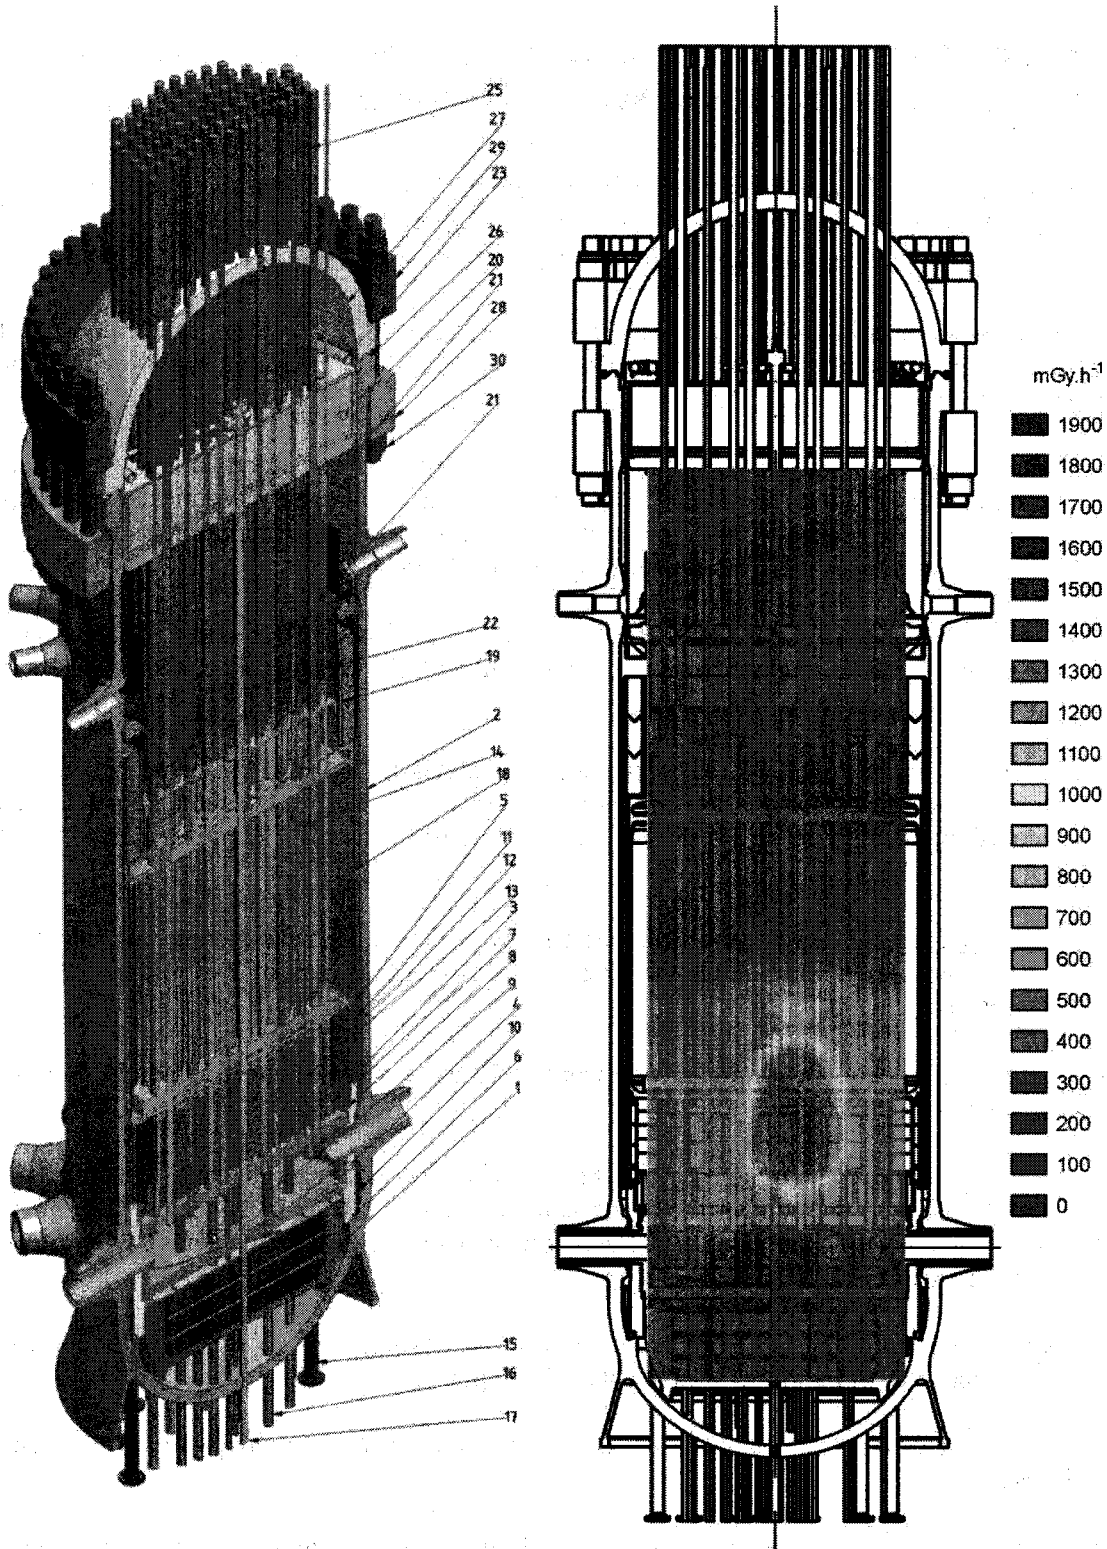
On the Fig. 1 it can be seen a drawing of the reactor and also radiation field levels derived from the measurements of dose rates in various channels. The 3-D model of the reactor that had been developed as part of this Project proved invaluable for orientation, visualisation, planning and analysis of results.

Dose rates were measured in the technological channels from the reactor hall floor to the bottom of the hot gas chamber in decrements of 1 m and 0.5 m. The highest absolute values of dose rates were found in channels located in the middle of the reactor (up to 1900 mGy.h⁻¹ in the active zone region).

Figure 1: Schematic diagram of the reactor and radiation field intensities
