Resin intrusion into the primary circuit of NPP Jaslovske Bohunice V-1.

Ing. Ondrej Grežd'o, SE a.s, grezdo.ondrej@ebo.seas.sk

Ing. Mráz Viliam, SE a.s, mraz.viliam@ebo.seas.sk

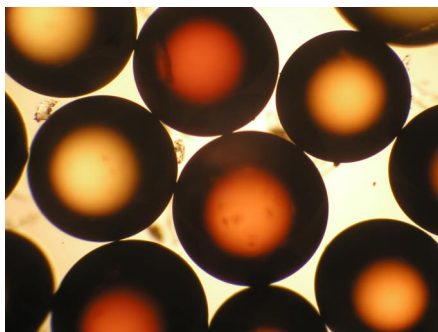
Fig.5. Resin from spent fuel pond vessel

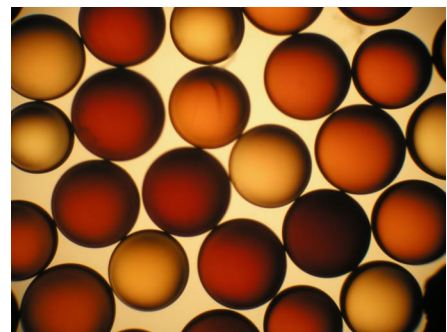
Fig.6. Resin from reactor
