International Conference
Nuclear Energy for New Europe 2007
Portorož /Slovenia /September 10-13

**CODEX-CT-1 AND CT-2 INTEGRAL TESTS:
TWO POSSIBLE SCENARIOS OF THE PAKS-2 INCIDENT**

Péter Windberg, Zoltán Hózer

Hungarian Academy of Sciences KFKI Atomic Energy Research Institute
Fuel and Reactor Materials Department

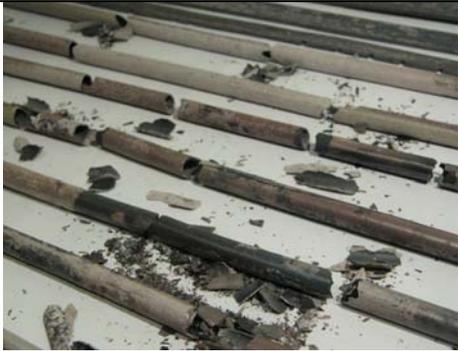
The state of fuel rods treated in the CODEX-CT facility was very brittle after the experiments. The X-ray view of CT-1 and CT-2 bundles, some cross section of the bundles and pictures of the cladding tubes and shroud plates used in the preliminary test are shown in the figures of Table 2.

View after the treatment	X-ray view of the bundle	X-ray view of the bundle

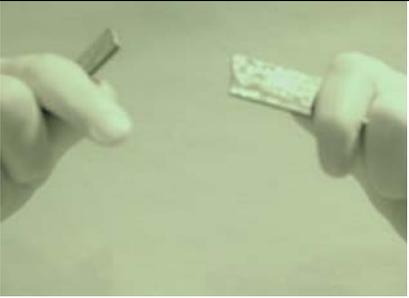
An brittle and oxidized shroud plate element	Cross section of CT-1 bundles at 760mm	Cross section of CT-2-at 760mm

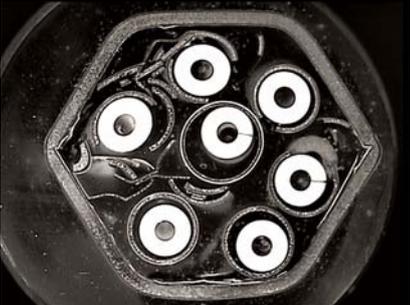
The CODEX-CT-1 and CT-2 tests were carried out with slightly different power, system pressure and fuel rod internal pressures. Both tests were performed in hydrogen rich steam atmosphere. The most significant difference between the two tests was that in case of CT-1 experiment the produced hydrogen was continuously released from the tank through an air letdown valve, while during the CT-2 test this valve was closed. The accumulation of hydrogen in the second test resulted in much lower degree of oxidation than in the first test. The zirconium components picked up large amount of hydrogen in both tests. The final reflood led to full cross section break of the CT-1 bundle and fragmentation of CT-2 bundle.
