FUEL ASSEMBLY RECONSTITUTION

Mário M. Morgado¹, Mônica G. N. Oliveira¹, Décio B. M. F. Júnior¹, Bárbara O. dos Santos¹ and Jorge E. dos Santos¹

¹ Eletronuclear Eletrobrás Termonuclear S.A.
Rodovia Rio-Santos BR-101, Km 522, Itaorna
23903-000 Angra dos Reis, RJ
mongeor@eletronuclear.gov.br

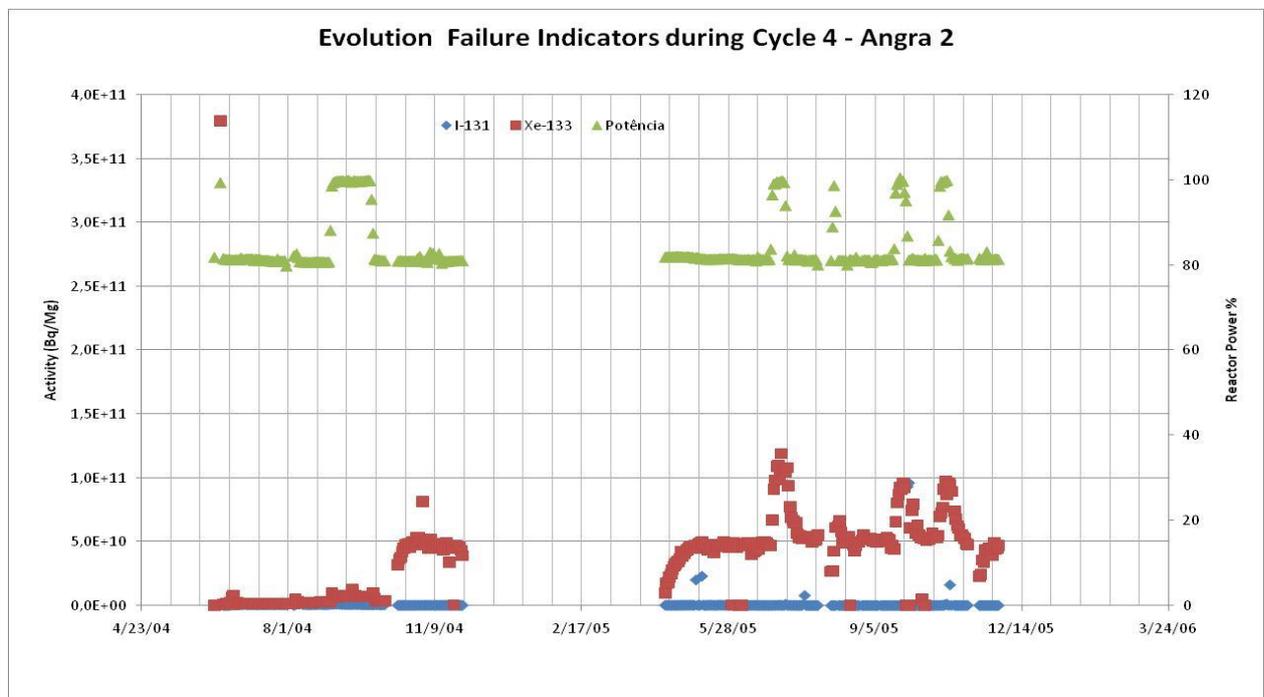
The Figure 1 shows the evolution of failures indicators in terms of the power during cycle 4 operation, where can be observed an increasing Xe-133 activity, after start up and during variations of power.

Figure 1. Evolution of Failures Indicators during the Cycle 4 with fuel assembly failed

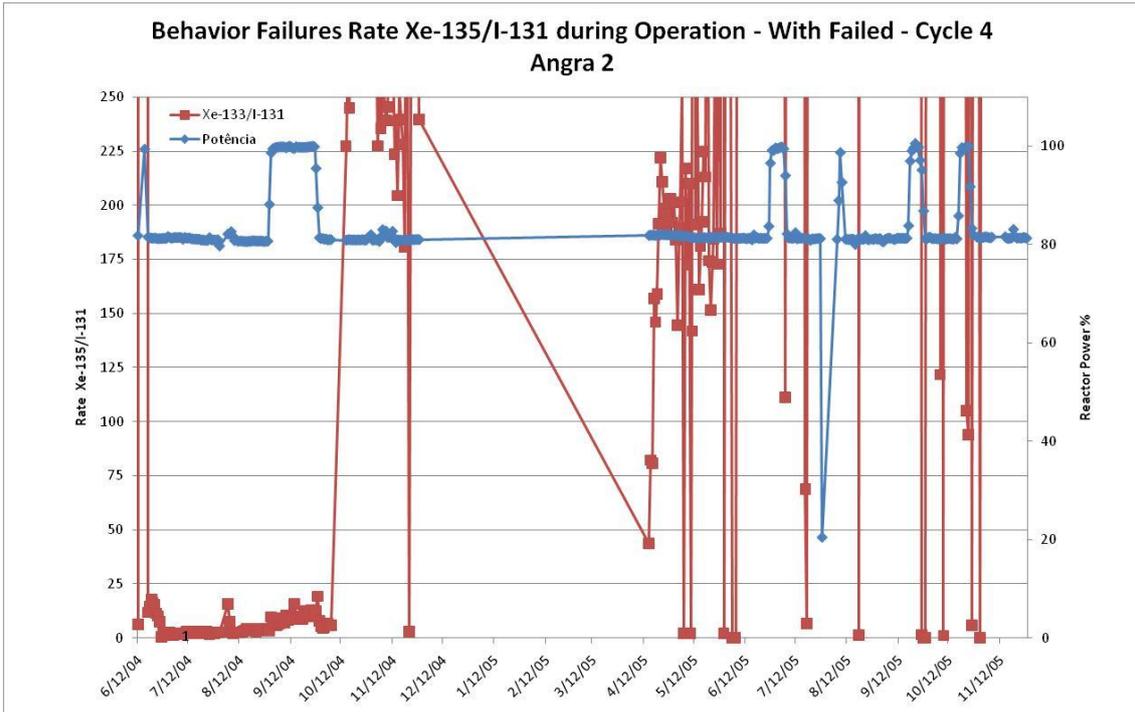
The Figure 2 shows the result of rate Xe-133/I-131, where points were greater than values established.

Figure 2. Behavior of failure indicator, Rate Xe-133/I-131, during Cycle 4 with an indication of fuel assembly failed in Angra 2.

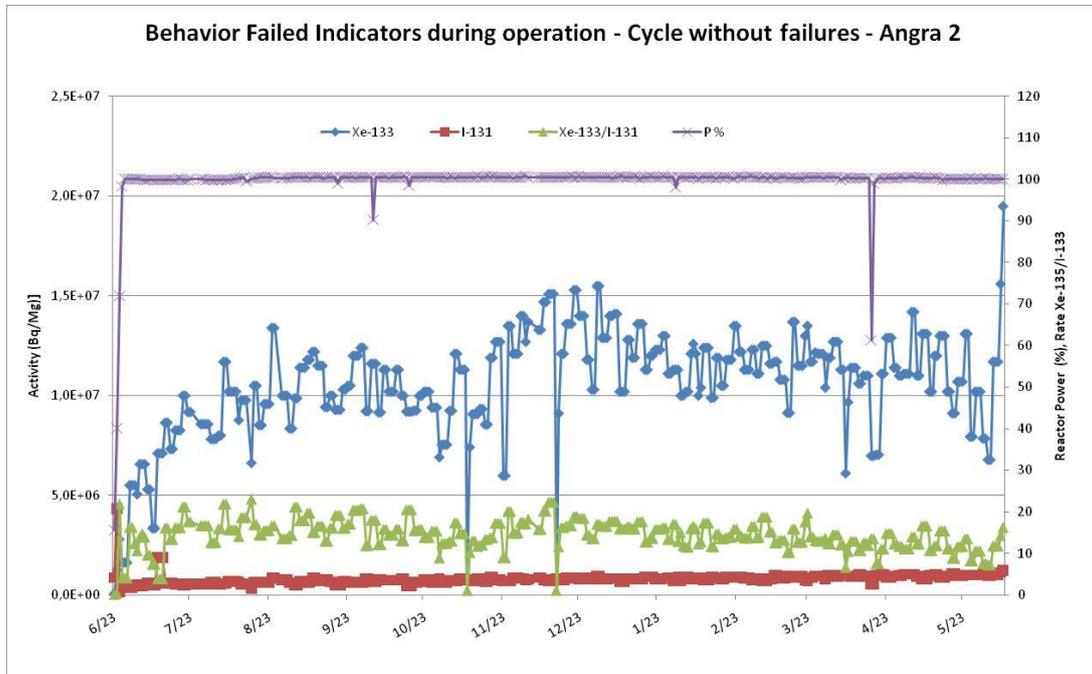
The Figure 3 shows the behavior of the failures indicators in terms of Power during a cycle without failure.

Figure 3. Behavior of failure indicators during a cycle with no indication of fuel assembly failed in Angra 2.

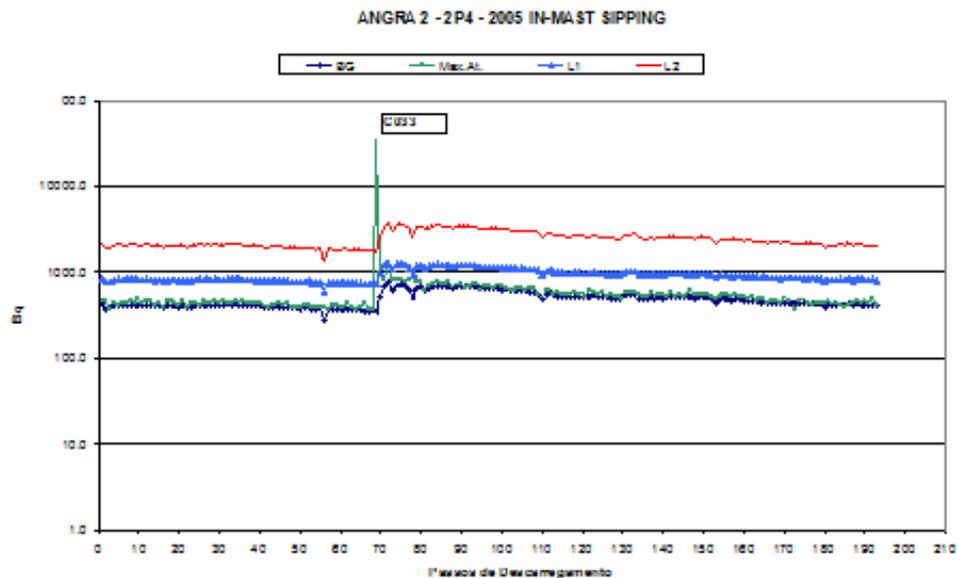
During the refueling outage 2P4, performed at the end of Cycle 4, the step of unloading the core, the "In-Mast Sipping" test recorded for the fuel C033 an activity from fission products greater than the average recorded for all other unloaded fuel assembly, Figure 4 [2]. Subsequently, an indication of failure observed during the cycle and recorded "In-Mast-Sipping" test and it was confirmed using "Box-Sipping" test, which also indicated an increase level of fission products in the water sample taken during the implementation of the test. After, the fuel C033 was confirmed as failed, a visual inspection was done on it, however had no evidence of defective in external fuel rods or spacer grid. During the visual inspection, were also inspected the top and bottom nozzle of fuel rods searching failures evidence in especially in solders. The fuel C033 Visual Inspection showed normal appearance to the residence time in the reactor, a cycle. After, it was stored in the pool spent fuel to wait the planning of repair, using the FARE (Reconstitution Fuel Assembly Equipment) system.

Figure 4. Analysis of the beta activity of fuel during unloading.

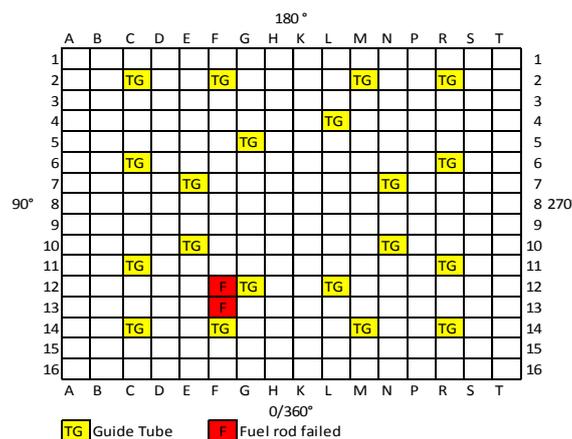
After “Box-Sipping” test, the Visual Inspection in fuel C033 was executed again, using the Visual Inspection System with Underwater Cameras, where was observed a “blister” (secondary located in fuel rod pellet damage caused by swelling) in column "P" (from 0 ° / 360 °), in first three fuel rods (VC). This observation indicated the need another test called Eddy-Current Test. The diagram used as a guide for the identification of fuel rods (VC), tubes Guides (TG) and identifies fuel rods failed (F) is shown in Figure 5.

Figure 5 – Scheme alpha numeric identification of fuel rods in fuel assembly.

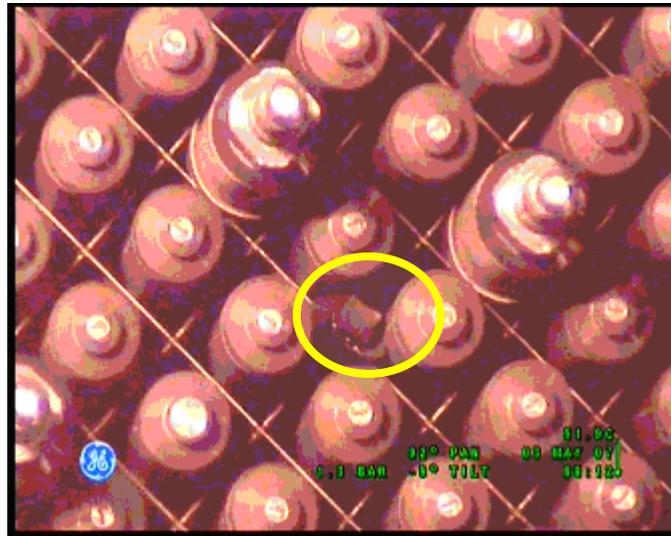
Then, after Visual Inspection, before of repair process, the bottom nozzle was removed and "debris" was located between the rods E12, E13, F12 and F13 against 1st spacer grid as can

be seen in Figure 6. After removal of the “debris”, the fuel rods in position F12 and F13 were identified as failed by "Eddy-Current” test and confirmed by visual inspection.

Figure 6 . “Debris” located between the fuel rods of positions E12/E13/F12/F13.

The VC F12 was noticed a failure in region near the spacer grid caused by "Debris" and another failure secondary, "Blister", near center of the VC. The VC was removed and placed in the “Canister”, the special place where is possible to put failed rod fuel in pool spent fuel. This VC was replaced by Dummy rod (Mass of Zircaloy rod).

The VC F13, during the visual inspection was noticed a failure in region near spacer grid caused by “Debris” and other secondary failures - "Blister", near center of VC. The VC was replaced by P12 position VC, which had burn up value close VC removed.

The VC P12 rod was moved to position F13 to avoid that more than two rods dummy in neighboring positions in fuel element. This point is important because of the "Debris" was between four fuel rods that also were neighbors of the two guides tube.

The VC P12 was also tested by “Eddy Current” test and wasn’t detected failure. In place of this rod (position transferred to F13), was placed a rod "Dummy" (Mass of Zircaloy rod).

After checked the integrity each fuel rod, the leak test of the fuel was checked again through "Box-Sipping” test and other Visual Inspection was performed using Underwater Camera. The result of “Box Sipping” test and Visual Inspection showed that the fuel assembly was intact and free of debris.
