Mass Alarms in Main Control Room Caused Condensate on the Instrumentation and Control Cards in Turbine Building

Cheol-Soo Goo
Korea Institute of Nuclear Safety, Korea

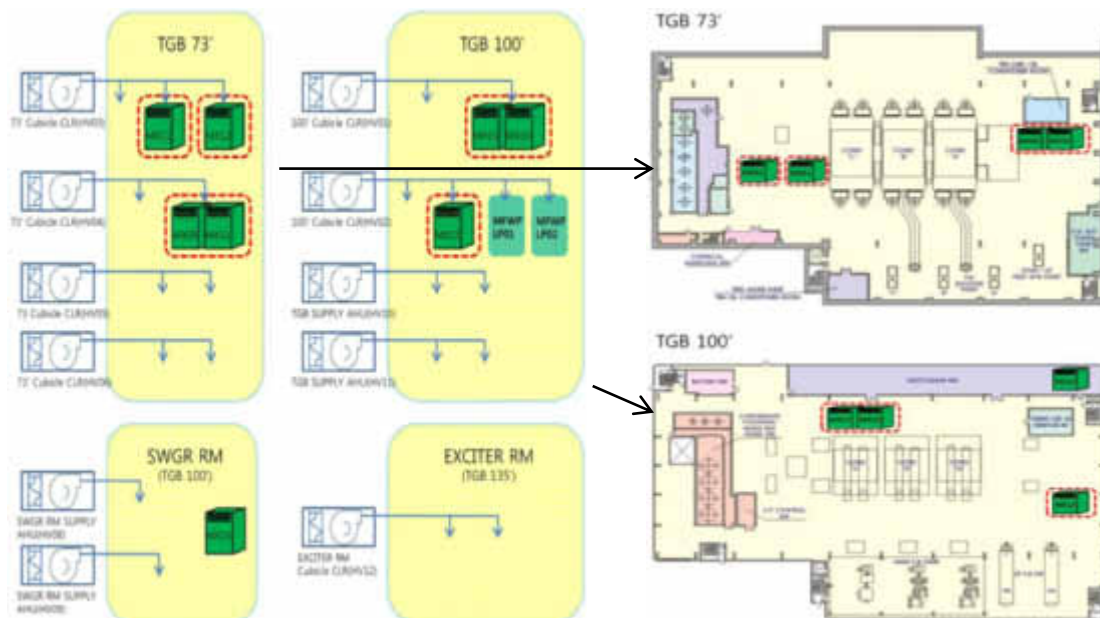
Figure 3. Cooler and Mux cabinet arrangement in the turbine and generator building

There are eight cabinets of PCS MUX in the turbine building which are installed in the separate five enclosures scattered in several locations in the building. Two chillers supply cooled water to the coolers and air handling units (AHU) for the cooling of the major equipment of PCS MUX cabinets, main feed water pump turbine control panel and exciter. Table 1 shows the cooling air supply facility and the major loads in the turbine and generator building. Each four coolers were serving to the turbine generator building level 73' and 100' respectively where four cooler supply cooling air to the building of 73' and 2 cooler and 2 AHU in 100'. Two chillers supply cooled water to the heat exchanger coils of the cooler and AHUs in the turbine generator building in which only one chiller operates and the other is on standby during summer. Figure 3 illustrate the layout and arrangement of the coolers and AHUs in the building.

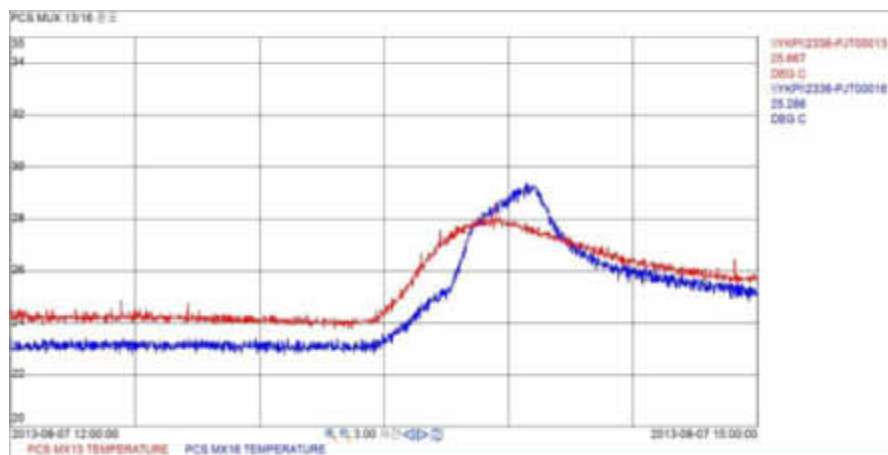
Figure 4. Temperature variation in the MUX 13(red) and 16

We can see a variation of temperature and humidity shown in figure 5 and 6 before and after the events in which humidity in enclosure increase rapidly than temperature and made condensation on the surface of cards in the MUX cabinets. Condensation water could be a circuit in the printed circuit board that may be a root cause of the alarms and indication in the main control room. Operating and maintenance manual describes a ground fault detection to detect ground failure that a power supply monitor contains three ground fault detection circuits. One circuit determines if catastrophic current leakage has occurred between control common and case ground. Similarly, the other circuits detect catastrophic current leakage from logic common and field common to case ground. Any current leakage between control common and case ground appears as a voltage across a resistor. No leakage yields a relative ground. Leakage of approximately 3.14 μA in either direction trips the window comparator sinking current to ground. As a result, the CONTROL POWER GND FAULT indicator lights on the front panel. And the window comparator energizes a solid state relay grounding the ground fault indication (GFI) line. The logic and field ground failure detection circuits operate in the same manner as the control ground-failure detection

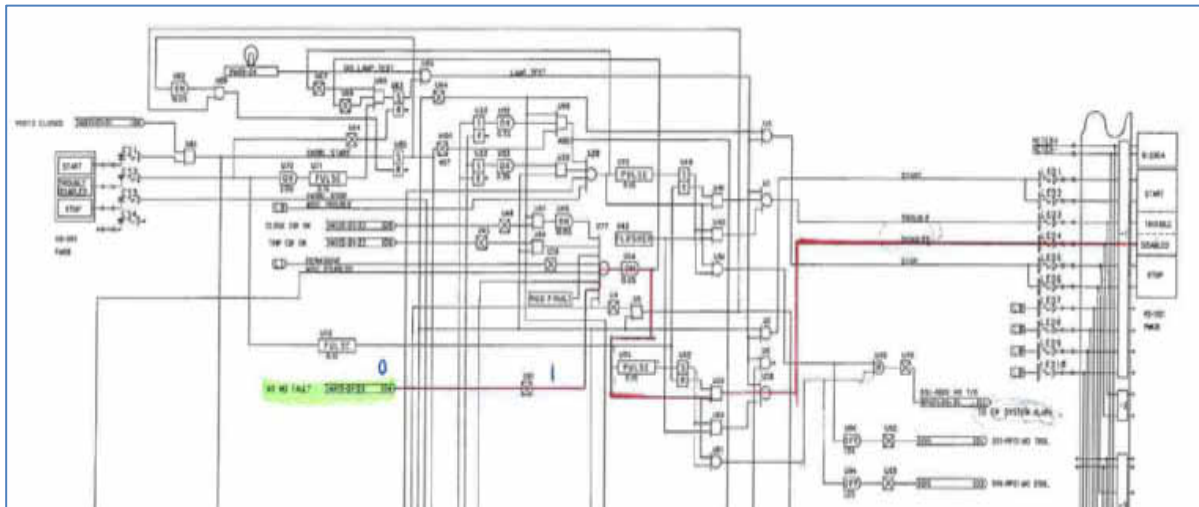
Figure 6. One of functional interconnection diagrams for fault indication

The three solid state relays that control the GFI line are wired in parallel. As a result, control, logic or field common leakage to case ground, grounds the GFI lines. The corresponding GND FAULT indicator lights on the front panel, to identify the faulty ground connection [2]. Figure 6, logic diagram, shows the process of the indication as a result of faults from the remote MUX cabinets, verifying an assumption that the root cause of the event is the condensation by rapid change of temperature and humidity in the enclosure. Leakage current through the bridge of water made a circuit to flow current over the ground fault limit.

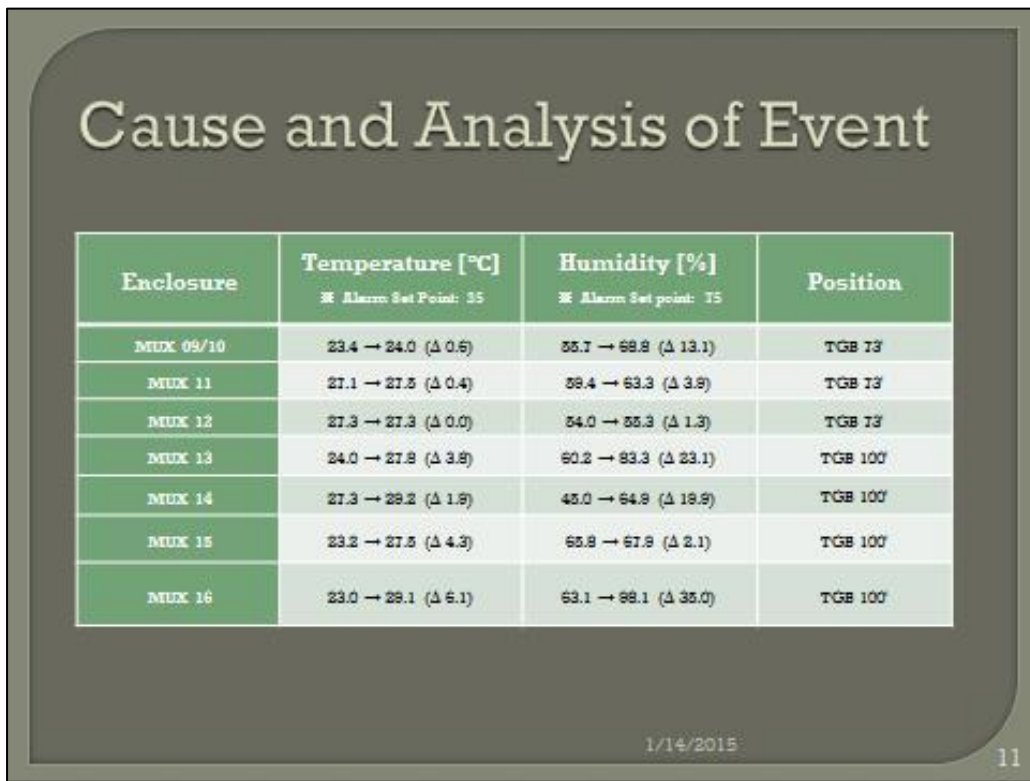
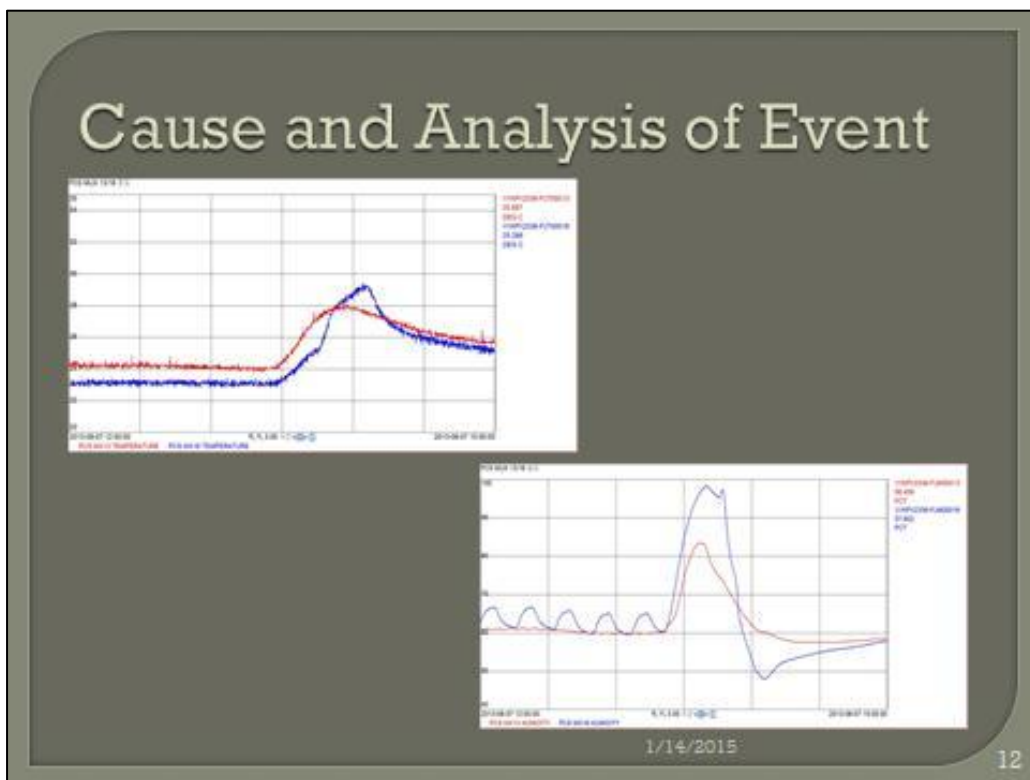
- Humidity in enclosure increase rapidly than temperature
- Made condensation on the surface of cards in the MUX cabinets.
- Condensation water could be a circuit in the printed circuit board
- Leakage of approximately $3.14 \mu\text{A}$ in either direction trips the window comparator sinking current to ground
- The logic and field ground failure detection circuits operate in the same manner
- Current leakage limit is approximately $0.981 \mu\text{A}$.
