# BWR Fuel Performance under Advanced Water Chemistry Conditions – a Delicate Journey Towards Zero Fuel Failures – a Review

**S. Hettiarachchi**

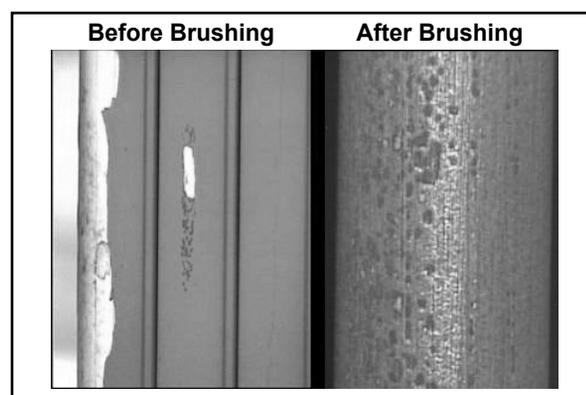
manage radiation fields. The most recent water chemistry change introduced into BWRs is the noble metal chemical addition during hot standby conditions by a process called noble metal chemical application (NMCA) and on-line NMCA application (OLNC) during full power operation of the plant. Following the first NMCA application at Duane Arnold (DAEC) BWR in 1996, some crud spallation was observed followed by crud spallation at Peach Bottom 2 in 1998, the second NMCA plant. The location of crud spallation was different in the two cases where the crud spallation was confined more to the lower end of the fuel rod in the case of Peach Bottom 2 (PB2) while at DAEC crud spallation occurred in the higher duty region (~ 75 cm from the bottom end plug) [4,5]. Since the low elevation crud spallation at PB2, shown in Figure 3, is not a high duty region, the phenomenon is less well understood. This kind of low elevation crud spallation was never seen in this plant again, or at any other NMCA plant. However, as a precautionary measure, a limit on the noble metal input over the life time of a fuel bundle was imposed following the Peach Bottom 2 fuel crud spalling observation [6],

Figure 3. Tenacious Surface Crud Spallation at Peach Bottom-2 [4].

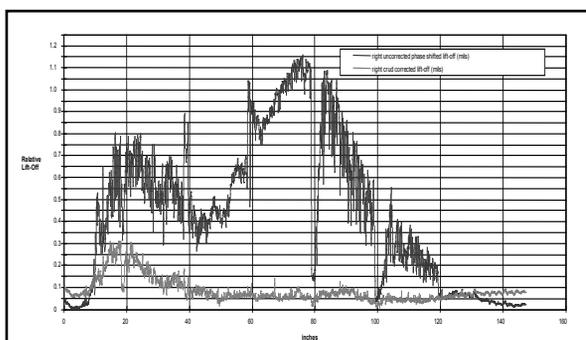
The eddy current liftoff measurements of crud deposited rods showed very large interference of the eddy current signal due to magnetic crud on the rod surface. Figure 5 shows the typical axial profile of the liftoff data from DAEC fuel rods as measured after correction to eliminate the interference. The corrected data (green trace) at each axial elevation represents the combined thickness of the zirconium oxide and the surface crud [4]. Such magnetic interference is common for fuel rods

Figure 5. Eddy current liftoff measurement after one NMCA cycle showing large interference due to magnetic crud [4].

operated in plants with zinc injection, where the fuel crud typically contains a zinc ferrite, which is strongly magnetic [7]. It can be seen in Figure 5 that the zinc-enriched crud deposited along the active fuel length from 10-120 inch (25 to 305 cm) elevations. The magnetic effect persisted throughout 3 cycles of operation. Hot cell post irradiation examination (PIE) was performed to determine the actual thickness of the zirconium oxide and the crud. In general, the cladding oxide thickness measured by metallography was low at less than 27  $\mu\text{m}$ , this is lower than that suggested by the corrected eddy current trace (green) in Figure 5, and most of the eddy current liftoff was the result of the 10 to 56  $\mu\text{m}$  thick, tenacious crud layer as confirmed by hot cell PIE after 4.5 years of plant operation following NMCA [4,5]. A part of the crud layer appeared to be crystalline containing 30 to 35% zinc, consistent with the  $\text{ZnFe}_2\text{O}_4$  phase. No fuel failures were detected at DAEC during the monitoring period covering cycles 15 to 17.

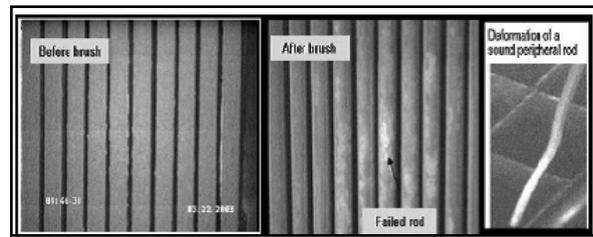
A BWR/6, experienced fuel failures during 2002-03 due to excessive crud deposition. The heaviest crud deposit occurred on the outer surface of peripheral rods at the second span (20 to 40 inches, 51 to 102 cm) from the lower end plug, Figure 6. Some peripheral rods failed due to local cladding penetration, while no interior rods exhibited heavy crud deposition or rod damage. Some peripheral

rods were found to bow away from the bundle, possibly due to higher cladding temperature and oxide growth on the peripheral side. Crud flake samples analyzed showed average metal contents in the crud in weight percent to be 71-84% Fe, 7-14% Zn, 2-8% Cu, 2-6% Si, and others <1%. Further analysis showed that the crud consisted of crystalline  $ZnFe_2O_4$  and an amorphous phase of zinc silicate  $Zn_2SiO_4$  filling the pores surrounding the zinc ferrite crystals. Analysis from two other BWRs confirmed the presence of zinc ferrite and zinc silicate in the crud deposits. Furthermore, when zinc silicate is present in the crud, the crud porosity can decrease from 50% to <10% due to pore filling by zinc silicate [2].

Figure 6. Tenacious Crud Build-up on Fuel Rods and Bow of a Peripheral Rod [2].

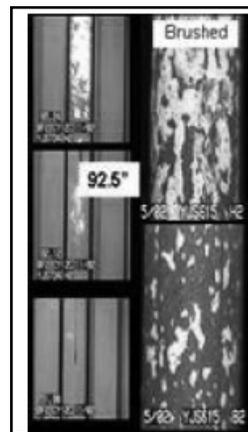
A BWR/4, Browns Ferry-2 experienced apparent corrosion-induced cladding failure of similar characteristics in 2002-04 and both had mid-cycle outages to remove failed assemblies and discharged all fuel in the reloads containing failed assemblies after 2 cycles [8]. Browns Ferry-3 also experienced fuel failures of similar characteristics in some 3rd cycle fuel rods as shown in Figure 7. The picture on the right was taken after brushing, exhibiting substantial surface spallation at the upper elevation of the failed rod [2].

Figure 7. Browns Ferry-2 Cycle 12 "corrosion" Failed Rod before and after Brushing [2].

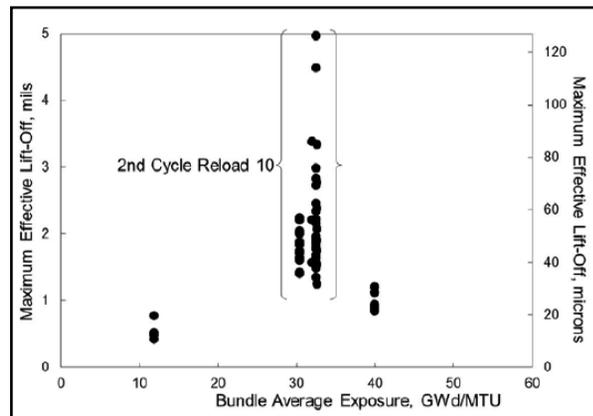
An example of a maximum effective eddy current liftoff measurement that provides an estimate of the cladding corrosion made on a Browns Ferry-2 rod is shown in Figure 8, and the associated corrosion behavior is shown in Figure 9 [9]. Fuel rods in 63 fuel assemblies from reload 10 failed, while fuel rods from reload 9 and reload 11 that were also present in the core at the same time as reload 10 fuel showed normal liftoff behavior as illustrated in Figure 8 [9].

Figure 8. BF-2 Lift-Off vs. Exposure Showing Affected Reload 10 Fuel Rods Compared to Normal Performance of Earlier (Reload 9) and Later (Reload 11) Reloads [9].

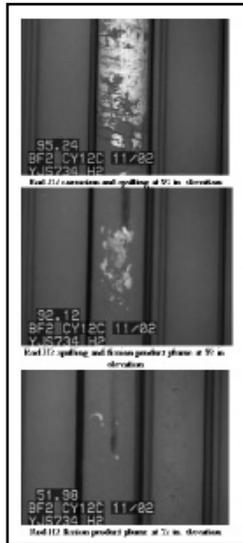
**Figure 9. Visual Appearance of Failed BF-2 Reload 10 H2 Rod; Leaking Locations Near 52 and 92 inches (132 cm and 234 cm) and Heavy Spalling Starting Near 95 inches (241 cm) [9].**

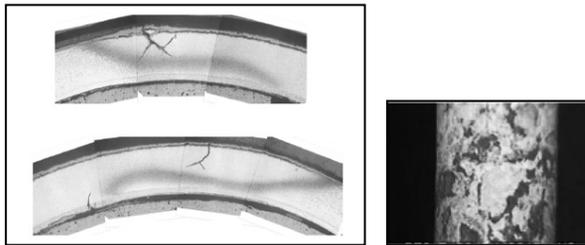
Further analyses of BF 2 rods showed that the rod perforation was caused by OD-initiated cracks through a locally hydrided region as shown in Figure 10 [9]. Outside-in cracking of BWR fuel rods can occur under power ramp conditions that promote radial hydride formation on the outer surface with modest bulk cladding hydrogen levels [10]. There was no significant wall thinning of the rods. As is evident from the Figure, fuel cladding cracking exhibited extensive multi-branch type cracks within a zone of large hydride localization. Cracks appear to have originated both from the inner as well from the outer surface. The cracks in the zirconium oxide layer are an indication that the oxide layer is non-protective [9].

**Figure 10. Cladding Cross-section from a Failed BF-2 Reload 10 Rod at 95.9 inches (244 cm) Showing Cracks Within Massive Hydride Localization near Primary Failure Location along with a Photo Showing Excessive Crud/Oxide Spallation [9].**

The investigation established that the BF-2 Reload 10 fuel failed by accelerated cladding nodular corrosion that resulted in the absorption of corrosion generated hydrogen. Localization of hydrides is postulated to have resulted from local thermal gradients that are caused by local differences in oxide growth and spalling of oxide. Massively hydrided regions then fractured under tensile loading that arose with accumulation of exposure during the course of normal operation. The specific manifestation of hydrogen and its localization in the BF-2 corrosion failures is a new, or previously unrecognized, BWR failure mechanism that has not been published in the industry [9].

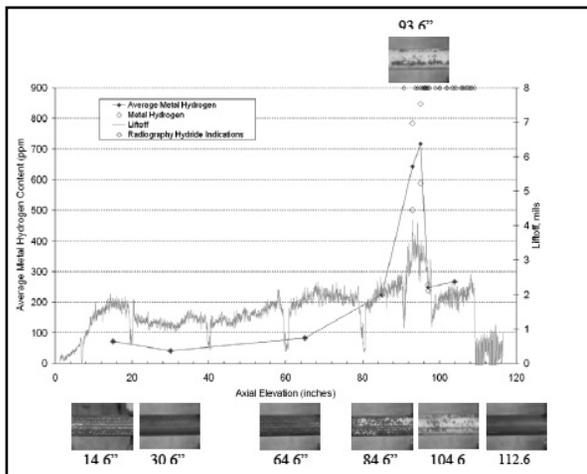
The examination of a sound partial length rod had surface characteristics similar to the failed rod with heavy spalling and corrosion with a ~ 90 micron eddy current liftoff peak near 95 inch (241 cm) elevation as shown in Figure 11 [9]. Despite the appearance and the increased eddy current liftoff, there was no visible perforation or through wall corrosion in this rod [9].

**Figure 11. Visual Appearance, Lift-off, Cladding Metal Hydrogen Content, and Radiography Hydride Localization Indications in Sound BF-2 Reload 10 Rod [9].**
