Identification and Analysis of Dominant Factors Affecting the Fuel Failure Rates in WWER-1000 Units in Czech Republic, Bulgaria, Ukraine and Russia

SRC RF TRINITY, Moscow, Troitsk, Russian Federation

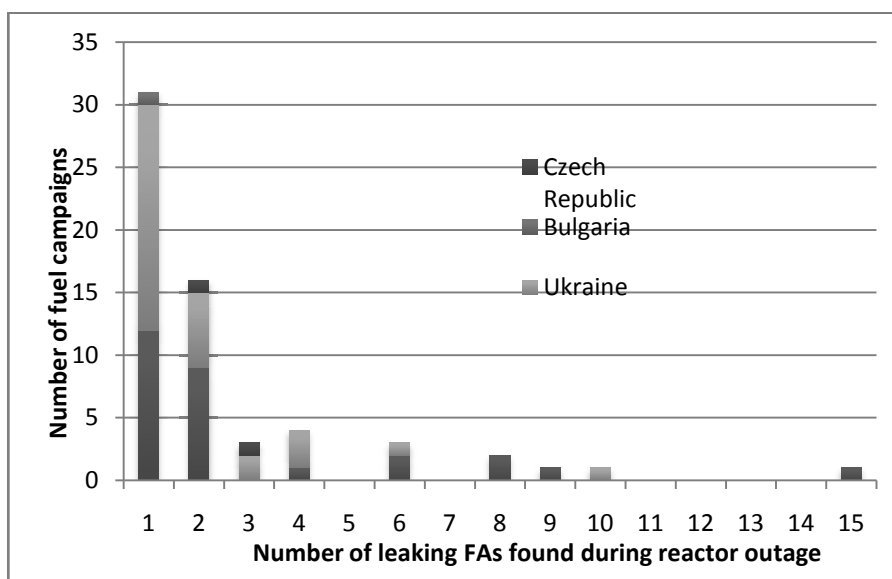
Figure 2. Statistics on fuel campaigns with different number of leaking fuel assemblies found in the core during the refueling outage

Fig. 2 shows the number of fuel campaigns with different amount of leaking FAs identified after the reactor shutdown.

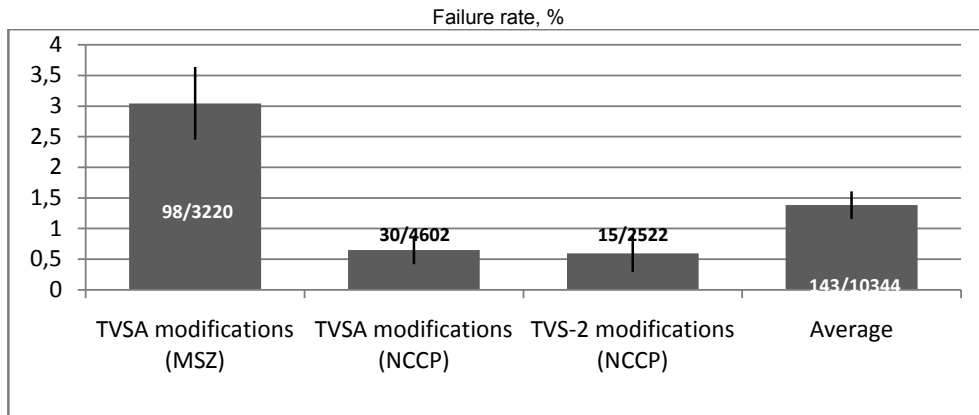
Figure 3. Consolidated data on the failure rates for TVSA and TVS-2 modifications (slash mark separates the number of leaking FAs and the total number of loaded FAs). Vertical dark lines represent the data uncertainty

Evaluations of the failure rates for different fuel types are summarized in Fig.3. Statistics shows that reliability of TVSA series seems to be somewhat lower than that for modifications of TVS-2. Nevertheless, the failure rate for TVSA and TVS-2 produced by the same manufacturer (NCCP) is similar.

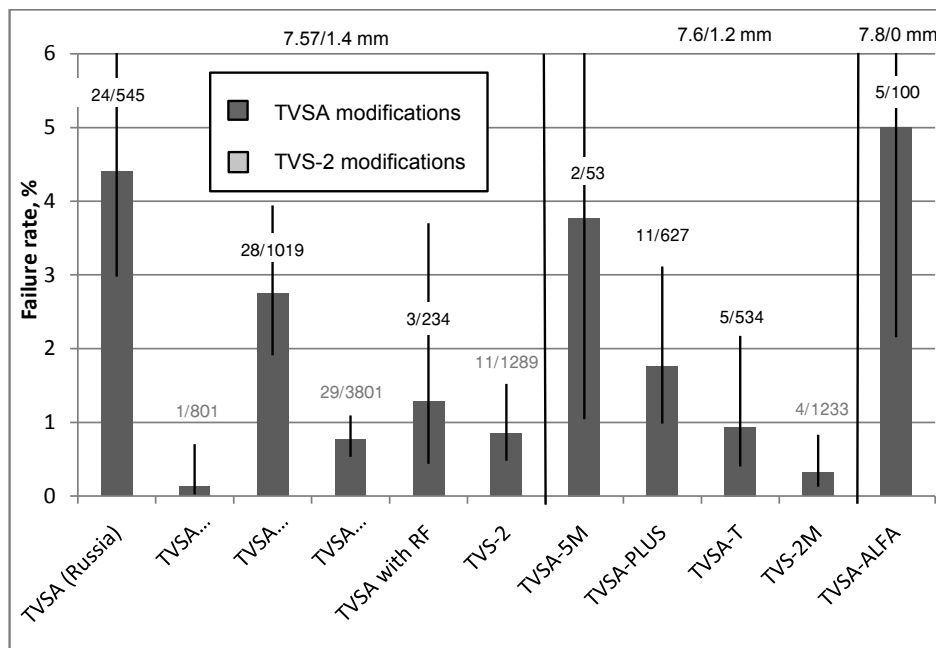
Figure 4. The failure rates for FAs of different design (slash mark separates the number of leaking FAs and the total number of loaded FAs). The light color indicates the fuel manufactured by NCCP

Fig.4 demonstrates the expanded statistics for the failure rates with taking into account FA modification, fuel pellet form factor, manufacturer and country where the fuel was put into operation.

In particular, Fig.4 demonstrates that FAs of similar design may show different failure rates even though they are equipped with fuel rods of the same type and are produced by the same manufacturer. It can be also seen that the same fuel design may exhibit rather different reliability in power units of different countries (e.g., see data on TVSA).

Worth noting is that FAs with both the highest and the lowest failure rates (see Fig.4) were equipped with coarse-grain fuel pellets (grain size

no less than 25 μm). Consequently, one may conclude that coarse-grain pellets are not the governing factor from the viewpoint of a failure.

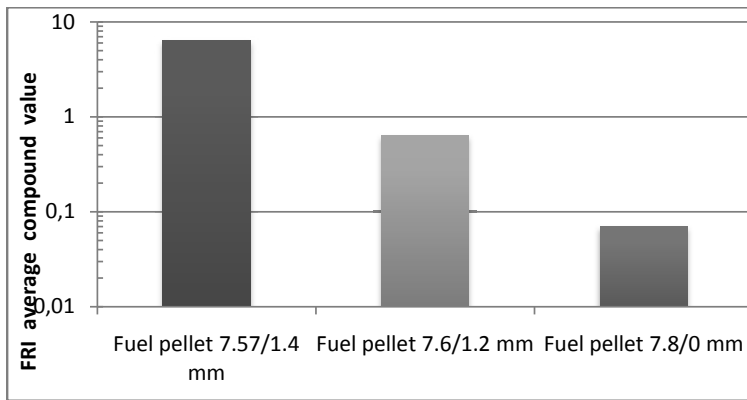
Figure 5. Average values of the FRI(¹³¹I) indicator (µCu/kg) as a function of fuel pellet form factor

Primary coolant activity after a failure depends on fuel rod design. Handling of the NPP data showed (Fig.5) that average activity levels for advanced fuel with 7.6/1.2 mm pellets were lower in comparison with the traditional fuel (7.57/1.4 mm pellets). In case of fuel pellets of the 7.8/0 form factor, fuel failures led to the least average activity levels. These trends are mainly due to peculiarities in fission product release from coarse-grained fuel and to diverse conditions of mass transfer inside leaking fuel rods of different design.

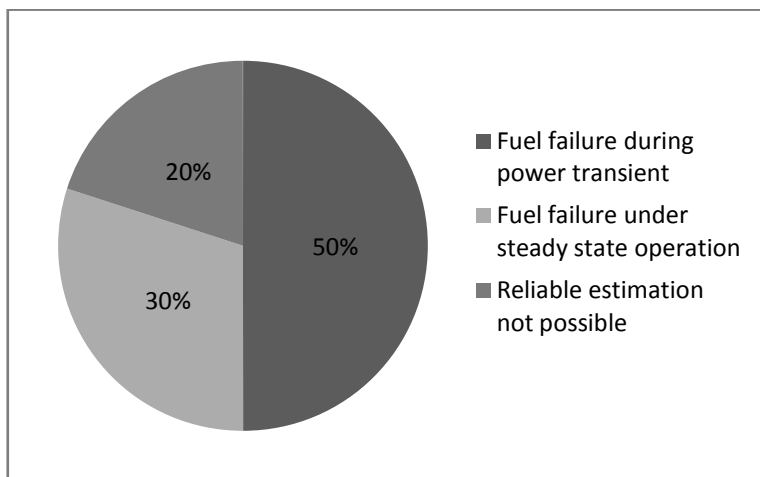
Figure 6. Reactor operation regime at the moment of fuel failure (by data on 40 fuel campaigns in 2003-2014)

In addition, the data on primary coolant activity was used to correlate occurrence of fuel failures to changes in reactor power (Fig.6). It was estimated

if the risk of a failure was higher under steady state operation or during load follows.

The study showed that in the most cases fuel failures occurred during power transients. However, load follow is not the root cause of a failure. In combination with power transient there must be some extraneous negative factors which can lead to a breach in cladding. Such negative factors may be related to, e.g., disturbances in the primary circuit during the transients. These 'disturbances' may contribute to relocation of foreign material with coolant flow. Impact of foreign material on fuel cladding may be aggravated due to this 'disturbances' as well (for instance, because of more intensive vibration of fuel rods).
