Project «Zero Failure Level». Organization, State, Tasks

PROJECT «ZERO FAILURE LEVEL»

Organization, State, Tasks

11-th International Conference
«Operation, modeling and experimental support of the fuel»
Varna, Bulgaria
September 26 – October 03, 2015

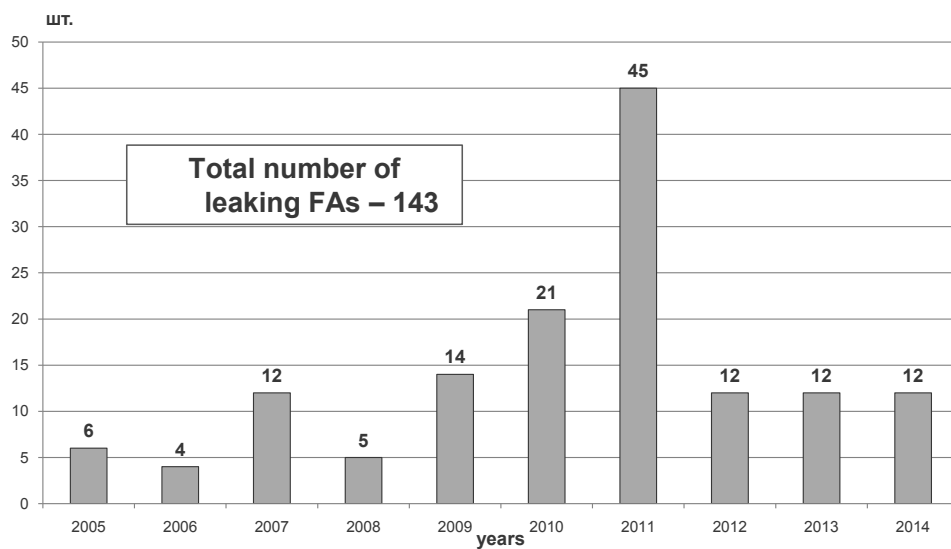
Yearly distribution of leaking FAs

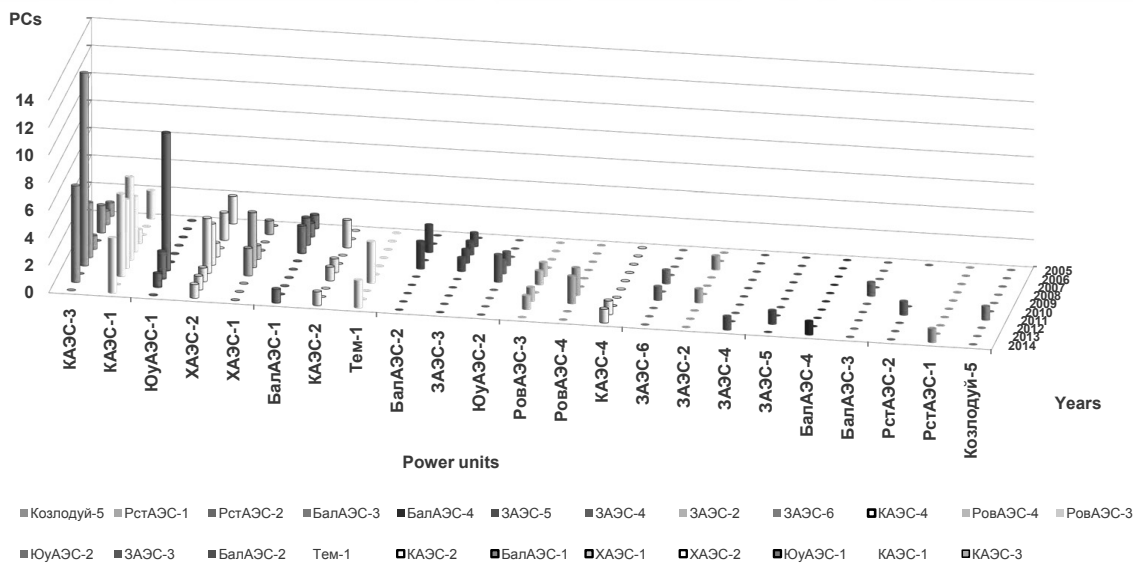
Distribution of leaking FAs per power units

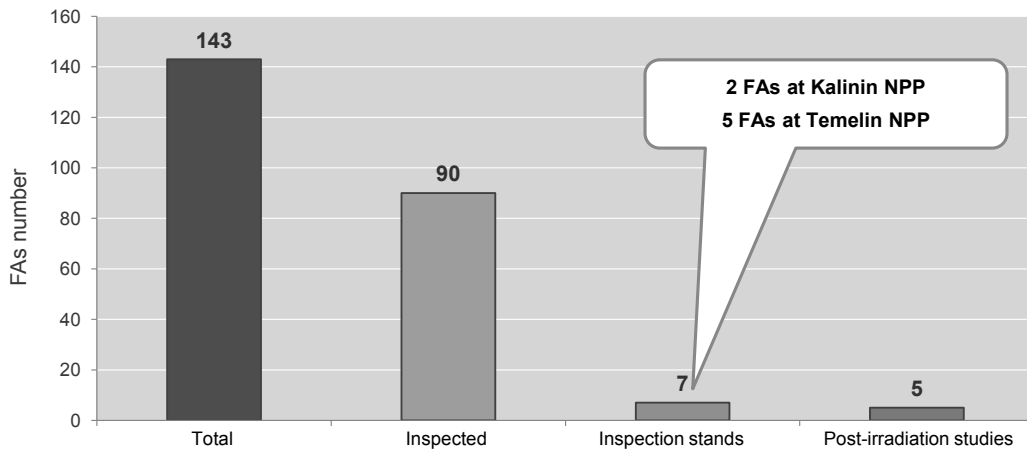
Cope of examination of leaking fuel assemblies

1. FA inspection in the mast of refueling machine is least informative method of identification of leaking fuel rod in the FA.
2. Inspection stands present at NPP allow to quickly inspect the FA and to identify the leaking fuel rod with the help of ultrasonic inspection system. But during inspections on inspection stands the cause of fuel rod leakage was not detected unambiguously not even in one inspected FA.
3. The Most informative method of inspection of leaking FAs is the post irradiation examination in hot chambers of NIIAR that allow :
 - To explicitly identify the leaking fuel rod;
 - To obtain complete information about the state of the leaking fuel;
 - To establish the cause of leakage.

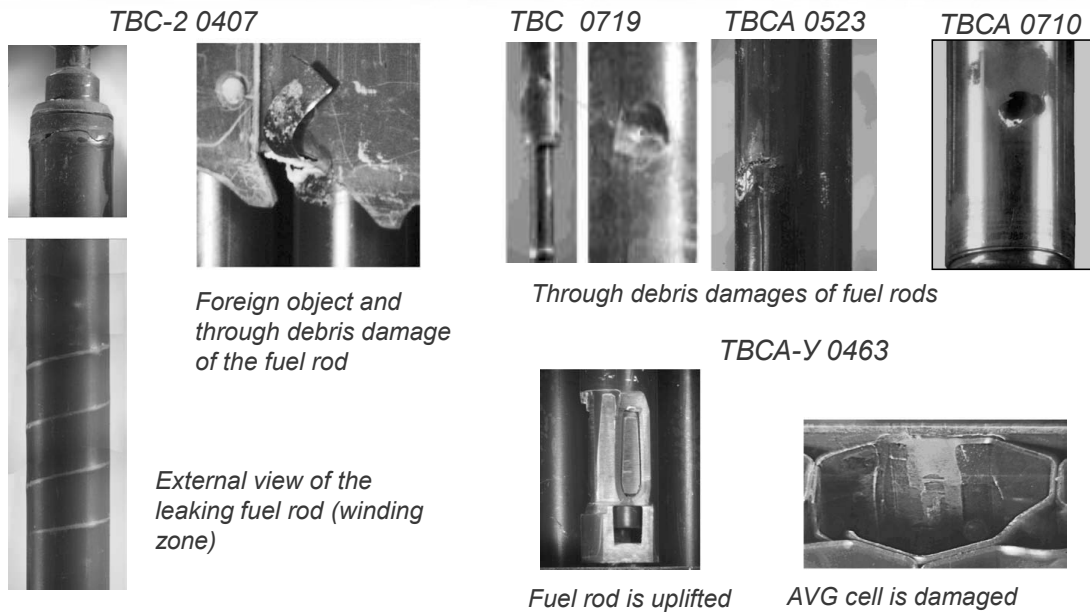
POST IRRADIATION EXAMINATION OF LEAKING FUEL ASSEMBLIES VVER-1000 (2)
