# Corrosion Assessment of Refractory Materials for High Temperature Waste Vitrification (U)

A document prepared for AMERICAN CERAMIC SOCIETY/SYMPOSIUM ON THE CORROSION OF MATERIALS BY MOLTEN GLASS at Cincinnati from 04/30/95 - 05/04/95.

## CORROSION ASSESSMENT OF REFRACTORY MATERIALS FOR WASTE VITRIFICATION

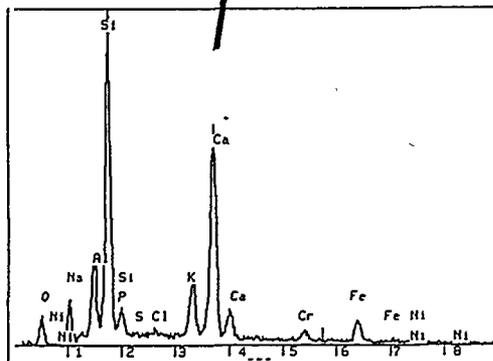
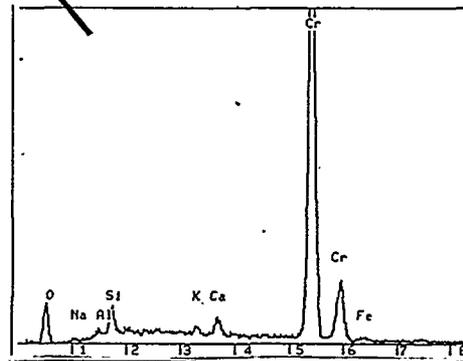
Scanning electron microscopy coupled with energy dispersive spectroscopy was used to examine the corrosion surfaces in detail and gain insight into corrosion mechanisms. It is hypothesized that in the metal alloys, degradation occurred by chloride breaking down the protective oxide film allowing subsequent oxidation of the base metal. A chromium oxide layer (devoid of nickel and iron) was seen consistently in the corrosion regions of all areas of the coupons (Figure 2). In the refractory samples, attack occurred by the dissolution of refractory constituents into the glass. A "dissolution layer" was observed in all exposed areas of the coupons (Figure 4). Although only trace amounts of salts were observed in the dissolution layer, it is thought that the salts may enhance refractory dissolution, thus, explaining the relatively rapid corrosion rates.

Figure 2. Inconel 690 coupon following exposure to the AH composition at 1300° C. Note the chromium oxide layer.
