# IONIZING RADIATION EFFECTS ON IMPLANTED PACEMAKERS

J. Holzer<sup>1</sup>, W. Binder<sup>2</sup> and H. Aiginger<sup>1</sup>

<sup>1</sup>Atomic Institute of Austrian Universities, Schüttelstraße 115, 1020 VIENNA

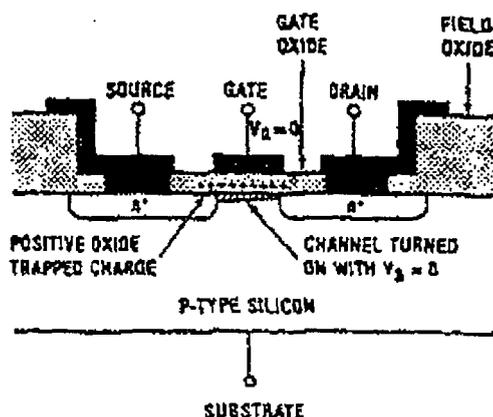
Figure 1. Charge distribution within the MOSFET after irradiation

Within the isolating Si- or Ge-Oxide-Layer, electron-hole pairs are produced during irradiation. Some holes are transported through the oxide layer by means of „hopping transport“ without recombination with electrons, while few holes are permanently trapped near the metallic gate contact, known as deep-hole-trapping. This trapped charge induces a voltage between the metallic contact and the inversion channel on the other side of the oxide layer. This mechanism is similar to that of a capacitor, where the space between the two contacts is filled with isolating material. Assuming that the charge on the capacitor is kept constant, the voltage has to increase in accordance with the increasing distance.

The characteristics of the whole device is influenced by the permanently trapped charge in the MOS-FET. In the worst case a n-channel-MOSFET is permanently in conducting state even without gate voltage.

The comparison with the capacitor explains the following findings: Cardiac pacemakers based on 8µm technology are more radiation sensitive than 5µm CMOS pacemakers, and these are more sensitive than 3µm based pacemakers. The same charge in a grater distance to the inversion channel produces more voltage thus increases the possibility of pacemaker failure.
