HAZARD EVALUATION FOR 244-AR VAULT FACILITY

Key Words: 244-AR, Vault, Flooding, Hazard Evaluation, HAZOP

HNF-4453
Rev. 0

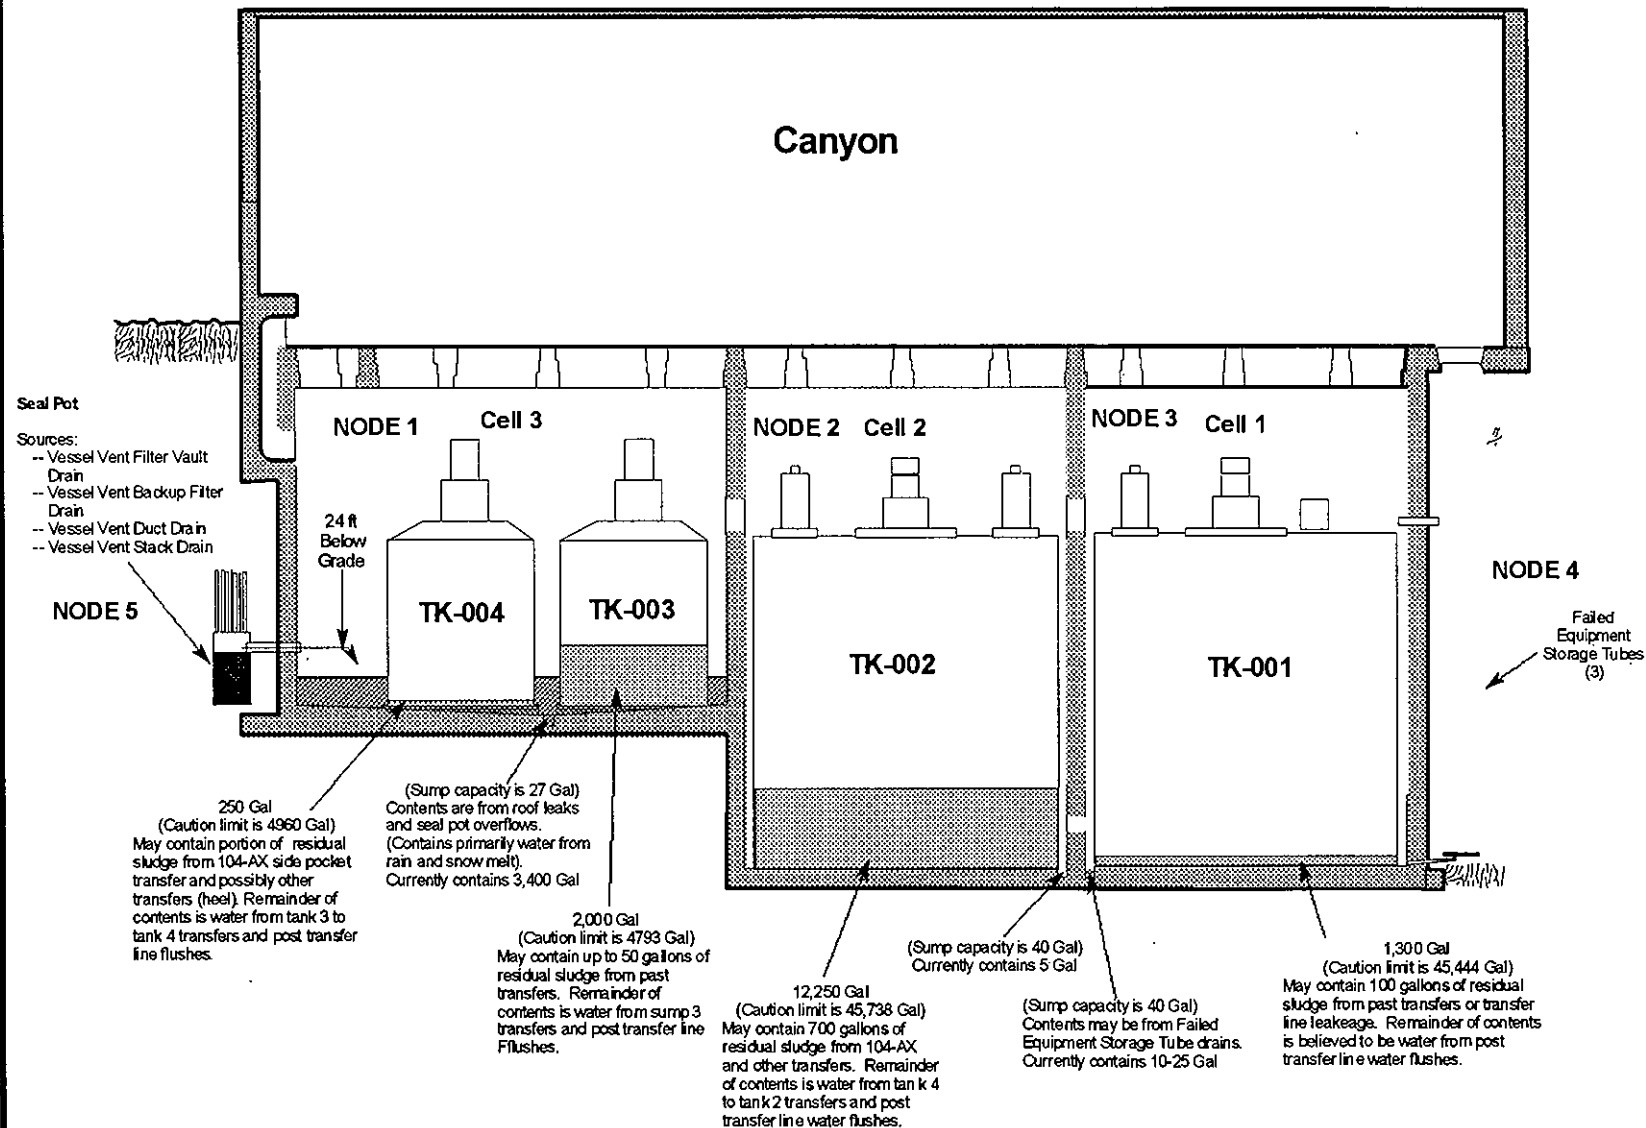
Figure 3-1. 244-AR Vault Facility HazOp Node Diagram

- Node 1: Cell 3 including TK-003 and TK-004
- Node 2: Cell 2 including TK-002
- Node 3: Cell 1 including TK-001
- Node 4: Failed Equipment Storage Tubes
- Node 5: Seal Pot Pit
