ANALYSIS OF THE EFFECT OF DISSIMILAR WELDING ON A HIGH PRESSURE FLARE STACK

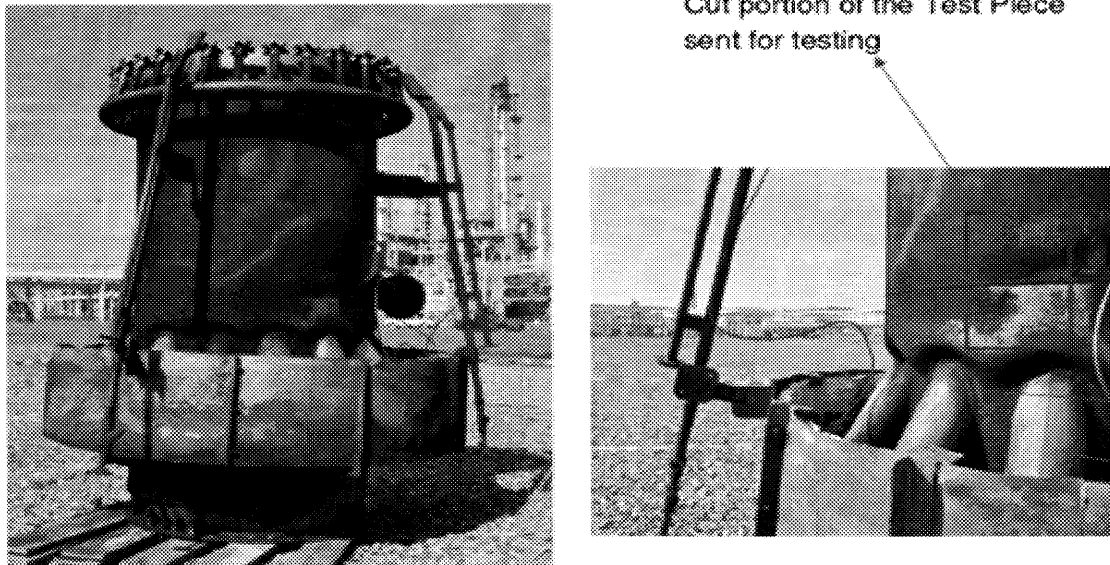
Figure 1: HP flare stack

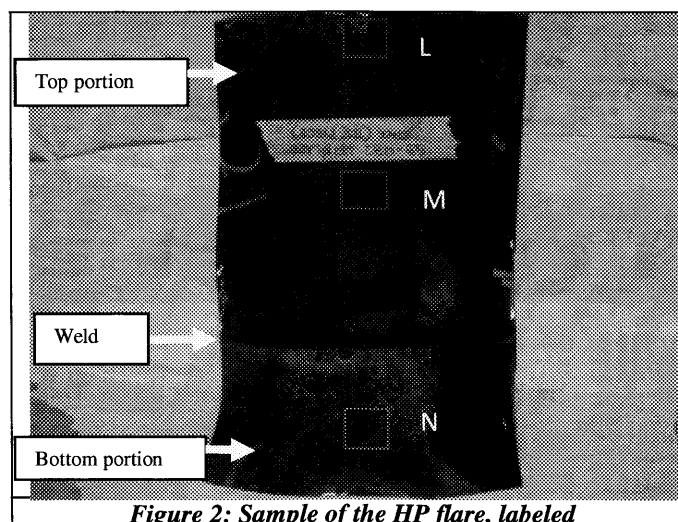
Figure 2: Sample of the HP flare, labeled

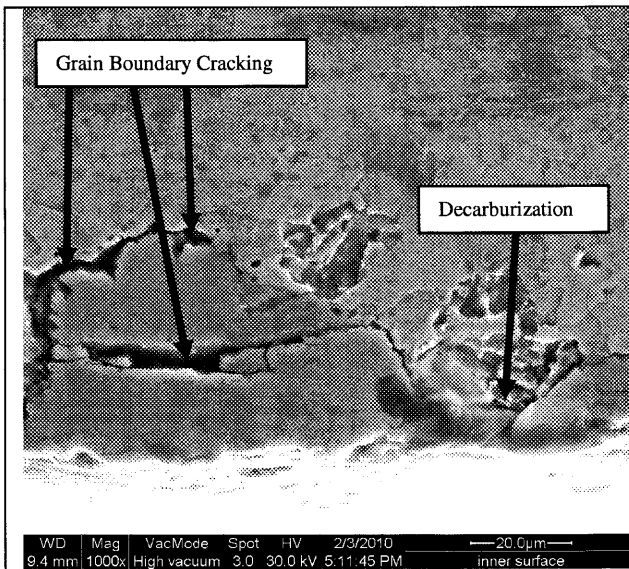
Figure 3: Cross-section along thickness on surface, X1K

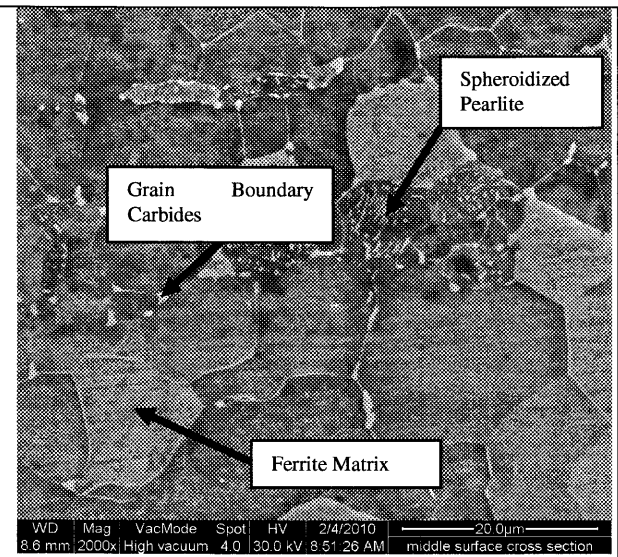
Figure 4: Cross section along thickness at the middle, X2K

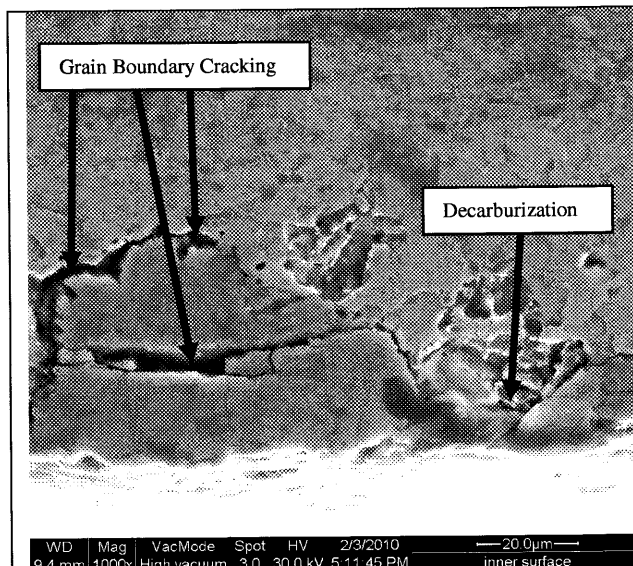
Figure 3: Cross-section along thickness on surface, X1K

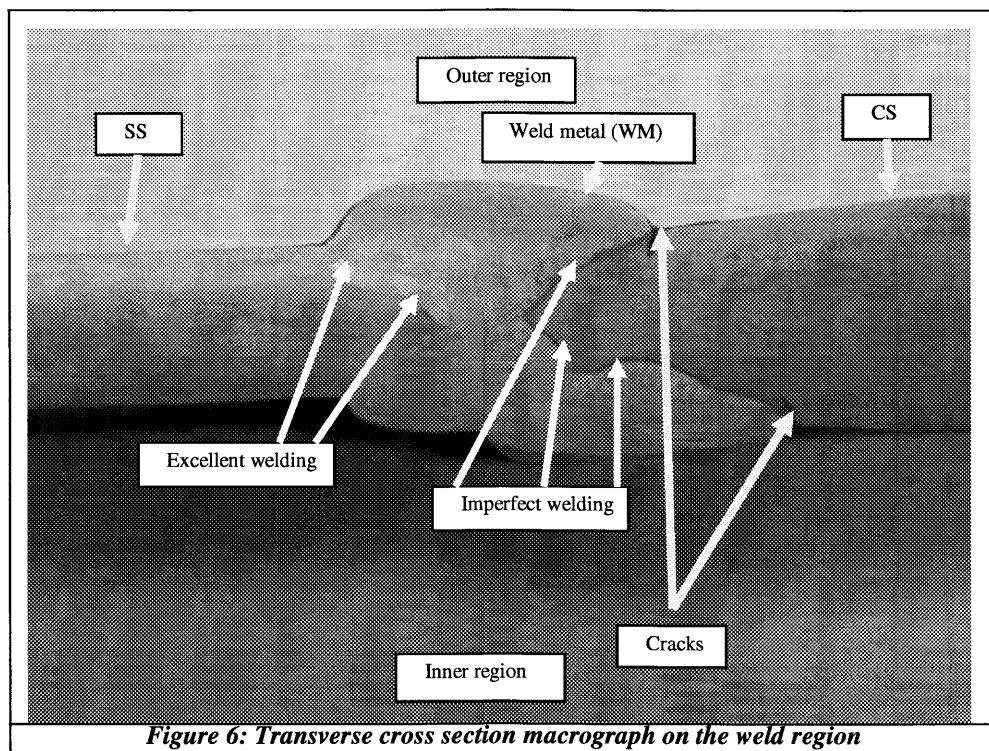
Transverse cross-section macrograph of the weld region is shown Fig. 6. The weld joining is excellent on the SS portion. However, cracks were detected on the inner and outer surface at the interface between the WM and the heat-affected zone of the CS. These cracks are in the vicinity of the unmatched border(s) of the WM and the CS, while no such cracks are visible in the SS-WM border(s).

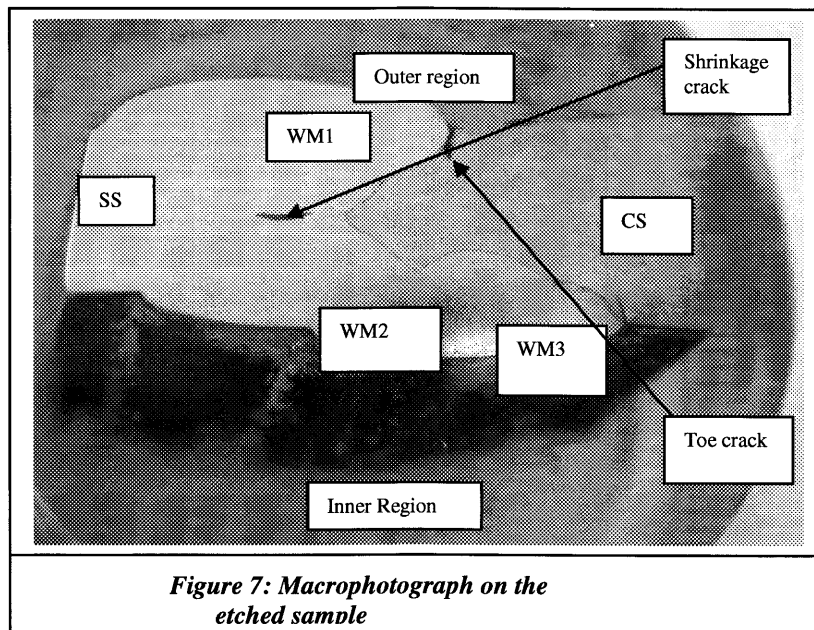
Microstructures along the weld region are shown in Fig. 7. There are three beads of weld metal, labeled WM1, WM2 and WM3 respectively, with the cracks highlighted. Figs. 8 & 9 show the microstructure of the border region between the WM-CS and WM-SS, along with its respective EDAX analysis, while Figs. 10 & 11 details and identifies the cracks that developed in the region.

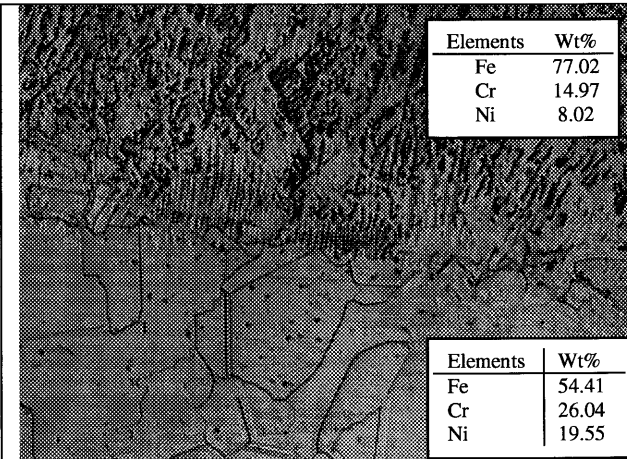
Figure 8: Microstructure at the interface between SS-WMI X80, matching borders, with EDX analysis of both sides

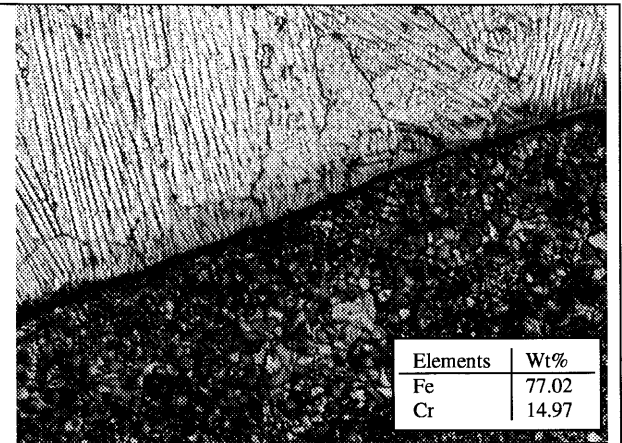
Figure 9: Microstructure at the interface between WMI-CS X80, separate borders, with EDX analysis of CS

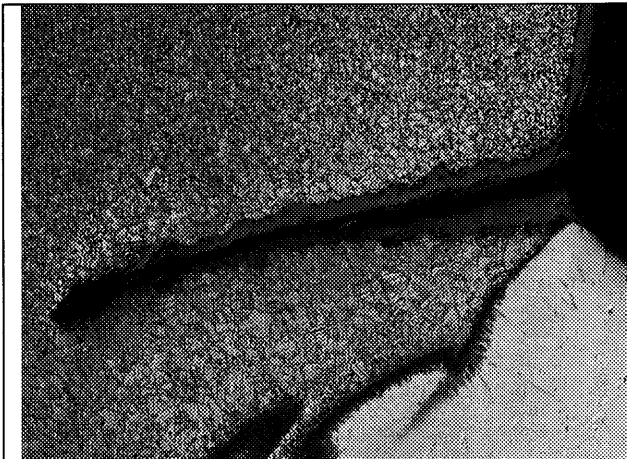
Figure 10: Crack at interface between WM (un-etched) and CS, X50, crack length is about 1 mm, identified as toe cracking

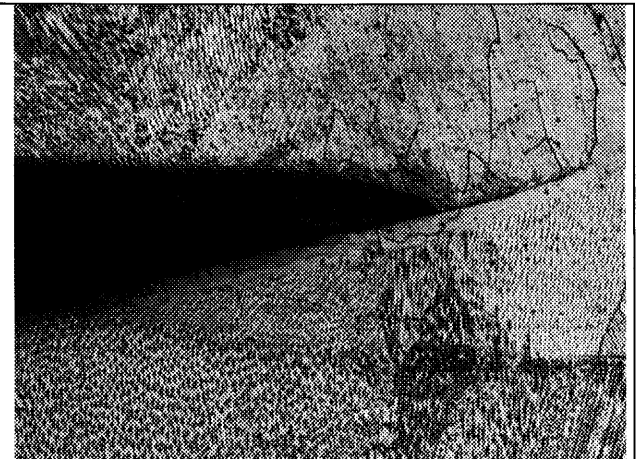
Figure 11: Tip of hole between two beads of weld metal, at left side, X80, identified as shrinkage cracks
