AECL-5801

MODEL BOILER STUDIES ON DEPOSITION AND CORROSION

P.V. BALAKRISHNAN and E.G. McVEY

**Presented at NACE Canadian Eastern Regional Conference on Corrosion
in the Power Industry, Montreal, Quebec, 27-29 September 1977**

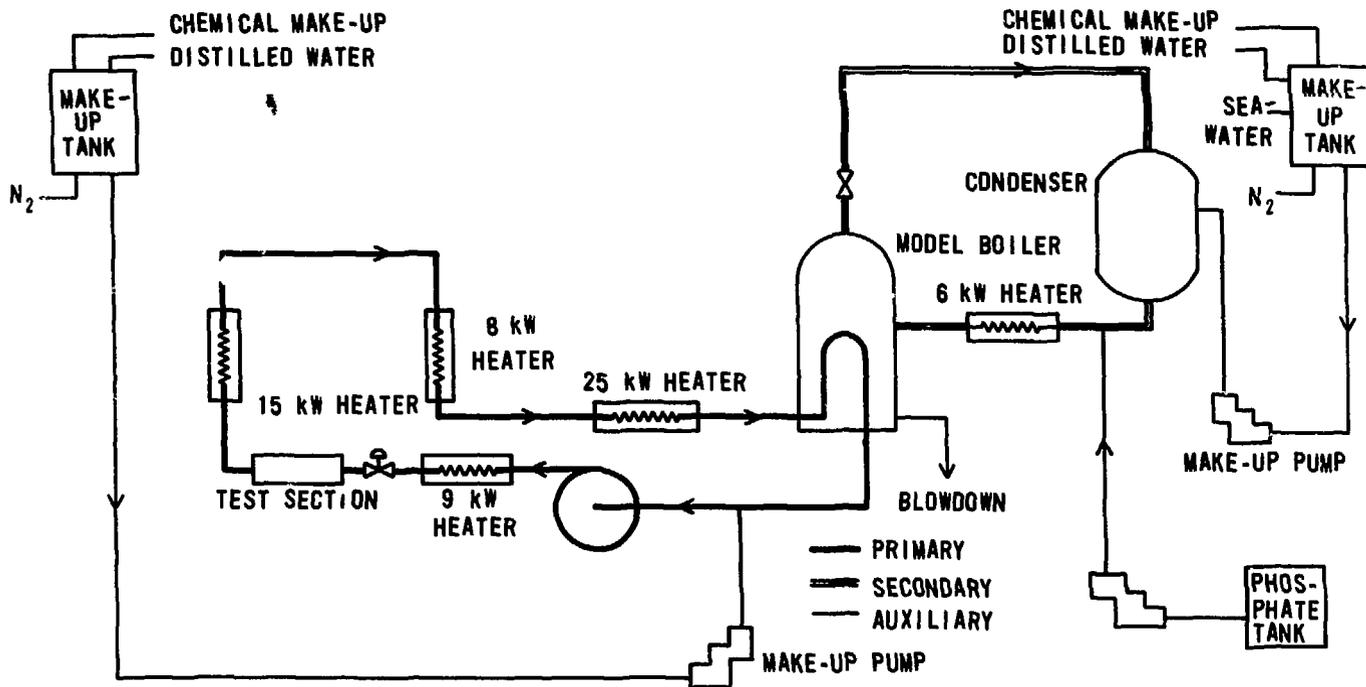
FIGURE 1 SCHEMATIC DIAGRAM OF MODEL BOILER INSTALLATION

A schematic diagram of the model boiler circuit is given in Figure 1. The boiler had a single Incoloy-800* U-tube (12.7 mm OD x 1.15 mm wall). The tube had appended to it on one leg a carbon steel umbrella to create a steam-blanketed region for studying effects of concentration of impurities in such regions (Figure 2), and to the other leg devices to simulate different crevices between tubes and tube support plates. The heat required to generate the steam in the boiler was derived from the primary flow through the tube taken from the loop. The model boiler system included a copper-tubed condenser and a 6 kW heater for preheating the water as it entered the boiler. The circulation was provided by natural density differences (natural circulation). The boiler was rated at 40 kW. The operating conditions of the loop were as listed in Table 1.

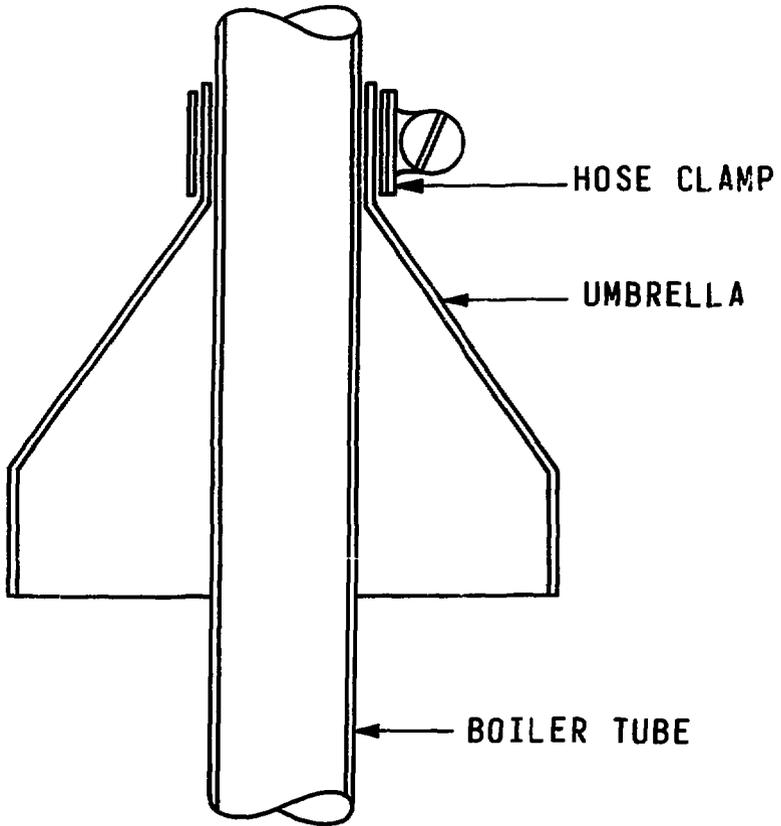
FIGURE 2 SKETCH OF THE CARBON STEEL UMBRELLA ON BOILER TUBE

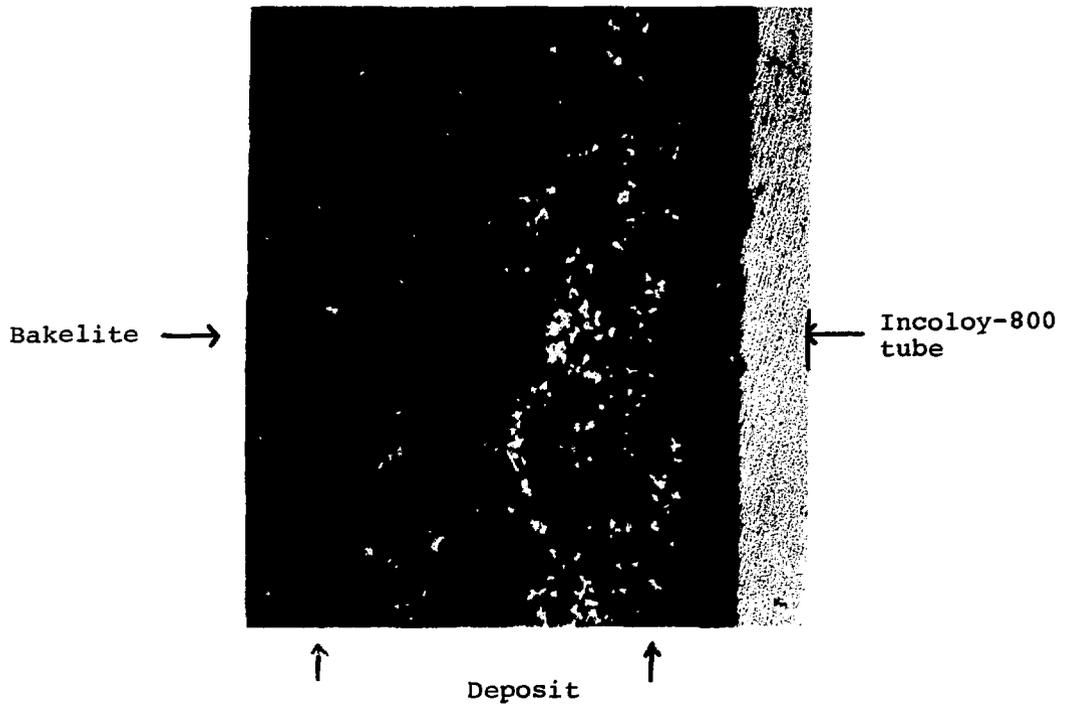
FIGURE 4a Optical micrograph of deposit 500x

After 47 days in this phase, the deposit formed was thinner than that formed during the first phase. Both the loose outer layer and the hard inner scales were present. A section of the tube with the deposit intact was examined by the SEM/EDS technique. The optical micrograph and the secondary electron micrograph of the sections are shown in Figures 4a and 4b respectively. The elemental maps of the deposit are given in Figures 5a through 5g which show the distribution of the different elements through the scale. Figure 6 shows a composite elemental X-ray map obtained by tracing the boundaries of major concentration for each element. Four layers are apparent, with similar elemental constituents but different concentration profiles. Figure 7 shows the X-ray spectra collected for each layer. The elemental composition for each of these layers is given in Table 5. The bottom two layers are rich in copper, which may have been deposited on the tube in the metallic state since it is the least electro-positive metal in the system. Iron is more predominant in the middle two layers. The iron may be existing as magnetite. Magnesium, introduced as an impurity with the sea-water, predominates in the top two layers, while calcium, also a

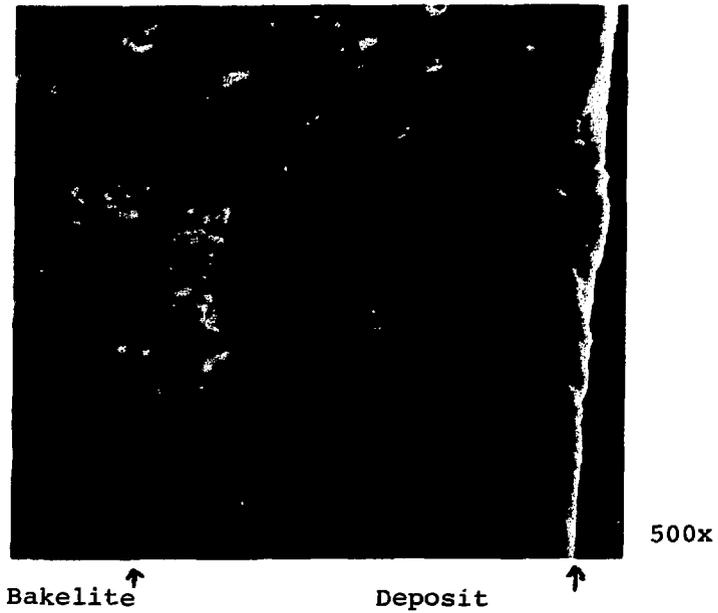
FIGURE 4b Secondary electron micrograph of deposit

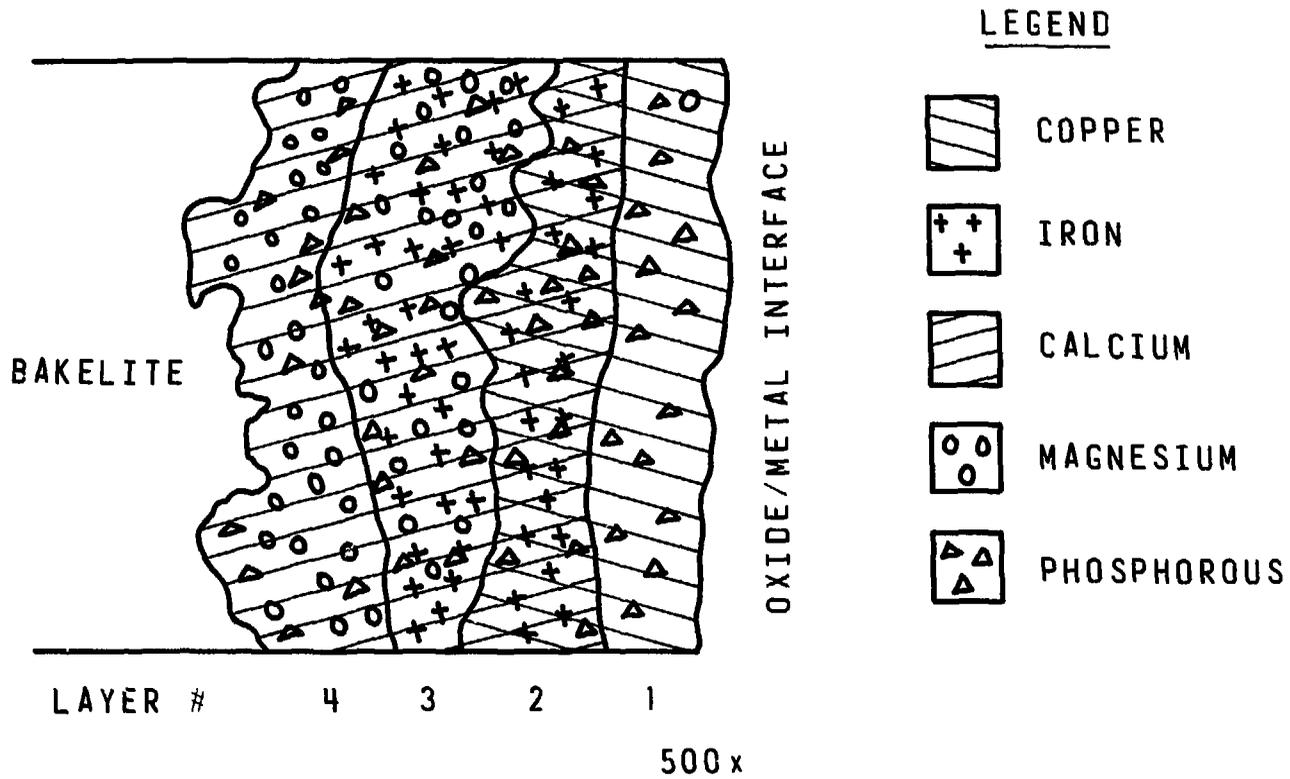
FIGURE 6 COMPOSITE ELEMENTAL X-RAY MAP OF DEPOSIT

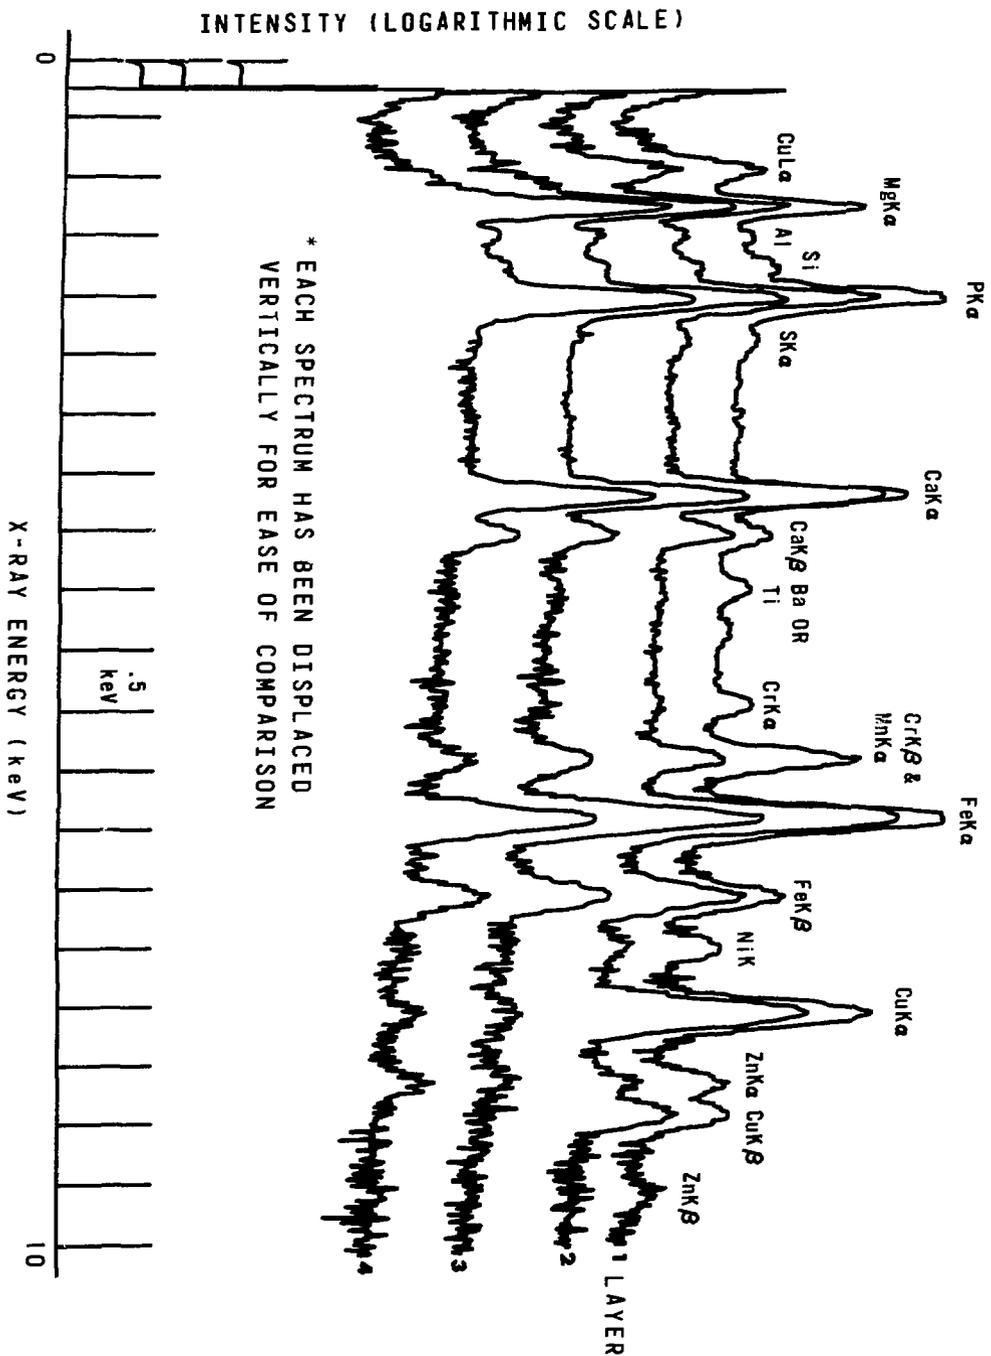
FIGURE 7 TYPICAL X-RAY SPECTRA* COLLECTED FROM EACH LAYER
