OCTOBER 1979

**TENSILE PROPERTIES OF IRRADIATED AND
FATIGUE EXPOSED STAINLESS STEEL
DIN X 6 CrNi 1811
(SIMILAR TO AISI TYPE 304)
PLATE AND WELDED JOINTS**

Netherlands Energy Research Foundation ECN

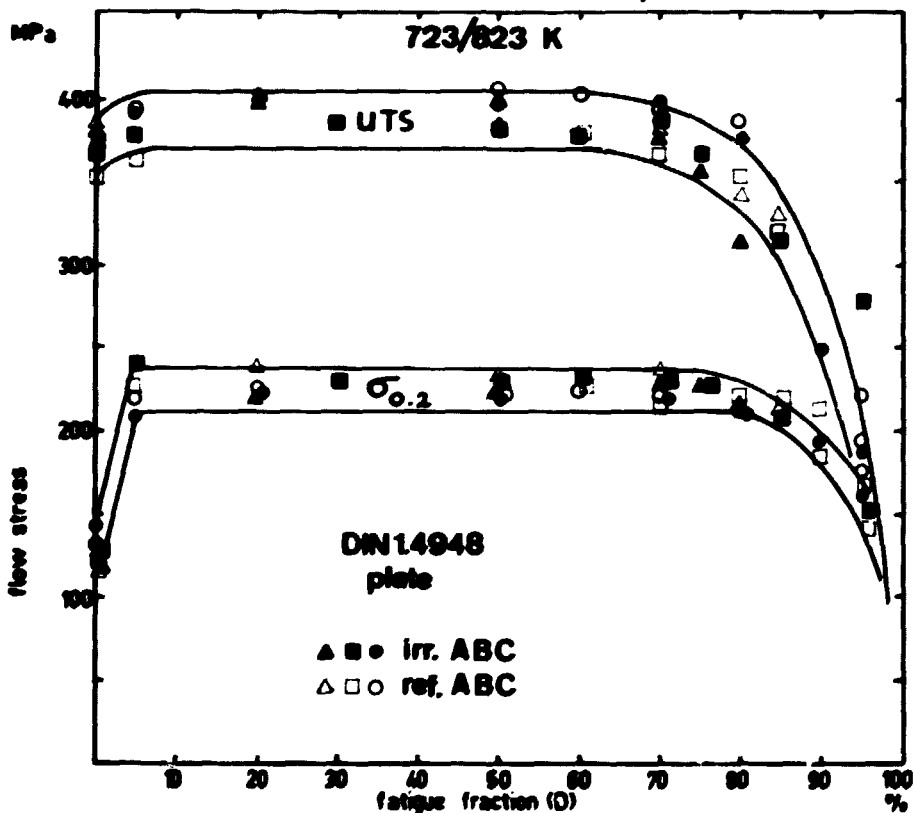
Fig. 7. High-rate tensile stress values at increasing prior fatigue fraction. Stainless steel DIN 1.4948 plate metal at 723 K and 823 K.

All measured 0.2-yield stress values and the UTS values are plotted in a similar way in figure 7. The same behaviour as shown in figure 6 can be observed for all material conditions. No distinction between irradiated and unirradiated test results can be made. All data fall within scatterbands of about 40 MPa. This includes the data for 723 K and 823 K.

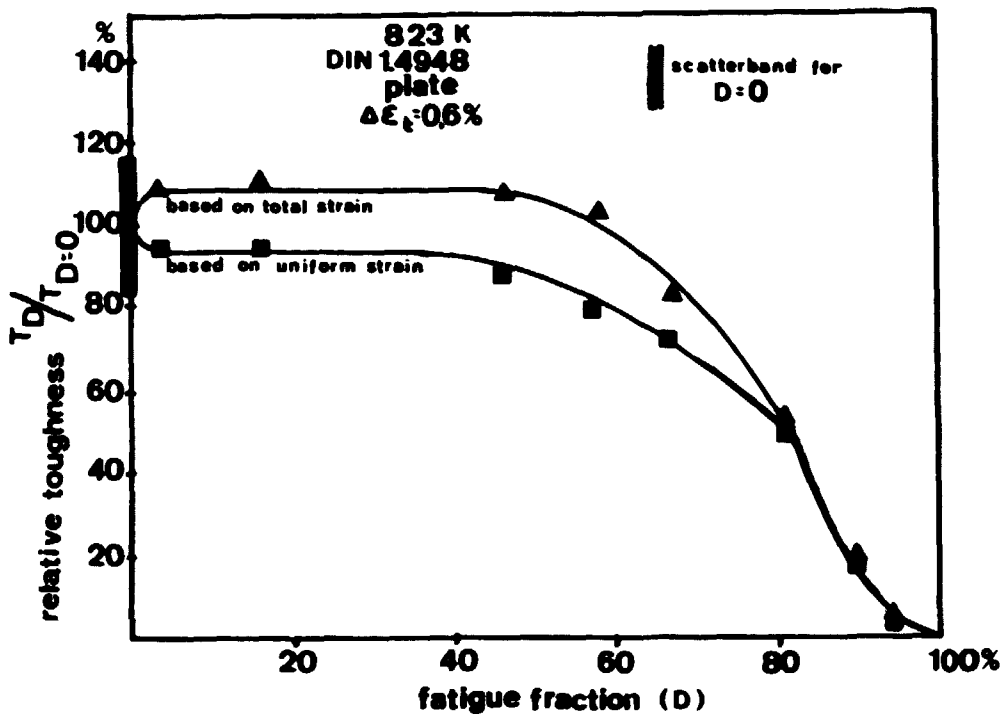
Fig. 12. Normalized toughness of plate metal DIN 1.4948 at 823 K at increasing prior fatigue fraction.

The effect on toughness, of prior fatigue loading at a strain range of 0.6%, is shown in figure 12. Normalized toughness, expressed as the ratio of the area under the load-displacement curves with and without prior fatigue loading, are given for plate metal DIN 1.4948 at 823 K. It is shown that for D between 0 and 0.05 the slight decrease of the ductility is balanced by the considerable increase of the yield stress. There is even a slight beneficial effect of prior fatigue cycling, although this effect is negligible when seen in relation to the scatter of the toughness of the plate metal without prior fatigue exposure. For the range of D -values between 0.05 and 0.6, where tensile properties were constant, also a constant value of the toughness is shown. For the high D -values ($D > 0.6$) the decrease of tensile properties cause a decrease of the toughness too. Here the toughness values get below the scatterband of the original material. In the same figure, also the normalized uniform toughness values (area under the curve up till tensile instability at the uniform strain) are plotted. At low D -values ($D < 0.05$) a slight decrease is shown and the onset of the rapid decrease can now be observed at the lower D -value of 0.5. At the high D -values ($D > 0.8$) the two curves coincide, showing that there is no necking after prior fatigue loading to such high fractions of fatigue life.

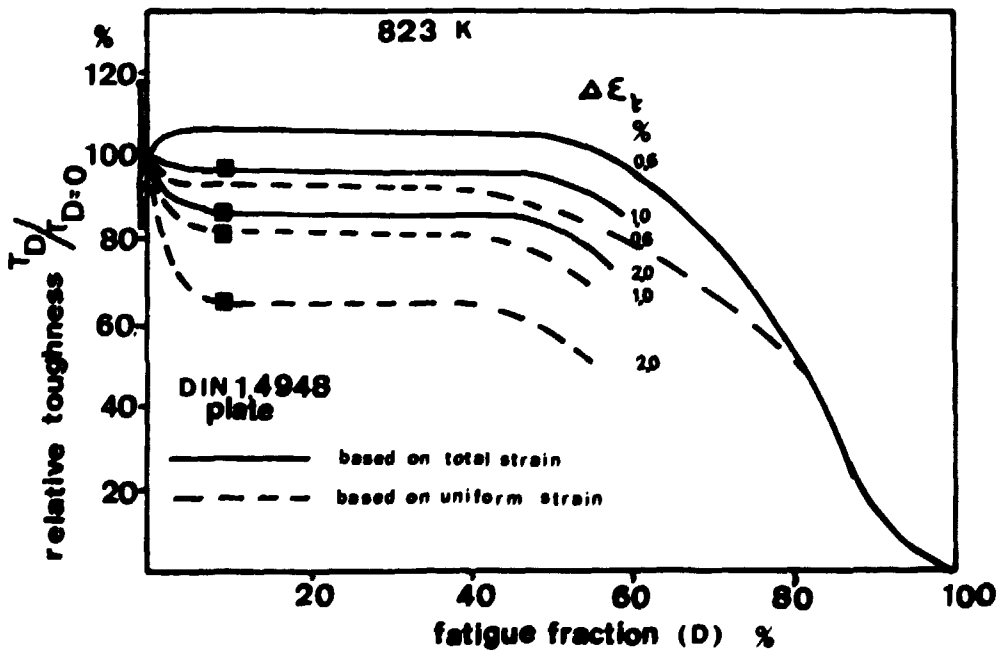
Fig. 13. Trend-curves of normalized toughness of plate metal DIN 1.4948 at 823 K after prior fatigue exposure at different strain ranges.

Fatigue exposure at the higher strain ranges of 1.0% and 2.0%, caused considerable decrease of toughness, although the yield stress increased to 3 times the original yield stress value or even to a value above the original UTS (fig. 11). This is shown in figure 13, giving trend lines for toughness after fatigue at these strain ranges.

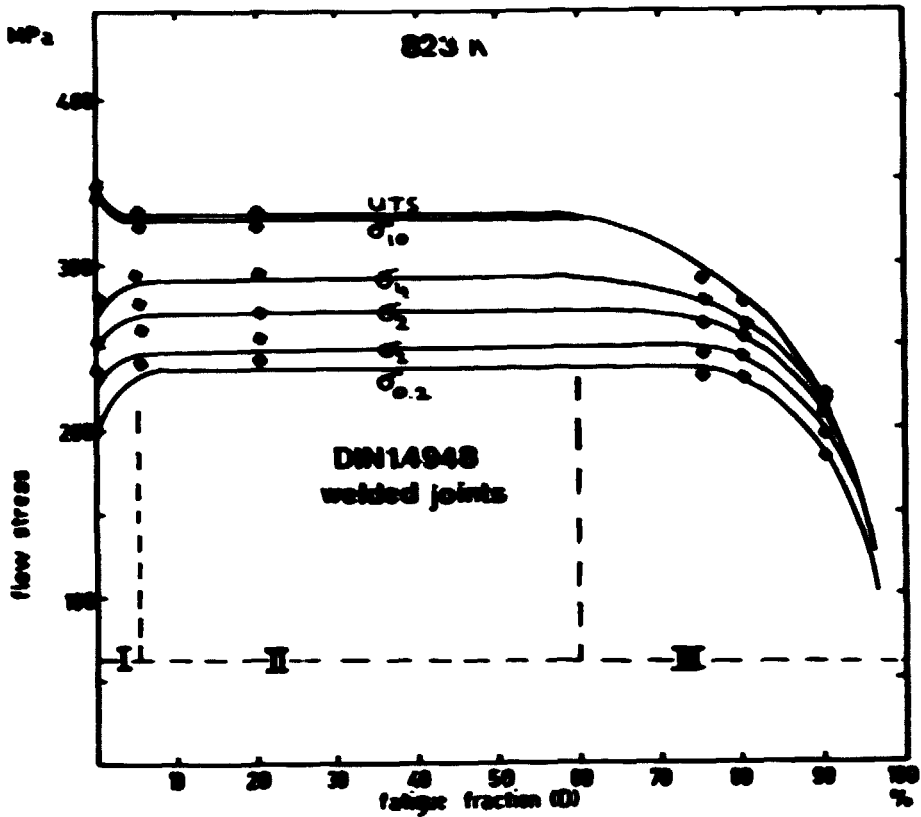
Fig. 14. High-rate flow stress values at increasing prior fatigue fraction. Welded joints DIN 1.4948 at 823 K.

Tensile stresses at discrete values of constant plastic strain (off-set values) of welded joints at 823 K without and with prior fatigue cycles are shown in figure 14. Similar effects of prior fatigue exposure as observed on plate metal can be seen: increase of tensile flow stress

values at low D-values, constant values for D between 0.05 and 0.6 and rapid decrease for $D > 0.6$.

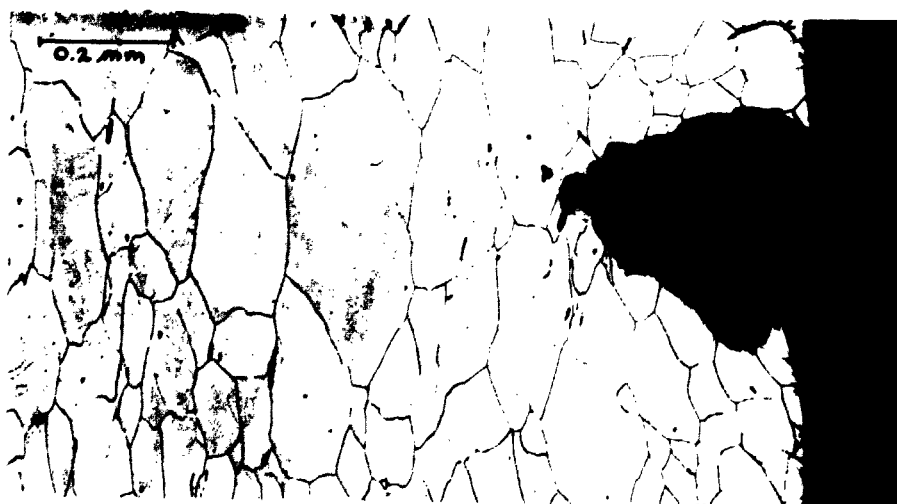
Fig. 24. Optical micrographs of tensile tested plate metal DIN 1.4948 after prior fatigue up to 70% of fatigue life, showing opened surface cracks.

The only significant change in the microstructure, as observed by optical microscopy, was the presence of transgranular surface cracks after prior fatigue loading. Figure 24 shows these surface cracks in a broken plate metal specimen at a D-value of 70%. Note that the cracks are widely opened and blunted and that no significant crack extension due to the monotonic (tensile) loading can be observed.
