## TEM OBSERVATIONS OF CRACK TIP - CAVITY INTERACTIONS

J. A. Horton,<sup>+</sup> S. M. Ohr,<sup>+</sup> and W. A. Jesser<sup>++</sup>

<sup>+</sup>Solid State Div., Oak Ridge National Laboratory,\* Oak Ridge, TN 37830

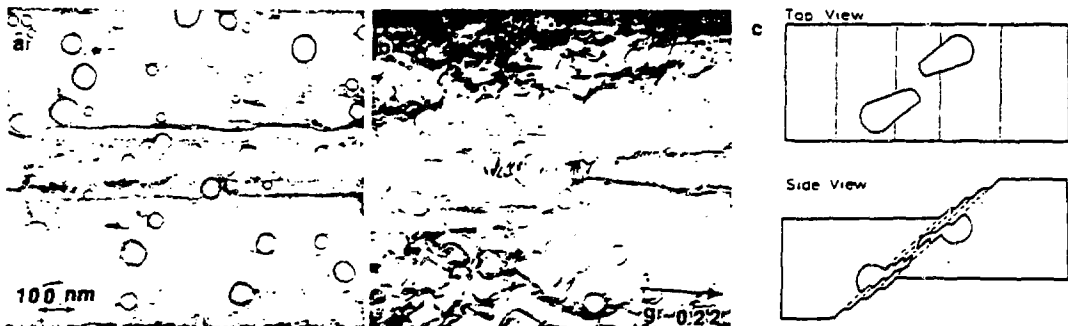
Figure 1: a. TEM micrograph of elongated cavities 6  $\mu\text{m}$  from the crack tip (experiment 1). b. Same area with dislocations in contrast. Electron beam direction ( $\beta$ ) near  $[011]$ . c. Sketch illustrating possible formation mechanism.

The  $\{110\}$  slip planes in figure 1 are inclined at  $53^\circ$  to the trace of the specimen. The direction of cavity elongation is  $[110]$  which corresponds to the probable Burgers vector of the slip dislocations involved in the process. These sheared

cavities are about 6  $\mu\text{m}$  in front of the crack tip. The original foil thickness was 120 nm. The shear displacement in the  $[110]$  direction is approximately 50 nm. The cavities were also sheared in the same direction by this amount. Stereo observations showed that cavities directly above or below the slip planes were unsheared. Furthermore, stereo viewing showed the elongated cavities to be planar. They also exhibited little mass thickness contrast differences. These observations suggest that cross sections of the cavities were offset by the dislocation interaction as depicted in the sketch in figure 1. This intersection does not result in volume enlargement. If enough slip planes are involved, this process should continue until the cavity has been sheared to a sharp-pointed cone (fig. 2). The number of atomic planes contributing to the shear is apparently equivalent to at least one half the cavity diameter or about 15 to 30 nm.
