D. N. BRASKI¹

MICROSTRUCTURE AND TENSILE PROPERTIES OF NEUTRON-IRRADIATED $(\text{Fe}_{0.61}\text{Ni}_{0.39})_3\text{V}$ ORDERED ALLOY²

REFERENCE: Braski, D. N., "Microstructure and Tensile Properties of Neutron-Irradiated $(\text{Fe}_{0.61}\text{Ni}_{0.39})_3\text{V}$ Ordered Alloys," Effects of Radiation on Materials: Eleventh Conference ASTM STP 782, H. R. Brager and J. S. Perrin, Eds., American Society for Testing and Materials, 1982, pp.

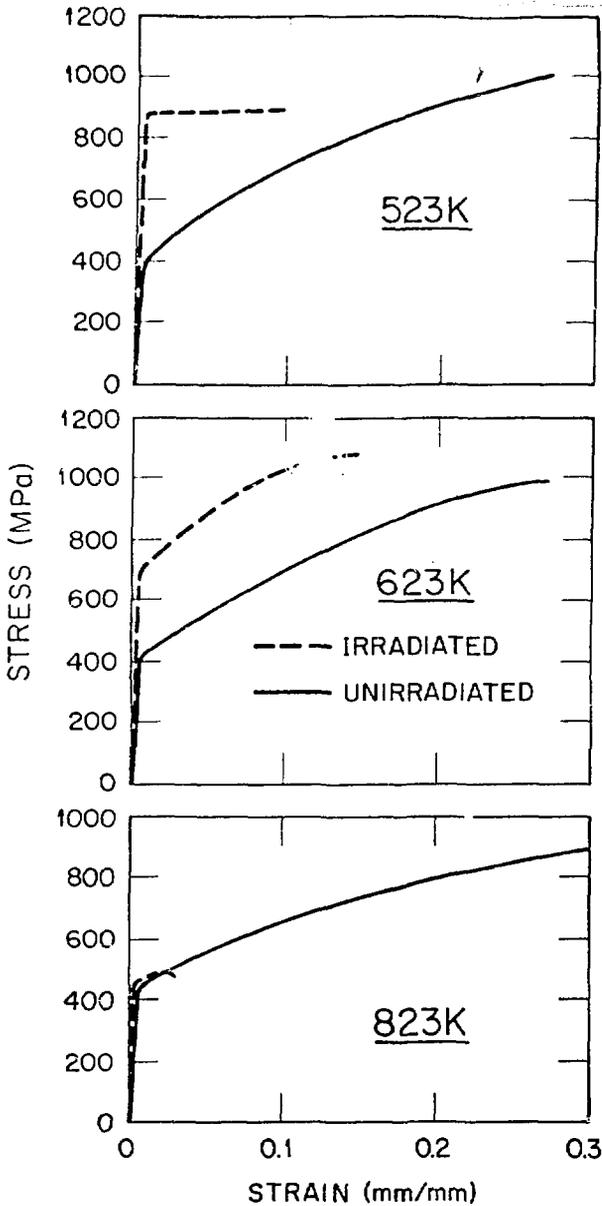
Fig. 1-Stress-strain curves for unirradiated LRO16 and for LRO16 which was irradiated to 4 dpa in ORR at 523, 623, and 823 K and tested at the same respective temperatures.

The results of the postirradiation tensile tests for LR016 are listed in Table 1 and typical stress-strain curves for the unirradiated and irradiated material are given in Fig. 1. At 523 K, neutron irradiation increased the yield point significantly, or "hardened" the alloy (Fig. 1). The specimen subsequently deformed plastically with virtually no work hardening until failure occurred and the total elongation was less than half of that measured for the unirradiated specimen. The small amount of work hardening and somewhat early failures measured at 523 K produced ultimate tensile strengths that were all lower than the unirradiated material (Table 1). After irradiation at 623 K, LR016 specimens were also hardened, but to a lesser degree than observed at the lower temperature. Their work-hardening behavior was closer to the unirradiated control specimen as demonstrated by the nearly parallel stress-strain curves. The ability of the irradiated specimens to undergo some strain hardening at 623 K enabled them to develop somewhat higher ultimate tensile strengths than found in the unirradiated alloy and values of elongation that were better than at 523 K (Table 1). Irradiation at 823 K produced no hardening and the stress-strain curves for the irradiated specimens followed that for the unirradiated material. However, failure occurred prematurely in all three specimens at relatively low values of strain. Consequently, the ultimate tensile strengths of these specimens were also reduced, as given in Table 1. The results in Table 1 are also shown graphically in Fig. 2. It is

"hardened" the alloy (Fig. 1). The specimen subsequently deformed plastically with virtually no work hardening until failure occurred and the total elongation was less than half of that measured for the unirradiated specimen. The small amount of work hardening and somewhat early failures measured at 523 K produced ultimate tensile strengths that were all lower than the unirradiated material (Table 1). After irradiation at 623 K, LR016 specimens were also hardened, but to a lesser degree than observed at the lower temperature. Their work-hardening behavior was closer to the unirradiated control specimen as demonstrated by the nearly parallel stress-strain curves. The ability of the irradiated specimens to undergo some strain hardening at 623 K enabled them to develop somewhat higher ultimate tensile strengths than found in the unirradiated alloy and values of elongation that were better than at 523 K (Table 1). Irradiation at 823 K produced no hardening and the stress-strain curves for the irradiated specimens followed that for the unirradiated material. However, failure occurred prematurely in all three specimens at relatively low values of strain. Consequently, the ultimate tensile strengths of these specimens were also reduced, as given in Table 1. The results in Table 1 are also shown graphically in Fig. 2. It is

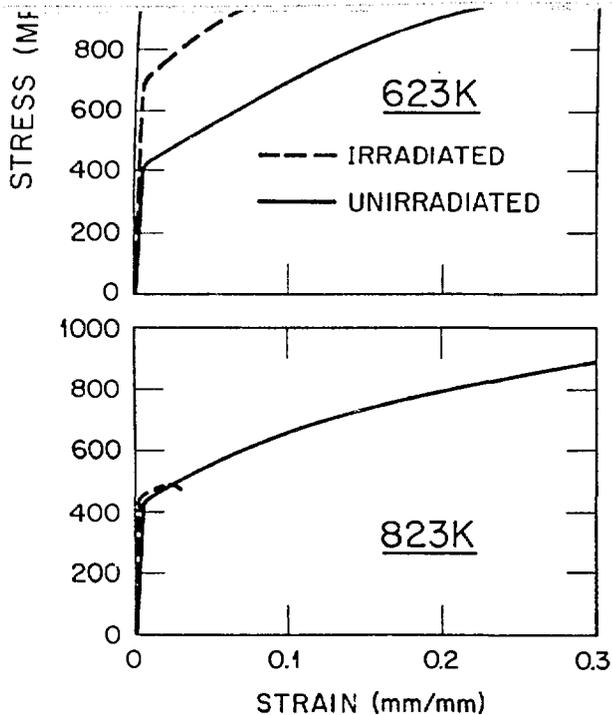
Fig. 1-Stress-strain curves for unirradiated LRO16 and for LRO16 which was irradiated to 4 dpa in ORR at 523, 623, and 823 K and tested at the same respective temperatures.

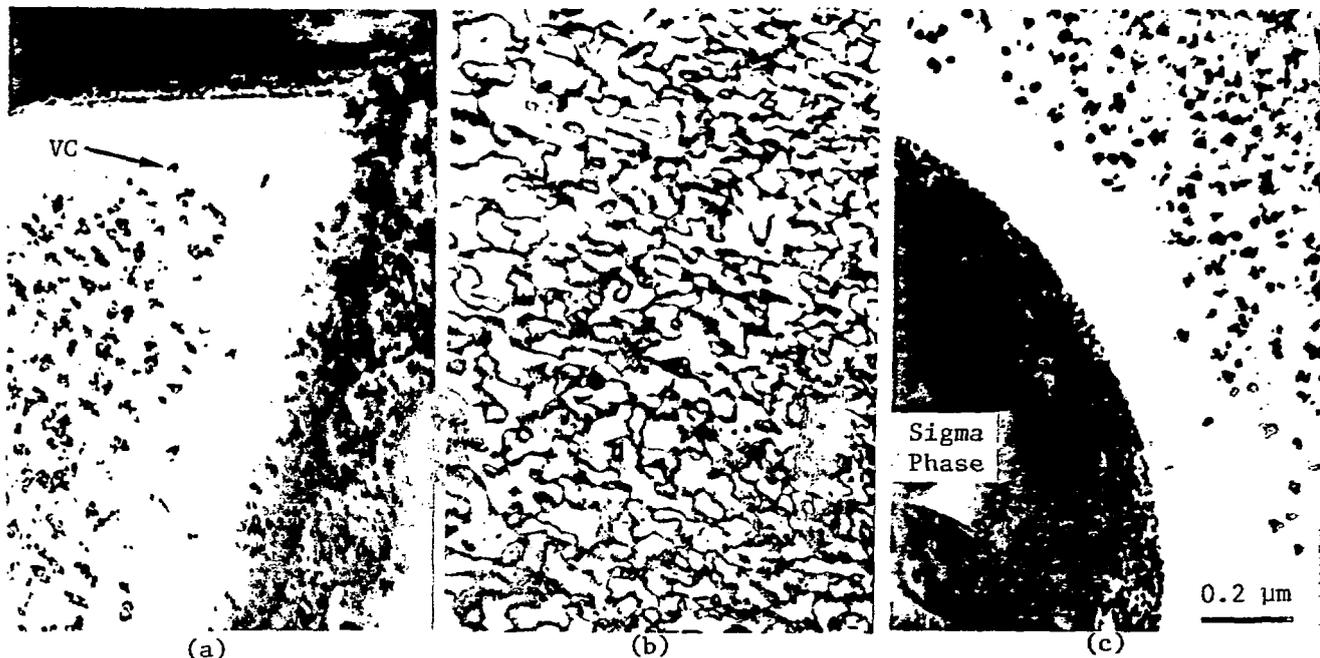
Fig. 3-Microstructure of unirradiated LR016. (a) Bright field, (b) dark field using superlattice (100) reflection, and (c) bright field showing sigma phase.

The unirradiated microstructure of LRO16 is shown in Fig. 3. It is composed of an ordered matrix containing small particles of vanadium carbide (diam \approx 25nm) and grain boundaries lined with similar particles (Fig. 3a). The identification of the particles as VC was supported by both electron diffraction and energy dispersive x-ray analyses [2]. The carbide particles had a cube-on-cube orientation relationship with the matrix

and produced strain contrast in the electropolished foil. Narrow zones on both sides of grain boundaries were denuded of VC particles (Fig. 3a). Figure 3b shows the ordered matrix of the alloy imaged using a (100) superlattice reflection in the dark field mode. The ordered domains and two-thirds of the antiphase boundaries (APBs) can be seen. When all of the APBs are imaged simultaneously, the ordered domains are equiaxed in shape. The average domain size was ~ 42 nm in diameter and the APBs had $a/2\langle 110 \rangle$ displacement vectors [4]. The microstructure also contained scattered regions of sigma phase as shown in Fig. 3c. Selected area diffractions showed that the sigma phase was tetragonal with $a_0 = 0.88$ nm and $c_0 = 0.46$ nm [2]. Energy dispersive X-ray analyses showed that the composition of the sigma was primarily Fe and V with some Ni [2]. It was observed that the sigma phase regions were often faulted.

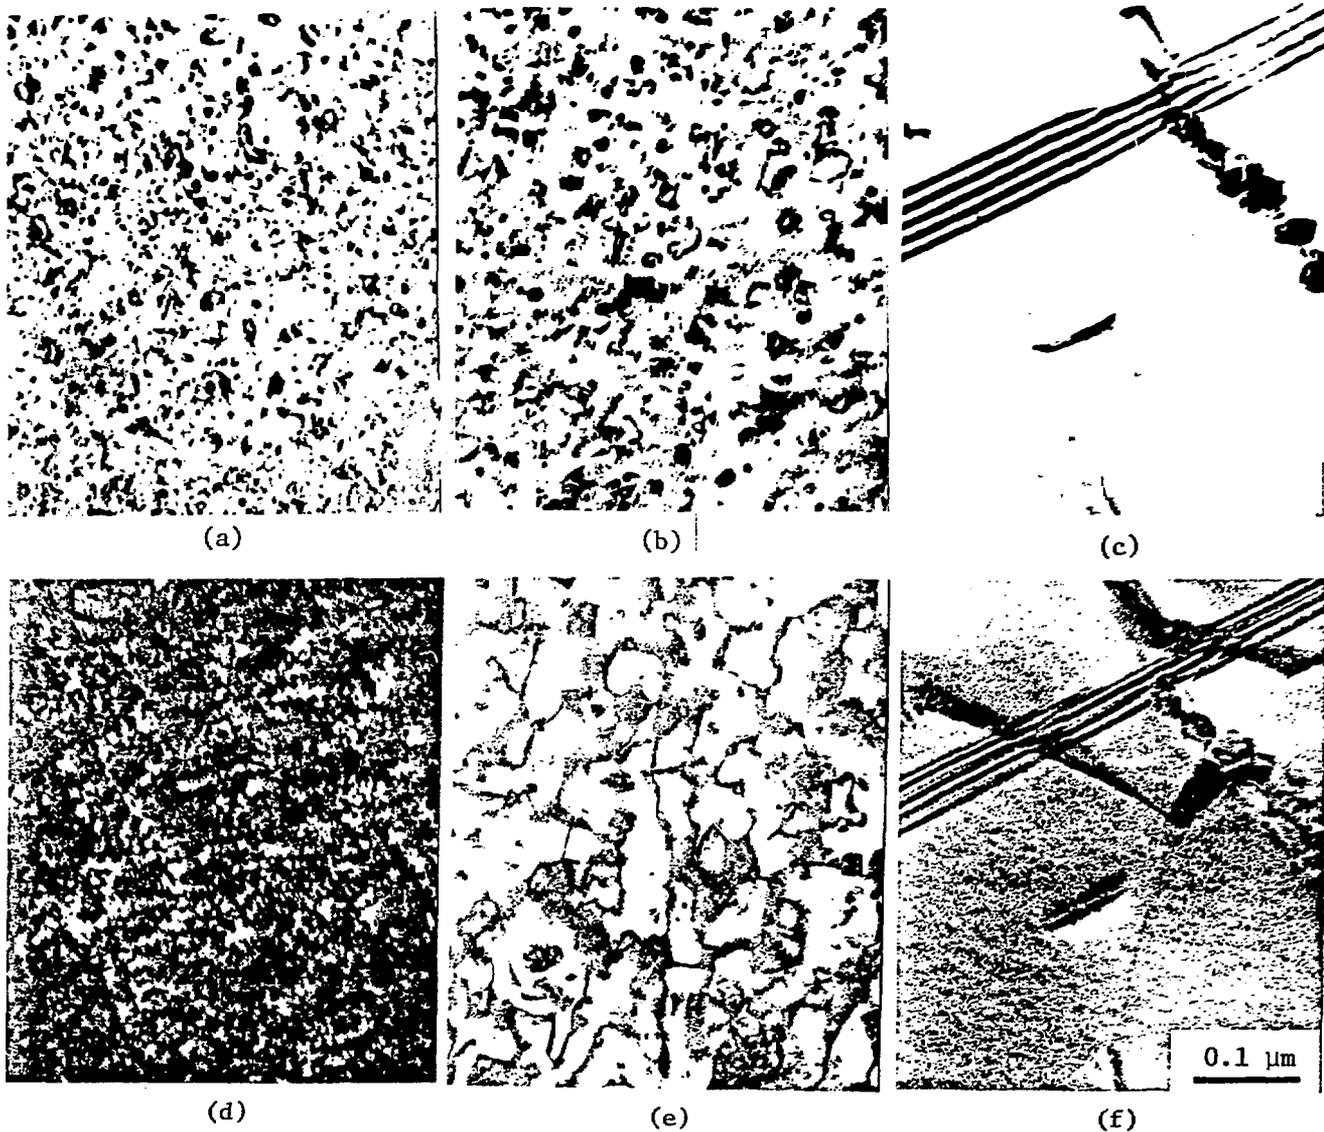
Fig. 4—Microstructure of irradiated LR016 shown in bright field for irradiation temperatures of (a) 523 K, (b) 623 K, and (c) 823 K. Ordered domains shown in superlattice dark field for the same specimens at (d) 523 K, (e) 623 K, and (f) 823 K.

The effects of neutron irradiation on the microstructure at the three different temperatures are shown in Fig. 4. Quantitative measurements obtained from these and other micrographs are listed in Table II. Irradiation at 523 K produced a relatively high density ($4.1 \times 10^{22} \text{ m}^{-3}$) of small dislocation loops (diam ≈ 12.0 nm) in an ordered matrix as shown in Fig. 4a. A few larger loops displayed fringes indicating they were faulted. Within the resolution of the electron microscope (~ 1 nm), no cavities were observed. Irradiation at 523 K as well as the two higher temperatures, caused most of the VC within the grains to dissolve. Such a phenomenon was probably due to the cascade processes driving precipitate atoms back into solution [5]. On the other hand,

the VC particles in the grain boundaries were coarsened. At 623 K, (Fig. 4b), less than half the number of loops were produced, but their average size of 26.4 nm was larger than at 523 K. The loops were faulted and interstitial in nature. A few cavities having average diameters of 3.3 nm were observed, resulting in approximately 0.01% swelling. Again, the structure retained its long-range-ordered structure.

At 823 K smaller numbers of larger-sized faulted loops were produced, as shown in Fig. 4c and Table II. Although most of the faulted loops were interstitial, approximately 10% were vacancy type. Not enough loops were analyzed at the lower temperature to establish whether some were vacancy type. A few cavities were observed that produced 0.07% swelling. Figures 4d, 4e and 4f show the ordered domains in LR016 after irradiation at 523, 623, and 823 K, respectively. The domains were effectively subdivided from their original size by the irradiation at the lowest temperature, and they increased in size with increasing temperature. This has been observed previously in an ion-irradiated cobalt-base LRO alloy [7] and is attributed to subdivision of the original domains by radiation-induced stacking faults which also serve as APBs. At 823 K the larger size of the domains was due to thermal growth [4], tempered by the few stacking faults. An interstitial faulted loop/APB has a different displacement vector (i.e. $a/3 \langle 111 \rangle$) compared to a thermal APB ($a/2 \langle 110 \rangle$) and somewhat lower energy [4]. Therefore, the average domain size was controlled mainly by number and size of loops which, in turn, was a function of temperature. The average domain size turned out to be nearly the same as the average loop size and both increased with increasing irradiation temperature (see Table II).

At 523 K, neutron irradiation hardened the grain matrices by producing relatively large numbers of small interstitial (Frank) loops (Fig. 4a). Fewer loops and somewhat less hardening occurred at 623 K (Fig. 4b). It is well known that a high density of small defects in the microstructure serves as obstacles to dislocation movement and that their introduction will increase the yield stress or "harden" a material. The small loops were also APB and their presence effectively reduced the unirradiated domain size of 42 nm to 7.5 and 25.2 nm after irradiation at 523 and 623 K, respectively. The movement of a superdislocation through an ordered domain increases the domain boundary area and the stress required to accomplish this is a function of domain size [9]. A maximum hardness in Cu_3Au was observed by Biggs and Broom [10] for 5-nm-diam domains, and by Davies and Stoloff [11] for 3.5-nm-diam domains. Since the ordered domains in LR016 were reduced in size during irradiation to 7.5 nm, it would appear that a portion of the overall hardening could be also attributed to domain

After irradiation at 823 K, the microstructure contained a relatively small number of larger loops (Table 2 and Fig. 4c). The structure was well ordered (strong superlattice reflection) and the ordered domain size had grown substantially (cf. Fig. 4d with 3b). Earlier work [4] on a cobalt-base LRO alloy showed that such growth was due to thermal aging. The amount of swelling was only 0.07%. Since the irradiated microstructure presented very few obstacles to dislocation motion, the stress-strain curves for this temperature were essentially identical to the unirradiated material (Fig. 1). However, the specimens failed prematurely after relatively low strains. The early failures were probably caused by the early formation of microcracks at sigma phase boundaries. This hypothesis is based on the observation of the very large cavities located at the sigma-phase/matrix boundaries after testing at 823 K (Fig. 6b). The cavities grew from the small cavities or helium bubbles produced by irradiation. The cavities grew by accumulating vacancies and perhaps more helium during the deformation process and they eventually coalesced to form microcracks. Helium bubbles located in the grains and grain boundaries did not appear to grow as did those on sigma phase boundaries. The helium bubbles attached to grain boundary VC particles did, however, influence preparation of the foils and nearly all of the VC particles were etched out of the foil (Fig. 5b). Growth of cavities on sigma phase boundaries, but

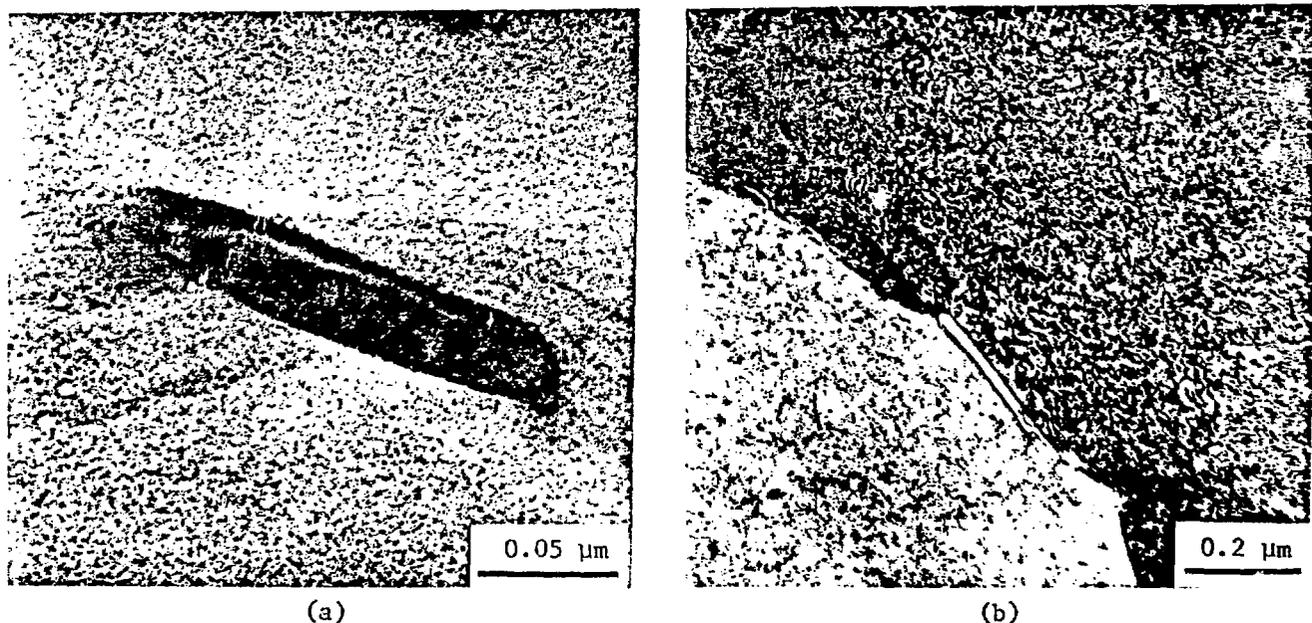
Fig. 5-(a) Grain boundary in LR016 containing a VC particle and small helium bubbles after irradiation at 823 K. Note the bubbles attached to the periphery of the VC particle. (b) Grain boundary in LR016 after irradiation and testing at 823 K showing how the particles were etched out during specimen preparation.

Some effects of plastic deformation at 823 K on the irradiated microstructure of LR016 are illustrated in Figs. 5 and 6. Figure 5 shows the effect of plastic deformation on typical grain boundaries. After irradiation (Fig. 5a), the grain boundaries

contained numerous cavities (probably helium bubbles) and thin lath-shaped VC particles. Small helium bubbles were often attached to the periphery of the VC laths as shown in the figure. Plastic deformation caused the VC laths to be preferentially etched out during specimen preparation as shown in Fig. 5b. Perhaps the bubbles attached to the laths grew during testing and coalesced. This would make the VC interfaces more susceptible to the electrochemical attack. Another possibility is that the bubble-weakened interfaces enabled the harder VC laths to separate physically from the softer metal matrix, thus enabling the laths to be easily etched out. It should be pointed out that the cavities or bubbles in the grain boundaries were not actually observed to undergo any significant growth after the elevated temperature deformation. This was not the case with sigma phase boundaries as illustrated in Fig. 6. After irradiation, the interfaces separating sigma phase from the matrix also contained numerous small cavities or bubbles (Fig. 6a). However, the tensile test at 823 K caused the cavities to grow an order of magnitude in size as shown in Fig. 6b. All of the sigma phase region in the foil had either large cavities attached or were etched preferentially (due to the cavities).

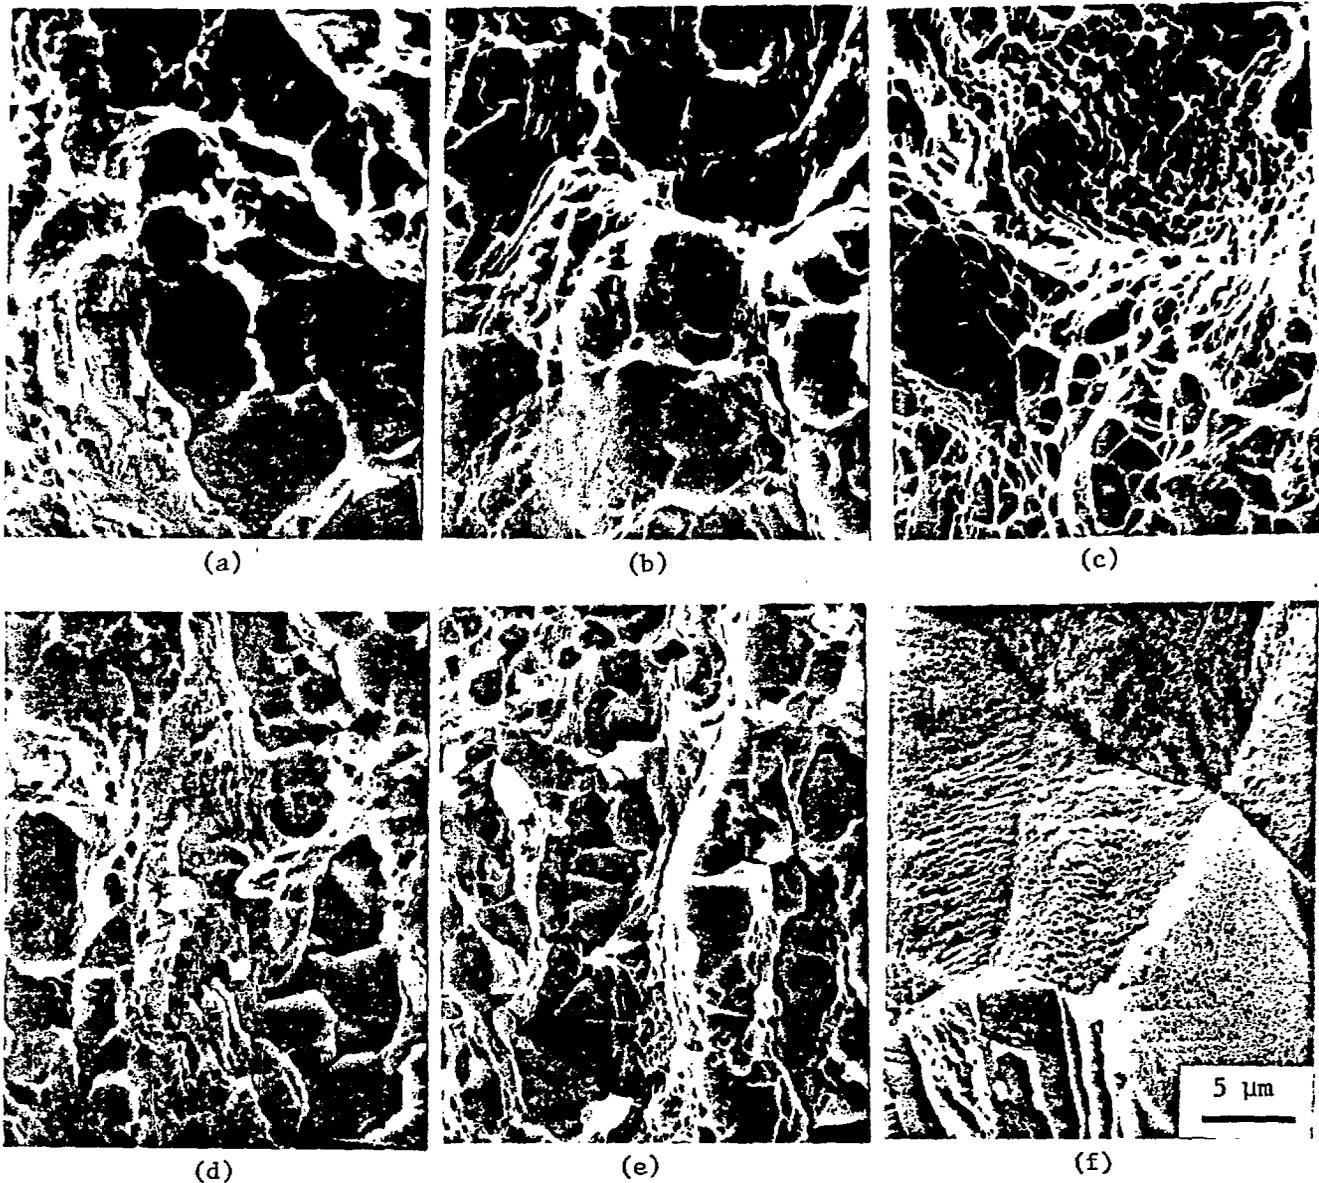
Fig. 7—Fracture surfaces of unirradiated LR016 specimens that were tensile tested at (a) 523 K, (b) 623 K, and (c) 823 K, and fracture surfaces of LR016 specimens that were irradiated and tensile tested at (d) 523 K, (e) 623 K, and (f) 823 K.

Scanning electron micrographs of fracture surfaces from LR016 specimens tensile-tested after irradiation are shown in Fig. 7. Figures 7a, b, and c show the fractures of unirradiated specimens tested at 523, 623 and 823 K, respectively. Figures 7d, e,

and f show the fractures of specimens which were irradiated before testing at the same temperatures. Unirradiated LR016 that was tested at 523 and 623 K (Figs. 7a and 7b) had similar fracture surfaces — i.e., ductile "dimples" mixed with some small flat facets. These facets are believed to be caused by fracture along or across the stronger, but more brittle sigma phase. At 823 K (Fig. 7c), the fracture surfaces were entirely dimpled which is characteristic of ductile fracture. Irradiation produced no significant changes in the appearances of fracture surfaces at 523 and 623 K (Figs. 7d

Fracture occurred in LR016 at the two lower temperatures by ductile tearing and the coalescence of microvoids as shown by SEM (Fig. 7). Some cracking along sigma phase/matrix interfaces or through the sigma phase itself probably occurred as well, and is thought to account for the flat facets seen in the fractographs for both unirradiated and irradiated material. There was no evidence, from either SEM or TEM, that helium played a major role in the fracture at 523 or 623 K. However, helium in the form of very tiny bubbles (unresolvable at 523 K) may have influenced fracture indirectly by adding to the matrix hardening.
