IN-PILE CREEP STRAIN AND FAILURE OF CW 316 Ti PRESSURIZED TUBES

J.L. BOUTARD, A. MAILLARD, Y. CARTERET, V. LEVY, and L. MENY.

20ème SYMPOSIUM INTERNATIONAL SUR LES EFFETS DE L'IRRADIATION SUR LES MATERIAUX
WILLIAMSBURG, VIRGINIA, 18-20 Juin 1984

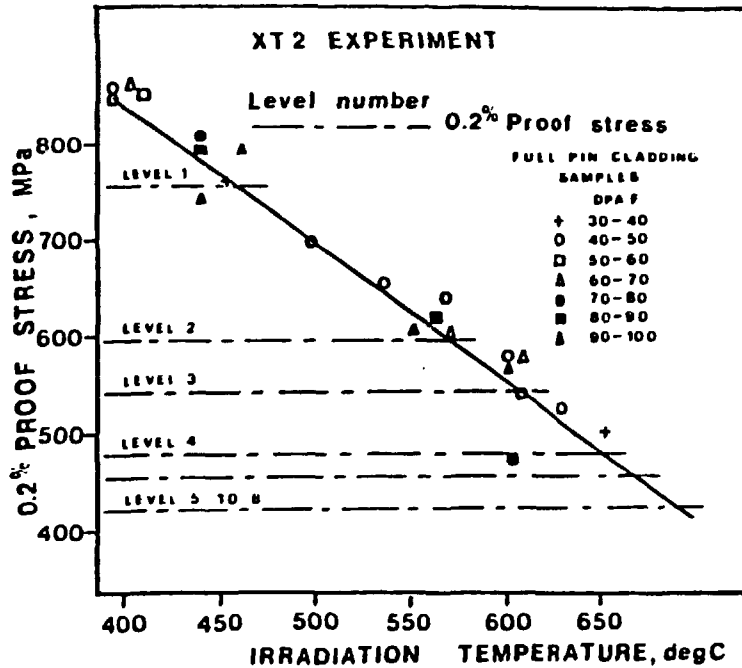
Figure A shows that in the range of 30 to 100 dpaF, the yield stress of fuel pin cladding at room temperature is independent of dose and thus can be described by a function of the sole irradiation temperature.

Figure A :
Room temperature yield stress of CW 316 T1 fuel pin cladding and XT2 samples versus irradiation temperature

Yield stress measured for XT2 experiment gives then an estimation of the irradiation temperature ranging from 450 °C for the lower to 660-680 °C for the upper levels, which is in rather good agreement with thermal calculations.

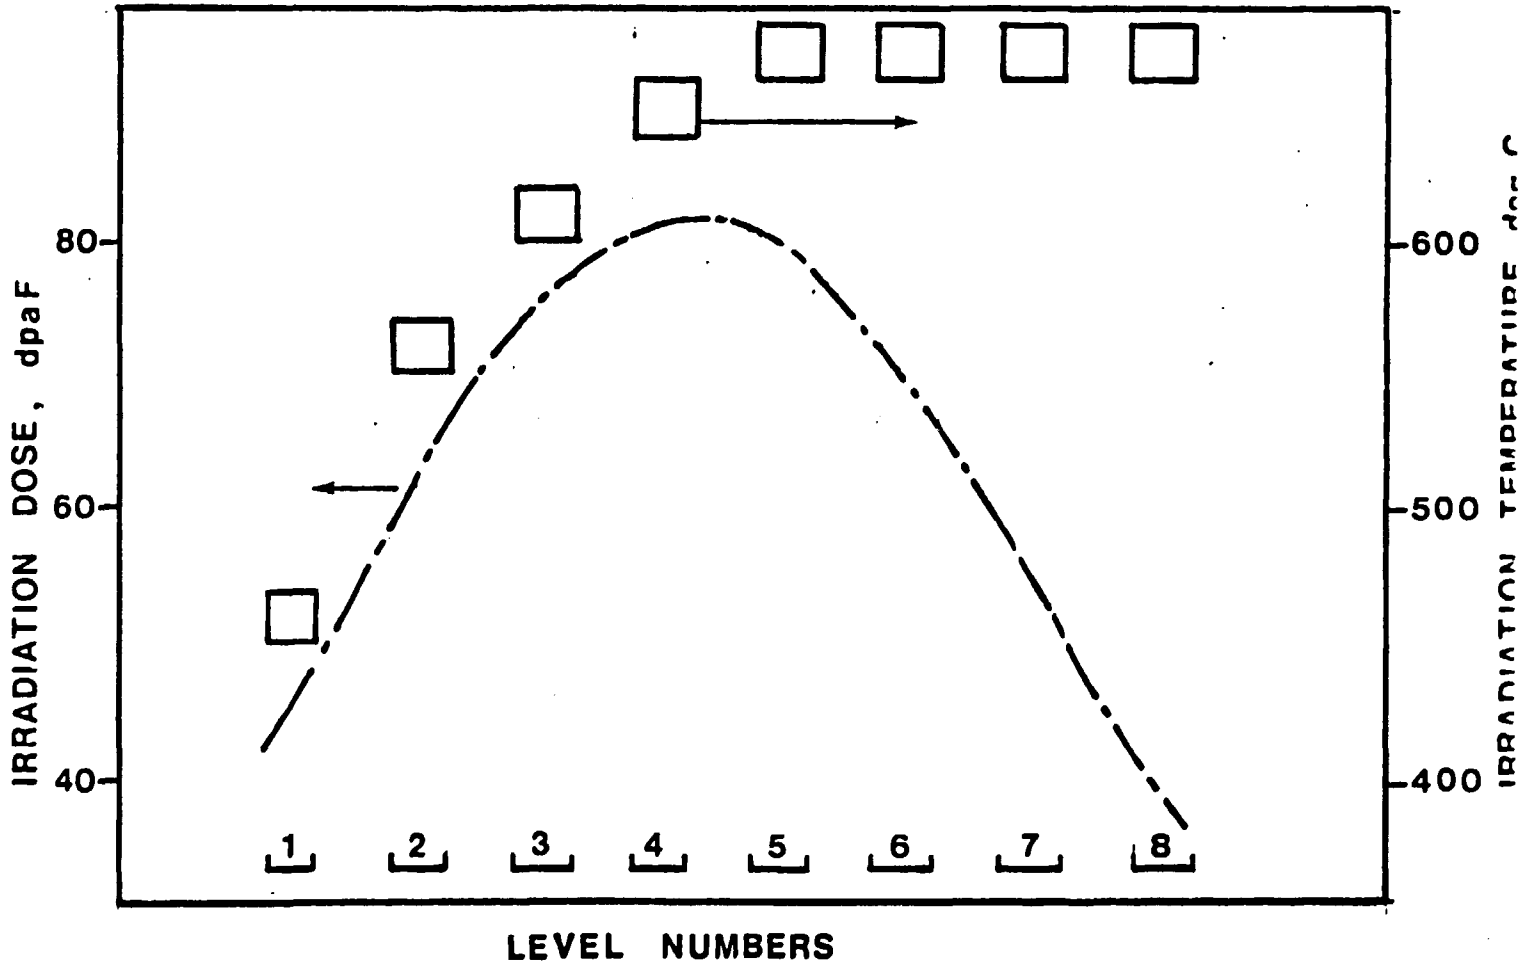
Fig. 1

Figure 1 shows the temperature and dose profiles of XT2 experiment, table I-a the stresses applied to the tubes of WY1 and WY2 batches.

Figure 1 : Temperature and dose profiles of XT2 in-pile experiment.

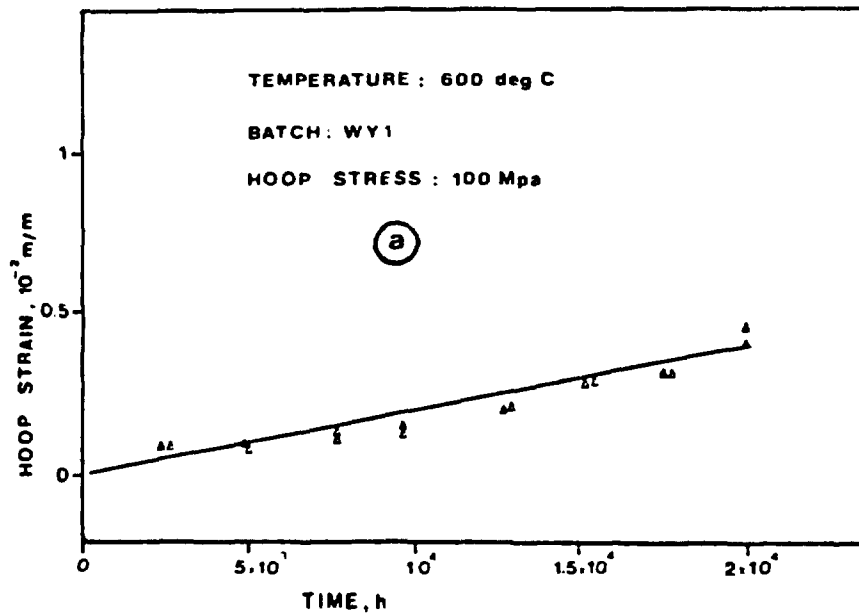
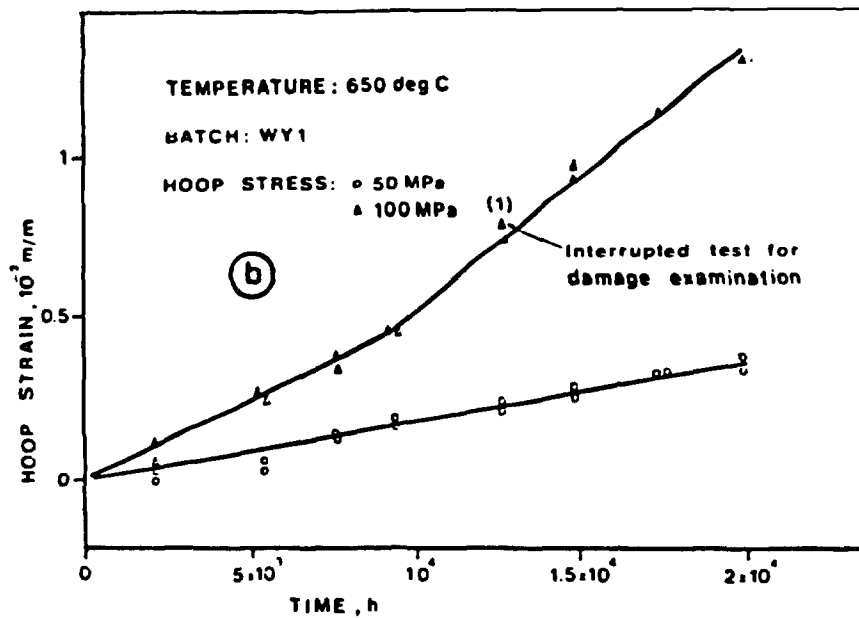
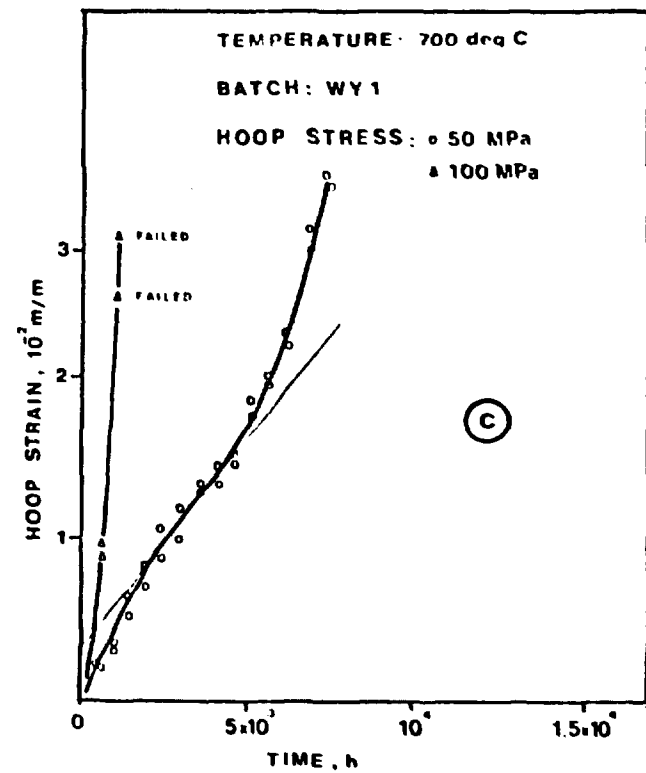
Fig. 2

Examples of the time evolution of plastic strain for WY1 batch are given in figure 2 : a - 600 °C, b - 650 °C and c - 700 °C. At 600 °C under 50 MPa, strains and experimental accuracy are of the same order. At 550 °C no deformation is recorded up to 20 000 h.

Figure 2 : Hoop strain of WY1 batch versus time at 600°C (a), 650°C (b) and 700°C (c).

For 600 and 650 °C it is difficult to detect a primary stage. For 600 and 650 °C under 100 and 50 MPa respectively, no tertiary stage appears. For 650°C under 100 MPa, a tertiary stage seems to occur around 10 000 h without any specimen failure up to 15 000 h.

At 700 °C primary, secondary and tertiary stages seem to exist under 50 MPa at least. Times to failure are in the range of 10 000 h under 100 MPa and over 7 500 h under 50 MPa.

In the 600-650 °C range, the stress dependence is quasi-linear : strains are $\sim 0.2\%$ under 50 MPa and $\sim 0.5\%$ under 100 MPa at 10^4 h (see figure 2-b). Such a dependence is in general agreement with diffusion creep. By comparison with theoretical prediction of COBLE [1] or NABARRO-HERRING [2], the WY1 strain rates could be mostly due to diffusion creep (see figure 3). Diffusion data used to do this comparison concern a 17% Cr - 12% Ni austenitic alloy and are taken from [3]. Experimental strain rates have an order of magnitude that seems closer to NABARRO-HERRING prediction than COBLE one. This could reflect an inhibition of the COBLE creep ; the same behavior is observed in Nb or Ti stabilized 20Cr - 30Ni stainless steel in unaged condition [4], while ageing before creep improves the agreement with COBLE prediction [5].

Test (1) reported figure 2-b (WY1 batch, 100 MPa, 650 °C and 1.5×10^4 h) was interrupted to look for creep damage, by optical and transmission electron microscopy (TEM). Grain boundaries display no damage neither creep cavities nor wedge cracks.

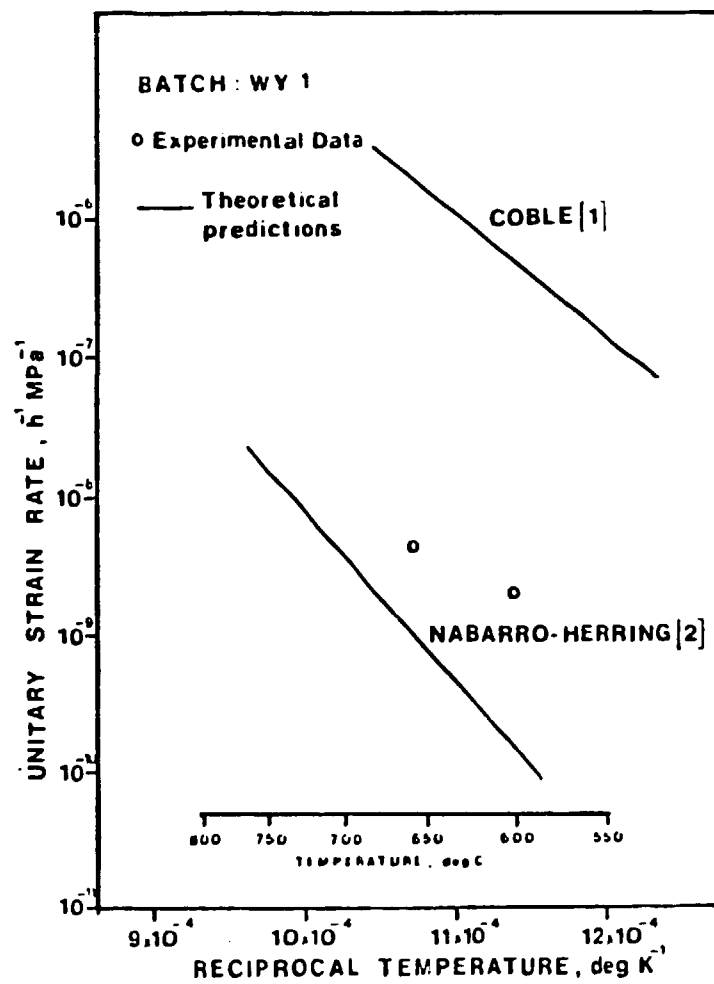
Fig. 3

Figure 3 : Comparison between experimental unitary strain rate and prediction of diffusion creep theories.

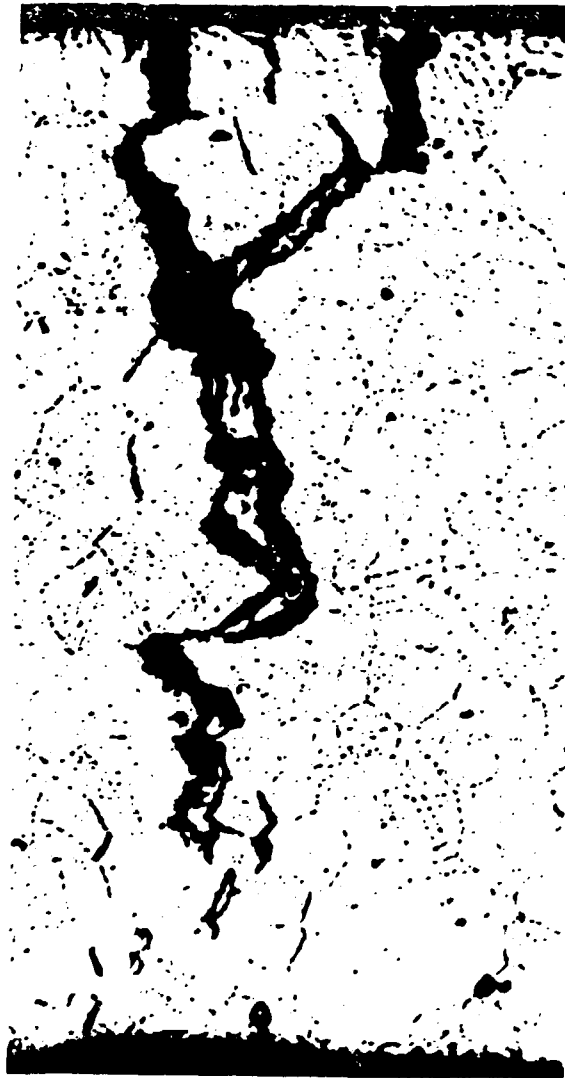
Fig. 4

Under 200 MPa at 650 °C, failures of WY2 tubes occur between 2500 and 5000 h. Examinations by scanning electron microscopy (SEM) of the outer surface show that these failures result from very thin and localized cracks. Optical observation of a cross section of one end of this crack displays a non-through inter-

granular crack (fig.4). As no creep cavities can be found by TEM [6], the black spots on grain-boundaries (see fig.4) must be intergranular precipitation which essentially consists of σ phase as revealed by TEM [6]. Otherwise localized wedge cracks exist (their direction being 45° from the crack of fig.5) : they might have nucleated on the intergranular precipitates as shown figure 5.

Figure 4 : Optical micrography of intergranular failure obtained on WY2 monitor (temperature : 650 °C ; hoop stress : 200 MPa).

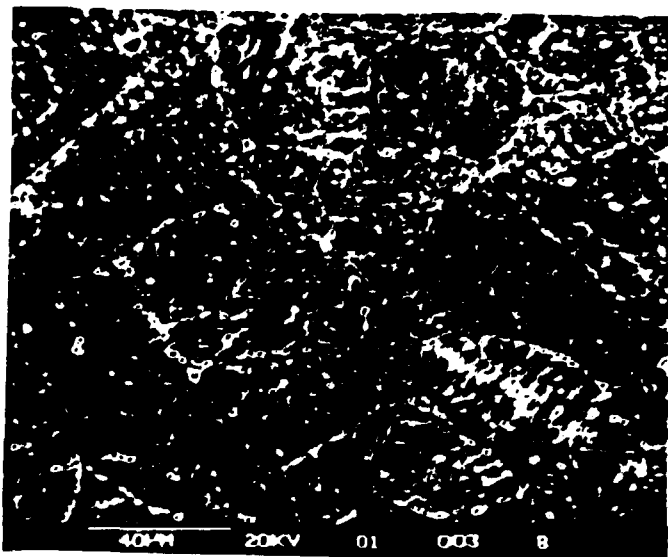
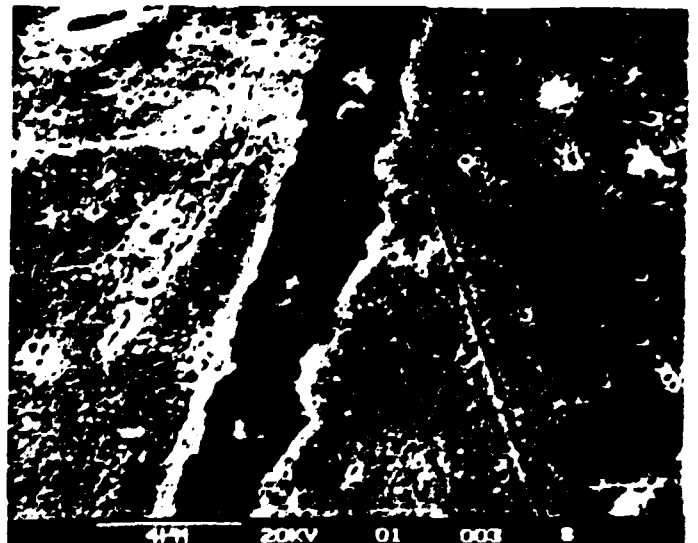
Figure 5 : Internal wedge crack observed by SEM on a the same cross section as in figure 4.

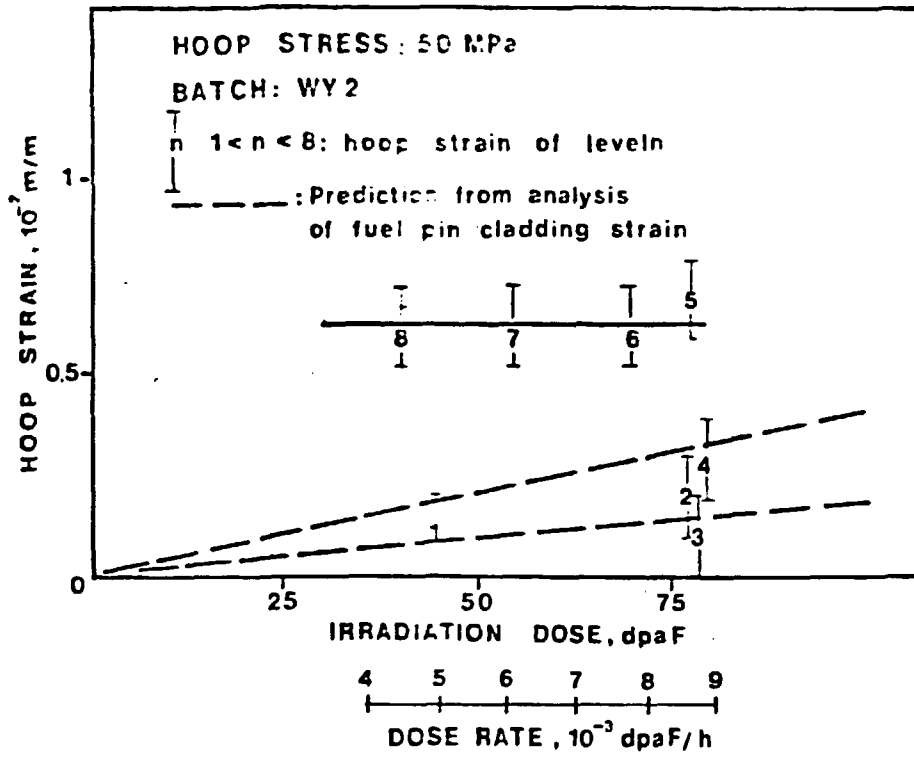
Fig. 6

The measured gas pressure after irradiation shows that all the tubes kept their initial gas content. As shown on figure 6 dose or dpa rate evolutions of plastic strains can be splitted into two groups.

Plastic strains for the lower levels 1,2 and 3 ($T_I \leq 600$ °C) are hardly larger than the experimental accuracy. Nevertheless they are in qualitative agreement with an expression such as :

On the opposite, for the higher temperature (levels 5 to 8) the plastic strains are rather independent of the dose or dpa rate and thus cannot be described by the previous expression even with a larger creep modulus. Therefore we tend to conclude that the observed strains are mainly due to out-of-pile deformation mechanisms.

Figure 6 : In-pile hoop strain of WY2 batch versus dose or dose rate.

dislocation creep and is in good agreement with the in-pile strains $\sim 8\%$ (see fig.6).

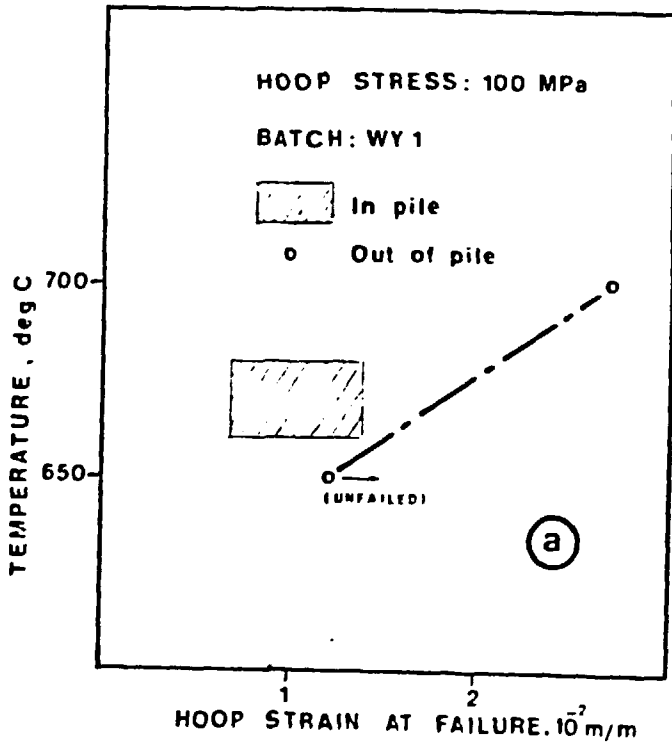
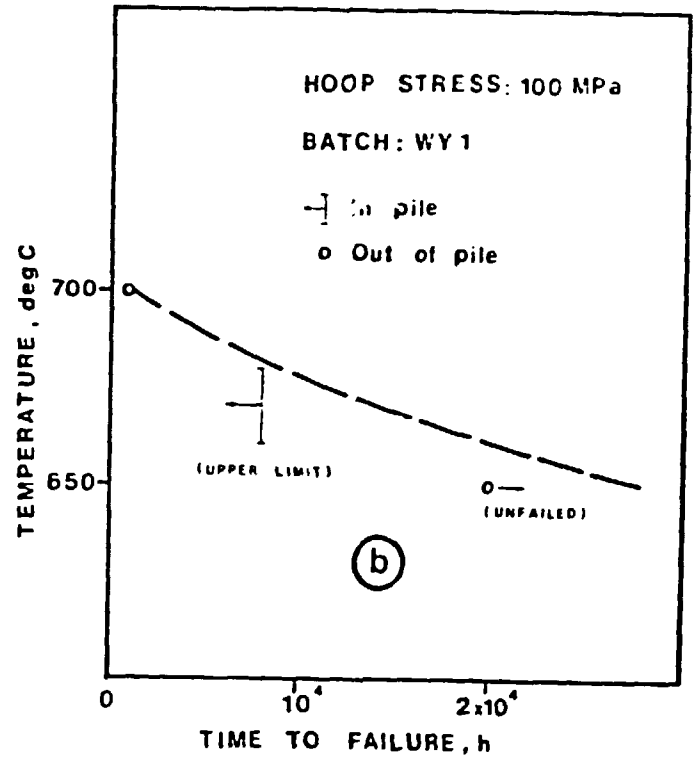
Fig. 8

Finally although better conditions for cavitation are fulfilled for the in-pile samples (smaller grain size, lower stress and higher temperature than for the out-of-pile tests), no grain-boundary cavity occurs and the creep damage remains of wedge-crack type. Nevertheless the failure strains and times of WY1 under 100 MPa (see fig.8) are smaller for in-pile tests thus showing some embrittlement occurs under irradiation.

Figure 8 : Temperature versus hoop strain at failure (a) and time to failure (b) (hoop stress : 100 MPa).
