BNL-NUREG--35629

TESTING OF NUCLEAR GRADE LUBRICANTS AND THEIR EFFECTS ON A540
B24 AND A193 B7 BOLTING MATERIALS *

Carl J. Czajkowski
Brookhaven National Laboratory
Department of Nuclear Energy
Upton, New York 11973

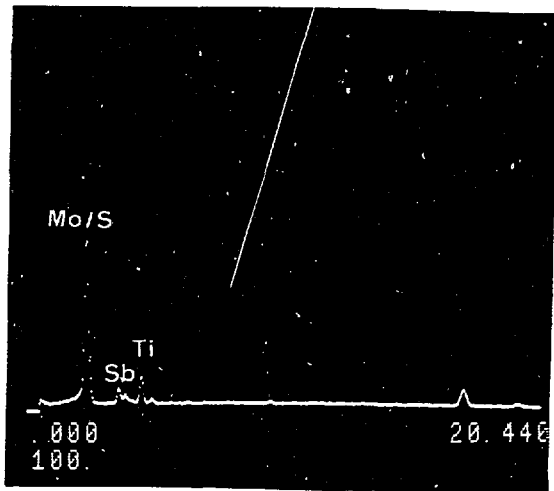
Figure 1 EDS scan of lubricant #2.

Figure 1 is an EDS scan of a commercially available MoS₂ (lubricant #2) spray. The scan detected both antimony and titanium in addition to the molybdenum and sulfur. The titanium is possibly used for coloring. The significance of the antimony addition is unknown.

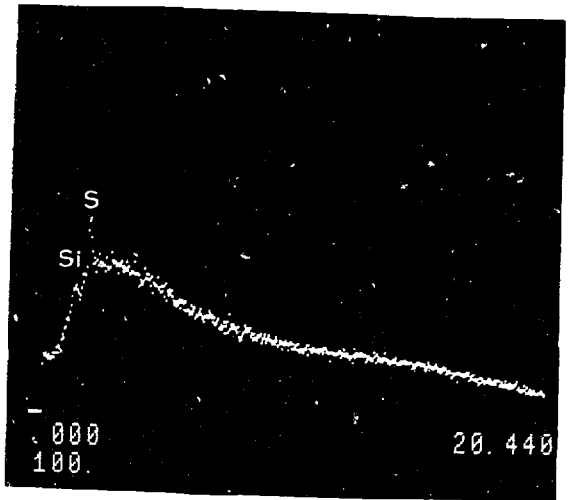
Figure 3 EDS scan of lubricant #5.

Lubricant #5, which is a graphite and isopropanol lubricant, was subjected to EDS and the resultant scan is shown in Figure 3. This lubricant showed a high sulfur peak with a trace of silicon also present. The presence of sulfur would not be normally anticipated in a graphite + alcohol lubricant and might be detrimental to highly alloyed steels under the proper conditions.

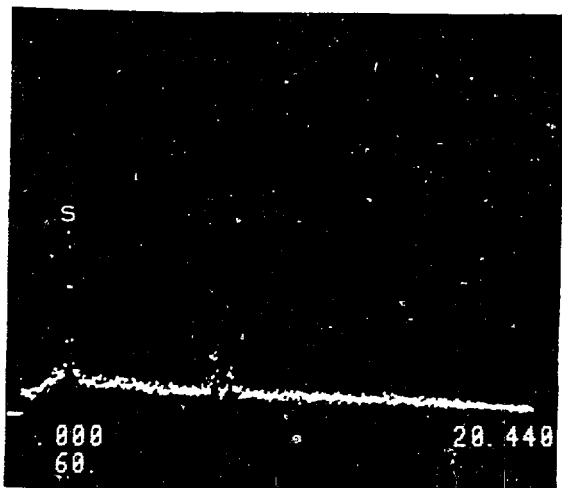
Figure 2 EDS scan of lubricant #4.

The EDS scan of lubricant #4 which is another moly-lube spray is shown in Figure 2. This scan showed only a sulfur peak with no molybdenum present at all.

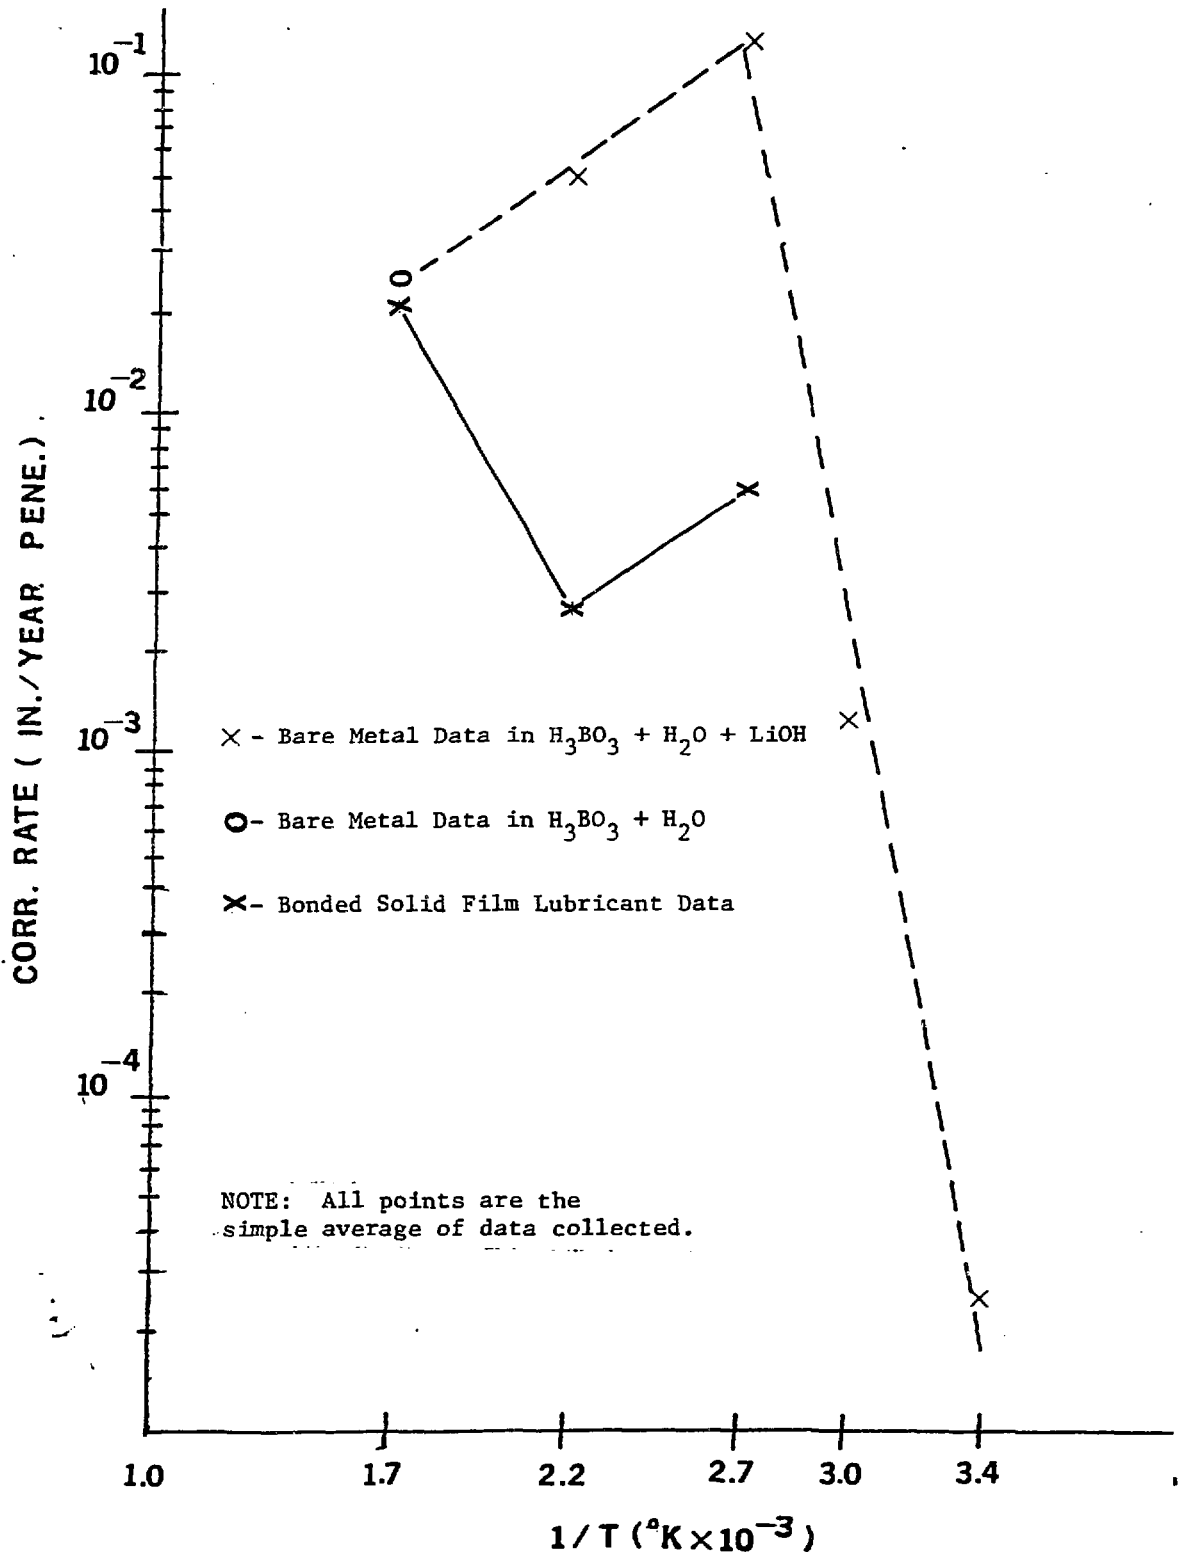
Figure 8 Graphical representation of weight loss experiments.

The data generated from these tests are plotted on the graph of the original test data in Figure 8.

It is evident that the corrosion rate at 178°C and 100°C for the solid bonded film lubricant is almost an order of magnitude less than for the bare metal alone. As no data were generated for the $H_3BO_3 + LiOH$ solution at 315°C, the corrosion rate for an A193 B7 material in 4000 ppm boron as $H_3BO_3 + H_2O$ solution is plotted. The point almost coincides with the bonded lubricant point denoting virtually no additional protection offered by the lubricant, at this temperature.
