BNL 39091  
INFORMAL REPORT

ANALYSIS OF SURFACE CONTAMINANTS ON BERYLLIUM WINDOWS

DECEMBER 1986

**NATIONAL SYNCHROTRON LIGHT SOURCE**

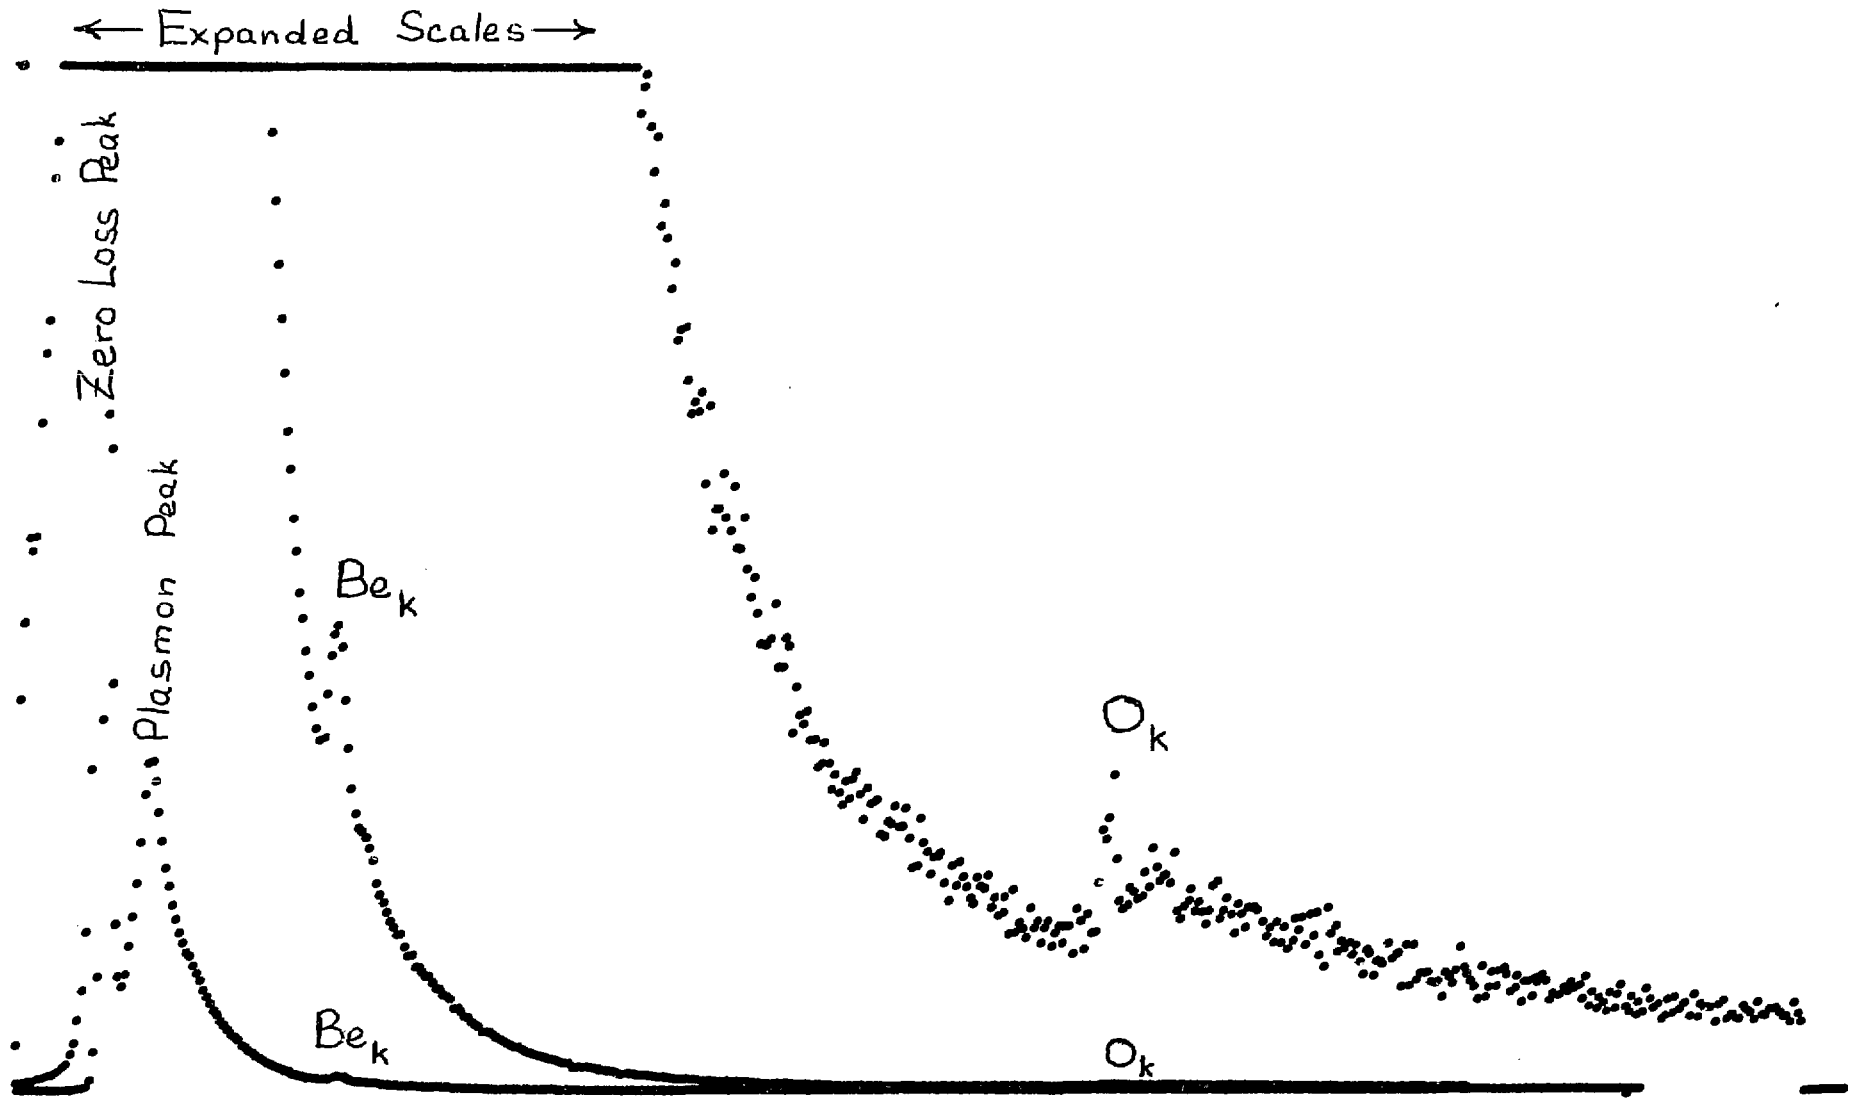
Fig. 13. Logarithmic plot of electron energy loss spectroscopy (EELS) showing presence of beryllium and oxygen in white powder.

Fig. 14. EELS plot showing beryllium (~ 111 eV) and oxygen (~ 532 eV) k absorption edges in white powder.

Also using window type C white powder, a final successful attempt at analysis was made using the facilities of a JEOL JEM-100C Transmission Electron Microscope (TEM) operating at a 120 keV accelerating voltage. In the electron diffraction mode, the ring pattern produced consisted of both diffuse as well as distinct rings indicating a mixture of amorphous and microcrystalline phases (see Fig. 11). As calculated, ring diameters corresponded to d-spacings of 2.28 Å, 1.62 Å, 1.37 Å and 1.18 Å which in turn were interpreted (R. Sabatini - DAS) to be representative of beryllium oxide - BeO (see Fig. 12). This finding was supported by electron energy loss spectroscopy (EELS - using a Gatan Energy Loss Spectrometer, Model 607, with a serial type detector) which detects the electron energies resulting from the interaction of the electron beam as it passes through the sample. The spectra clearly show the presence of beryllium (peak at 111 eV) and oxygen (peak at 532 eV), (see Fig. 13,14). Finally, the imaging mode of the TEM caused the fine mass of powder to charge up in the presence of the electron beam indicating the powder is an insulator. All of these factors, confirmed in the literature<sup>2-5</sup> indicate that the powder is BeO.
