RESULTS OF TRANSIENT OVERPOWER EVENTS
ON BREACHED AND UNBREACHED FUEL PINS*

R. V. Strain, H. C. Tsai and L. A. Neimark

INVITED PAPER to be presented at the International Conference on Reliable Fuels for Liquid Metal Reactors, sponsored by the American Nuclear Society, Tucson, Arizona, September 7-11, 1986

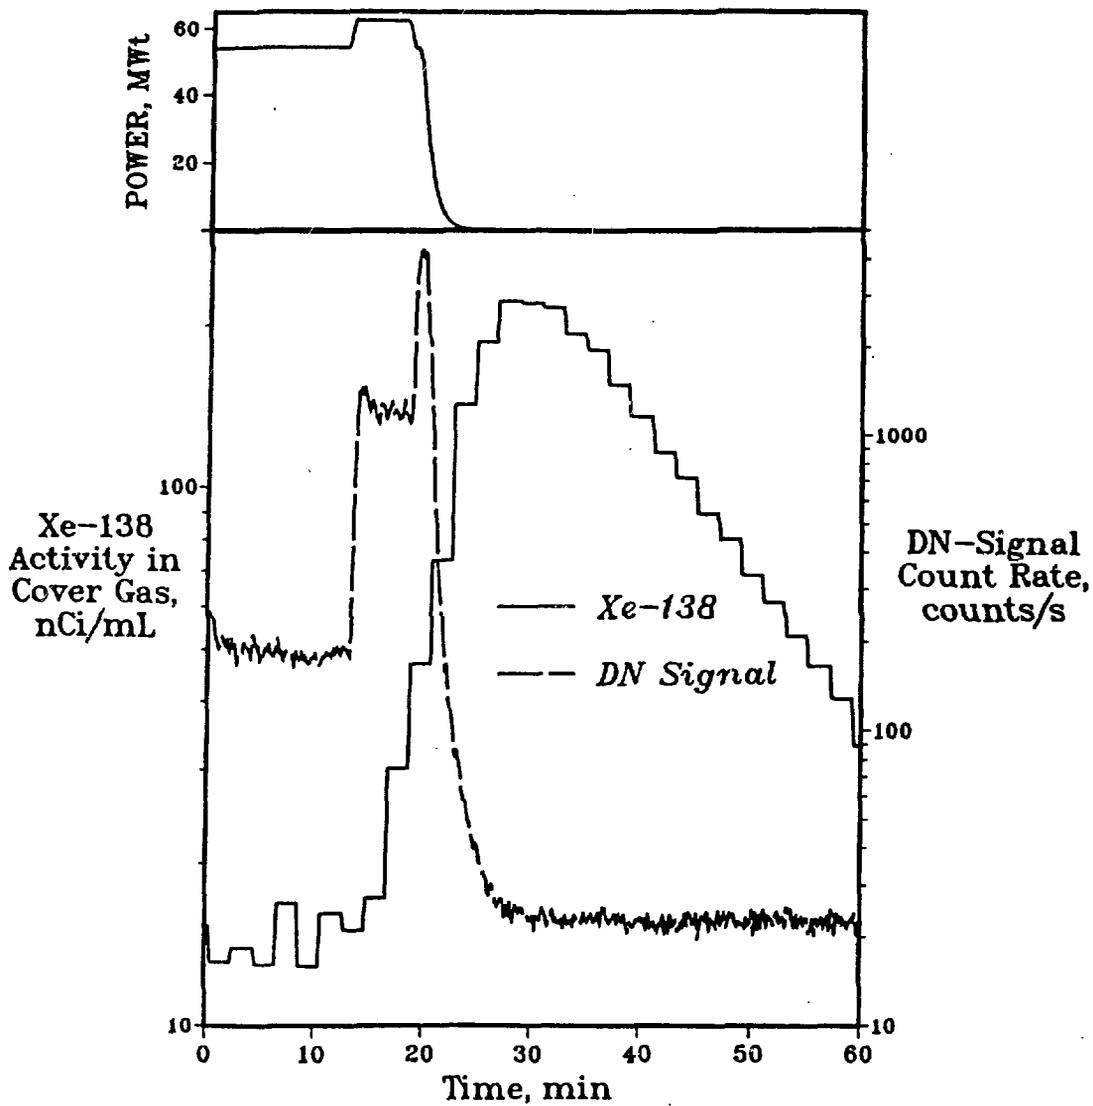
Figure 1. Power and Fission Product Release Data During the Second Transient and Reactor Shutdown.

The second 15% overpower transient was initiated about 68 h after the first transient. The reactor power, DN signal (FERD), and Xe-138 activity during the second transient are shown in Fig. 1. During the ramp up to the 15% overpower, the DN signal rose rapidly and then peaked at about 1540 cps on the FERD shortly after the high power level was reached. The DN signal then dropped to about 1200 cps on the FERD during the 5-min steady-state operation at the overpower level. However, during the overpower operation the signal was not very stable and several peaks near 1500 cps were recorded. As the power was reduced back to nominal full power, the DN signal again increased rapidly. Very shortly after the power began to level-off at nominal full power, the DN signal exceeded the preset administrative limit of 1600 cps on the FERD and an anticipatory reactor shutdown was initiated. The FDND in the BFTF indicated that the large peak recorded by the FERD was actually composed

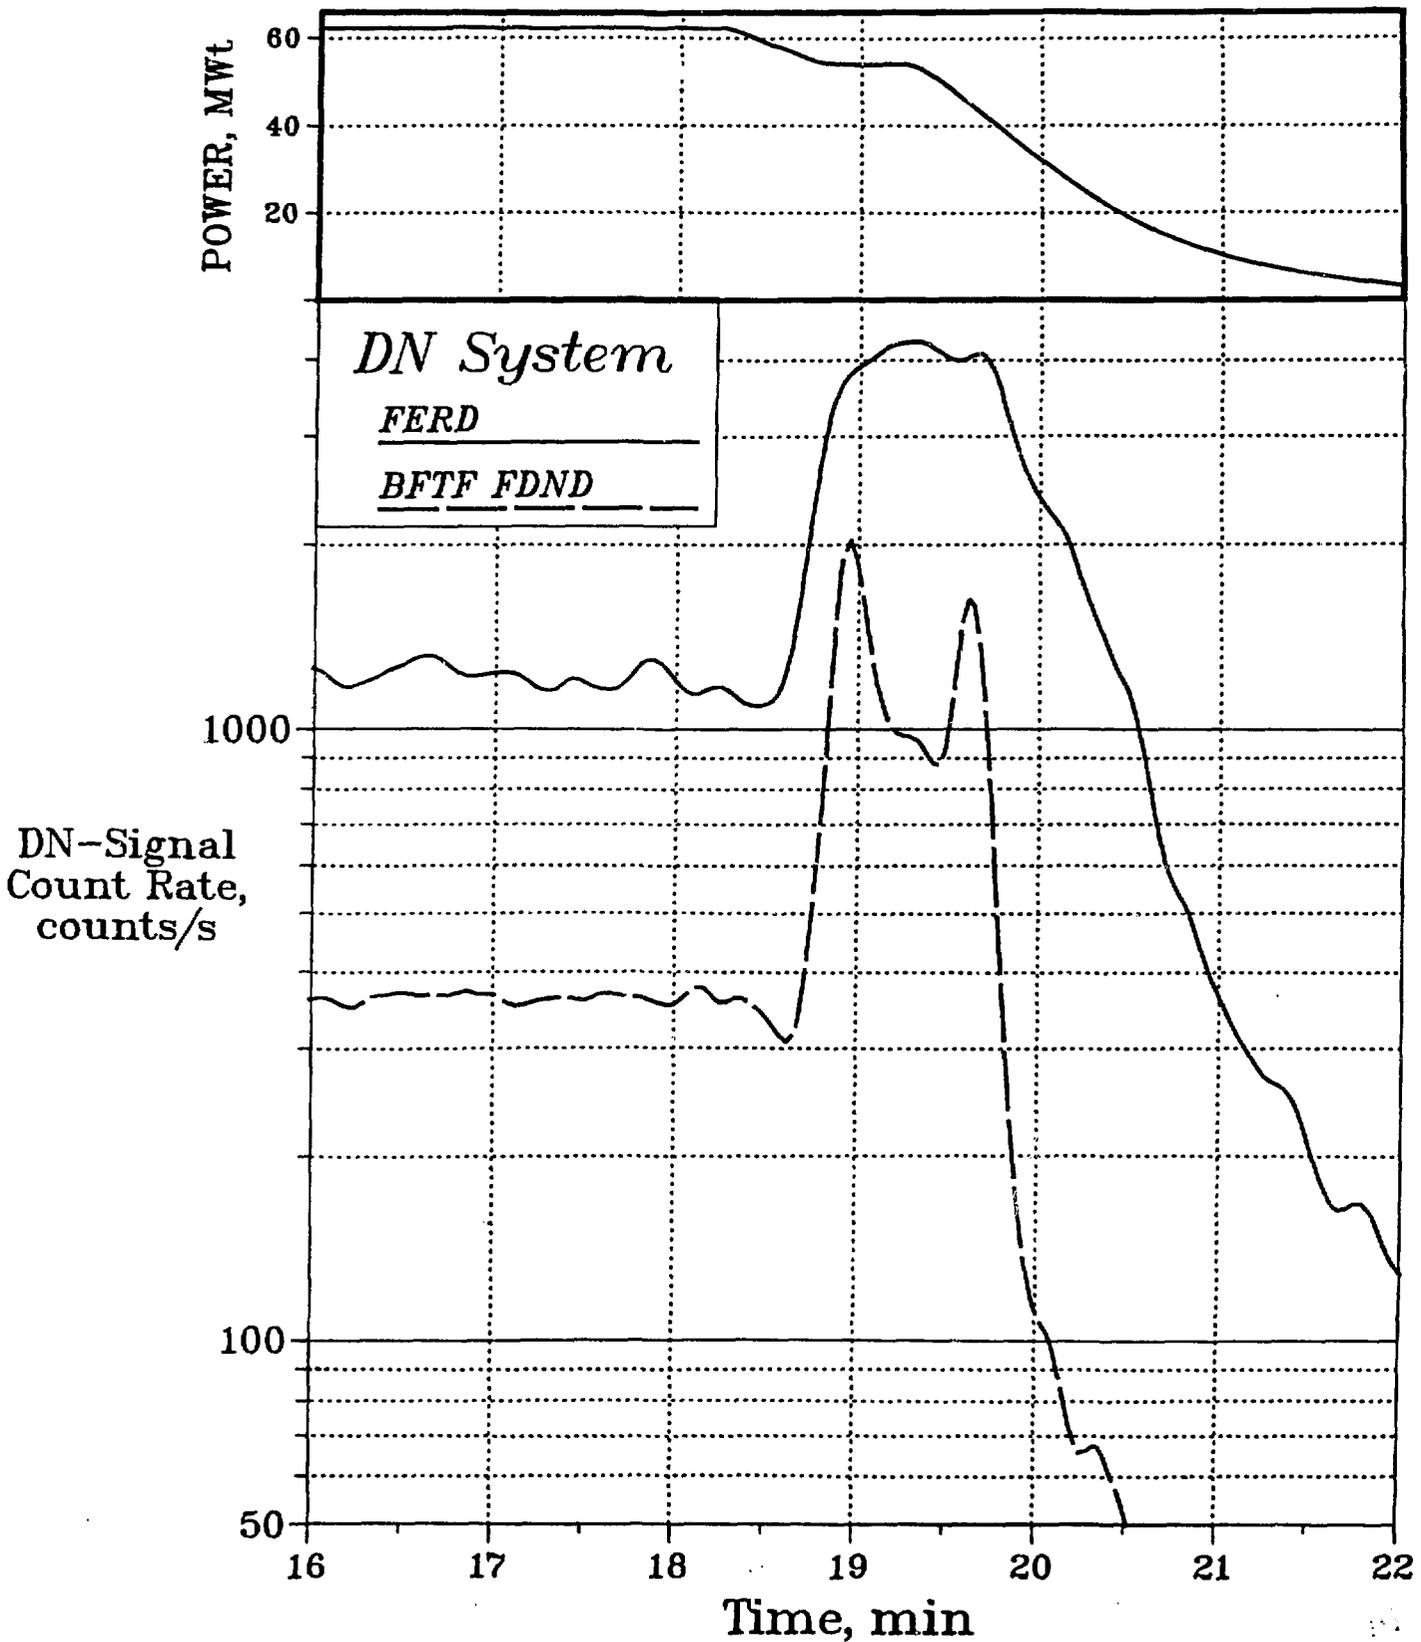
Figure 2. FERD and BFTF DN Signals at the End of the Second Transient and Reactor Shutdown.

of two peaks, one occurring on the comedown to nominal full power and the other occurring just after the anticipatory scram began (see Fig. 2). The maximum DN signal that was recorded on the FERD was about 4200 cps. During the second transient the fission gas activity essentially duplicated the behavior during the first transient. Again, shortly after the transient was started the Xe-138 activity rose until it reached a peak of about 250 nCi/ml, and then it declined after the reactor shutdown owing to the action of the cover gas cleanup system.

The two large peaks in the DN signal that accompanied the reduction in power from the 15% overpower to full power and the reduction from full power to zero power at the end of the second transient are obviously related to a phenomenon that occurs when the fuel cools. It is doubtful that these peaks were caused solely by the sweeping action of sudden fission-gas release from a freshly vented central void as this would not occur in two bursts.

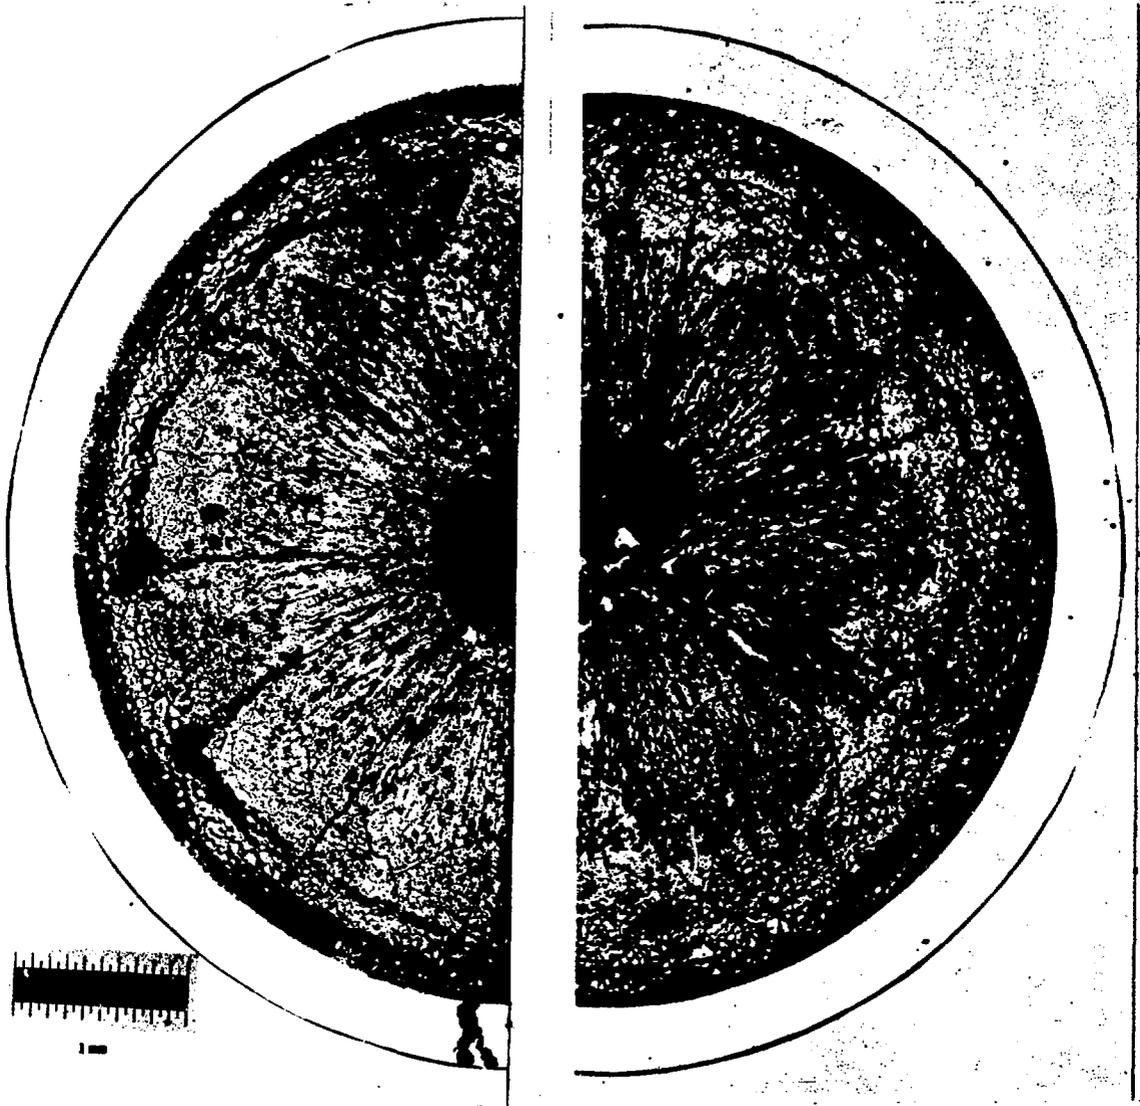
Figure 5. Cross-sections from the K2A and TOPI-2 Test Pins Below the Primary Breach.

Comparable cross-sections from the TOPI-2 test pin and one of the breached K2A test pins are shown in Fig. 5. The microstructures show that sodium ingress has a significant effect on the fuel. Prominent features in both pins were the presence of fuel-sodium reaction product between the fuel and cladding; large, irregularly shaped central voids; and large, blocky grains near the central void near the core midplane. The differences between the pins are subtle but indicative of the effects of the overpower transients.

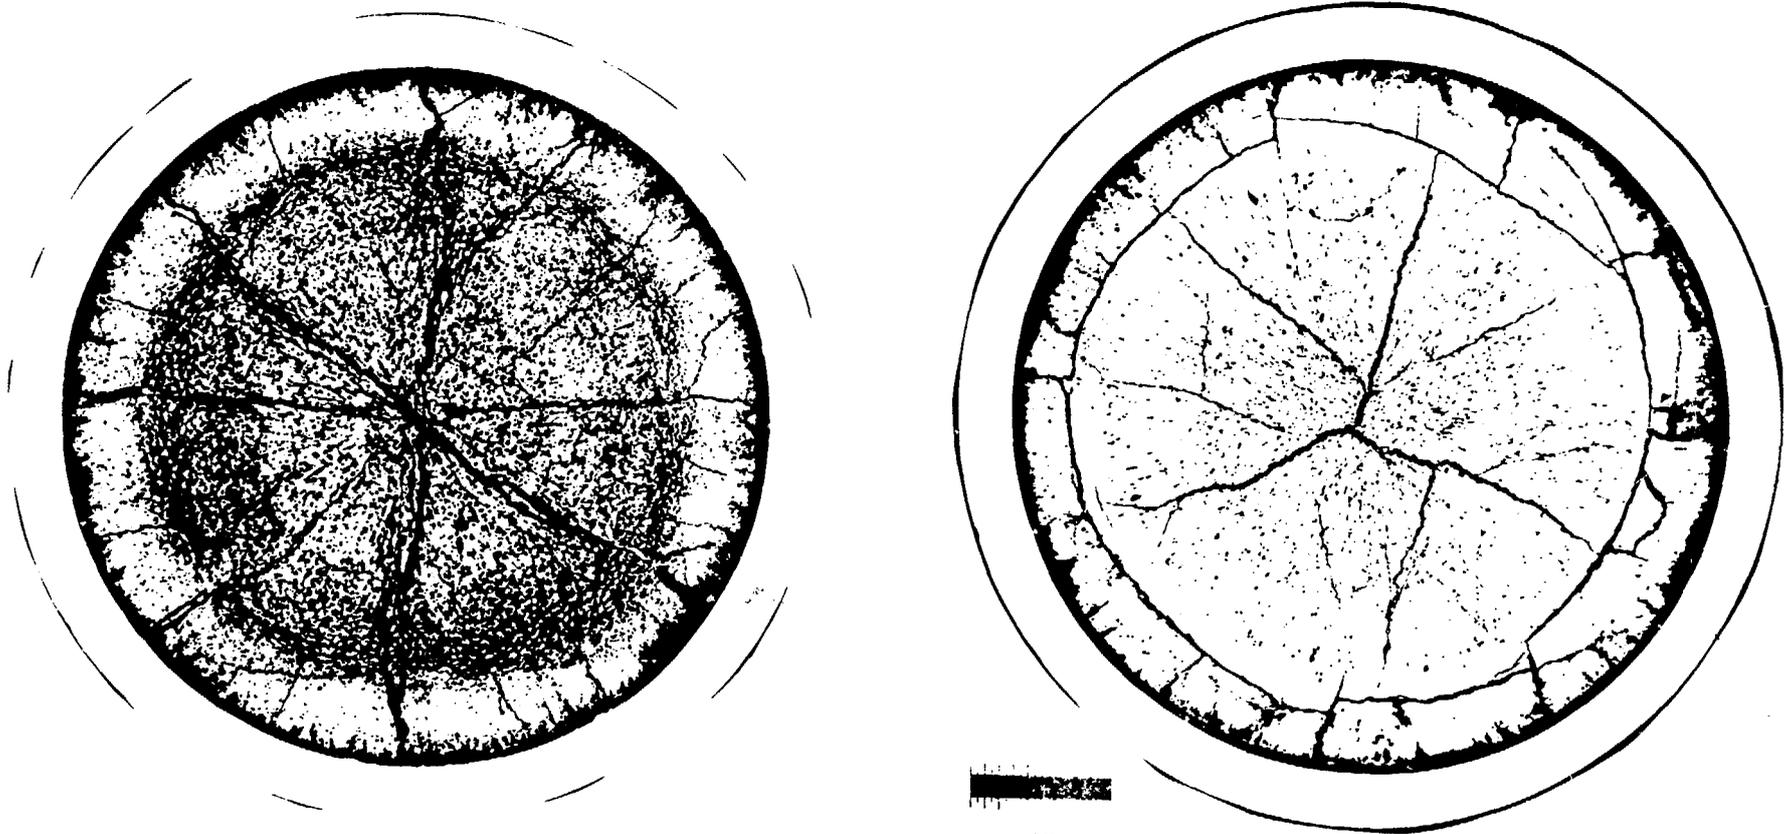
Figure 7. Comparison of TOPI-1A Test Pin P43-F104 (Left) and Its Steady-State Sibling (Right). Note the Formation of Microcracks at $X/L \approx 0.7$ in P43-F104.

The most pronounced thermal-mechanical effect of the applied overpower transient in the TOPI-1A pins is perhaps fuel grain-boundary separation, or microcracking. Such cracking was found in virtually every one of the preirradiated TOPI-1A pins that were destructively examined. Most of the microcracks were found in a circular band in the equiaxed grain-growth region where favorable conditions, including a high population of grain-boundary gas bubbles before the transient, were present. Apparently these gas bubbles coalesce and interconnect during the transient thereby weakening the boundary. Upon cooldown these weakened boundaries tear in response to differential thermal contraction forces. Fig. 7 illustrates the microcracks in the fuel pin after the transient and the lack of similar cracks in the steady-state sibling. The contribution of microcracking to local fuel volume changes was studied using a quantitative stereology technique. The analysis results for this pin and its sibling shown in Fig. 7 are illustrated in Fig. 8. Because microcracking represents a significant form of "fuel swelling," the extent of fuel microcracking can significantly affect the FCMI loading on the cladding on subsequent startups.

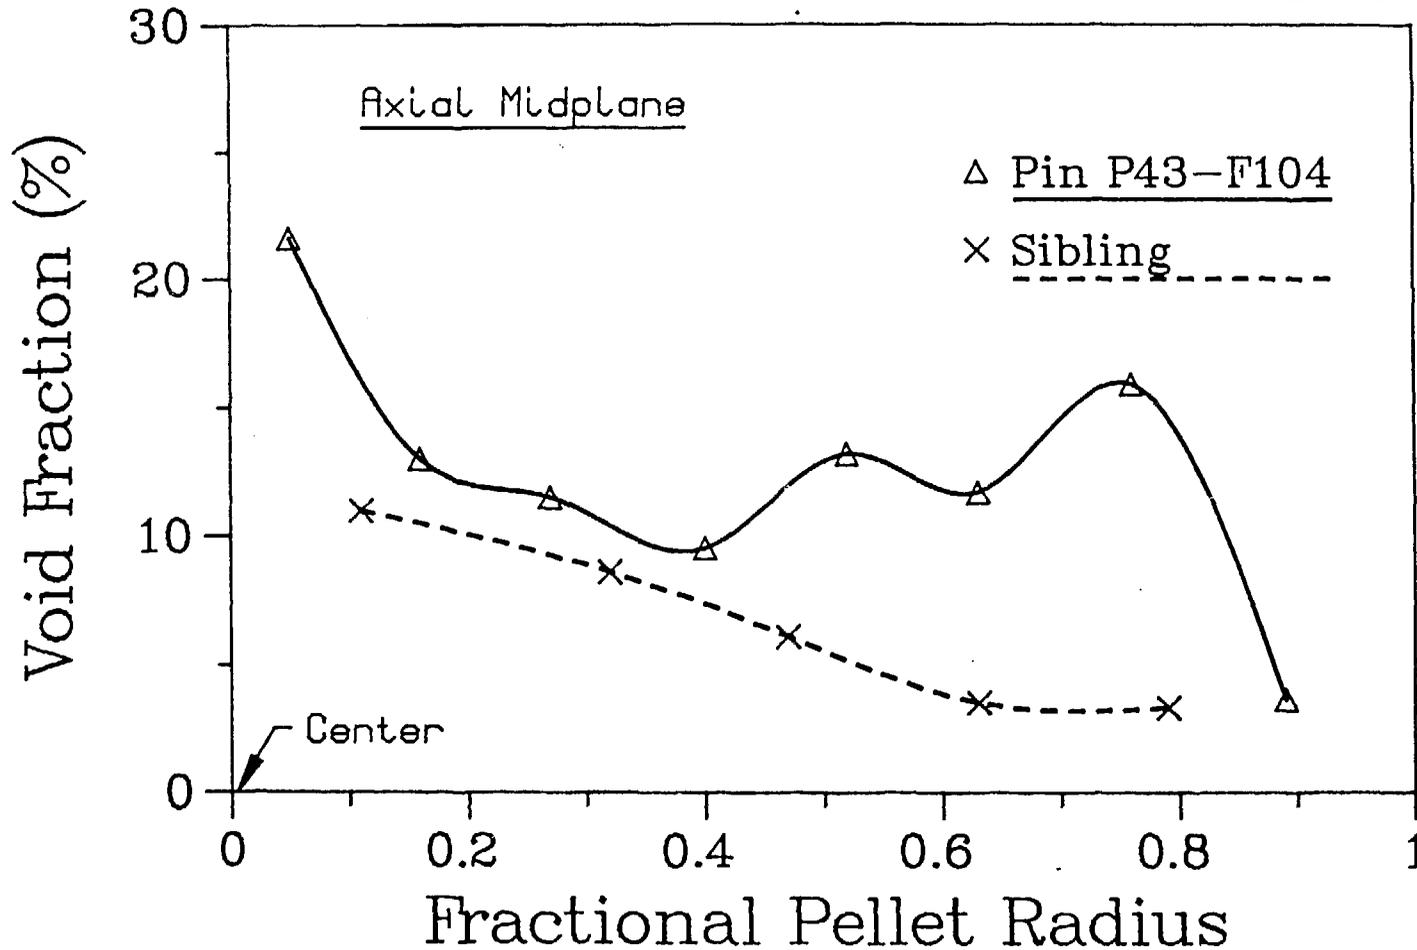
Figure 8. Void Fraction Distribution in TOPI-1A Pin P43-F104 vs. Its Steady-State Sibling. Note the Increase in Void Fraction in P43-F104 at $X/L = 0.6-0.8$ Due to Fuel Microcracking.

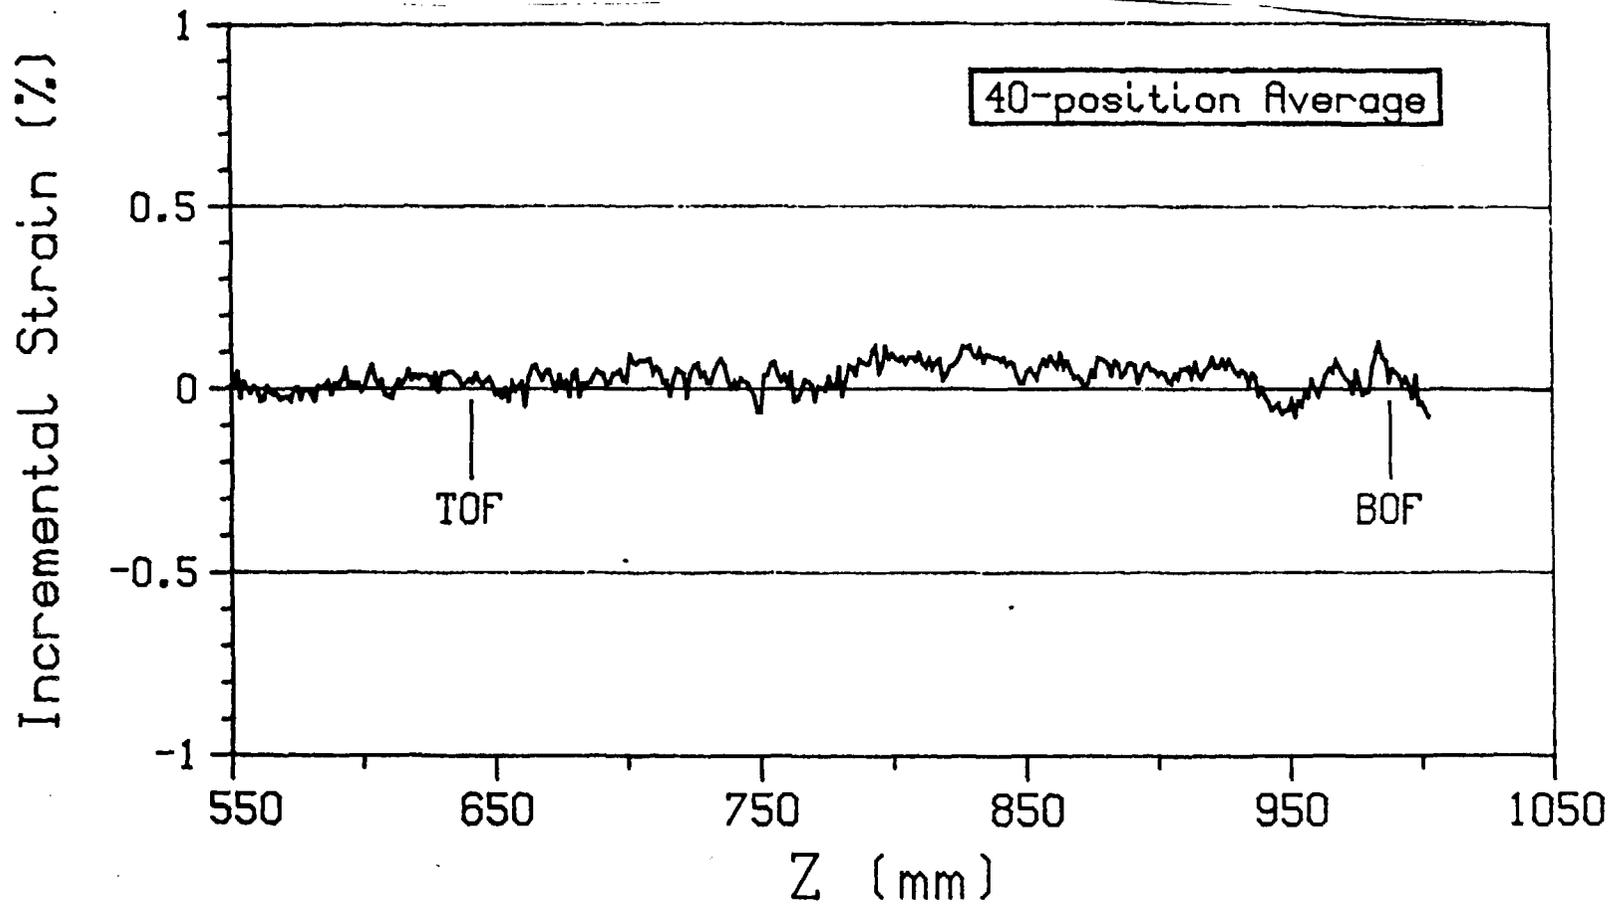
Figure 9. Profile of Incremental Strain Incurred in Pin P43-B15 During the TOPI-1B Transient.

The measured incremental strain profiles for TOPI-1B test pins P43-B15 and P40-D103 are illustrated in Figs. 9 and 10, respectively. In pin P43-B15, which had 0.38-mm-wall cladding, despite the high fuel smear density (91% TD), the overall incremental strain was small with a maximum of ~0.1% occurring near the midplane. In pin P40-D103, the incremental strain was substantially greater (~0.3% max.) owing primarily to the thinner 0.25-mm-wall cladding. The sharp rise of the incremental strain profile at the top of the fuel column in pin P40-D103 suggests that cladding loading was due mainly to fuel-cladding mechanical interaction. The overall profile showing greater incremental strain near the top end of the fuel column may be correlated with the reduction of cladding strength with increasing operating temperature.

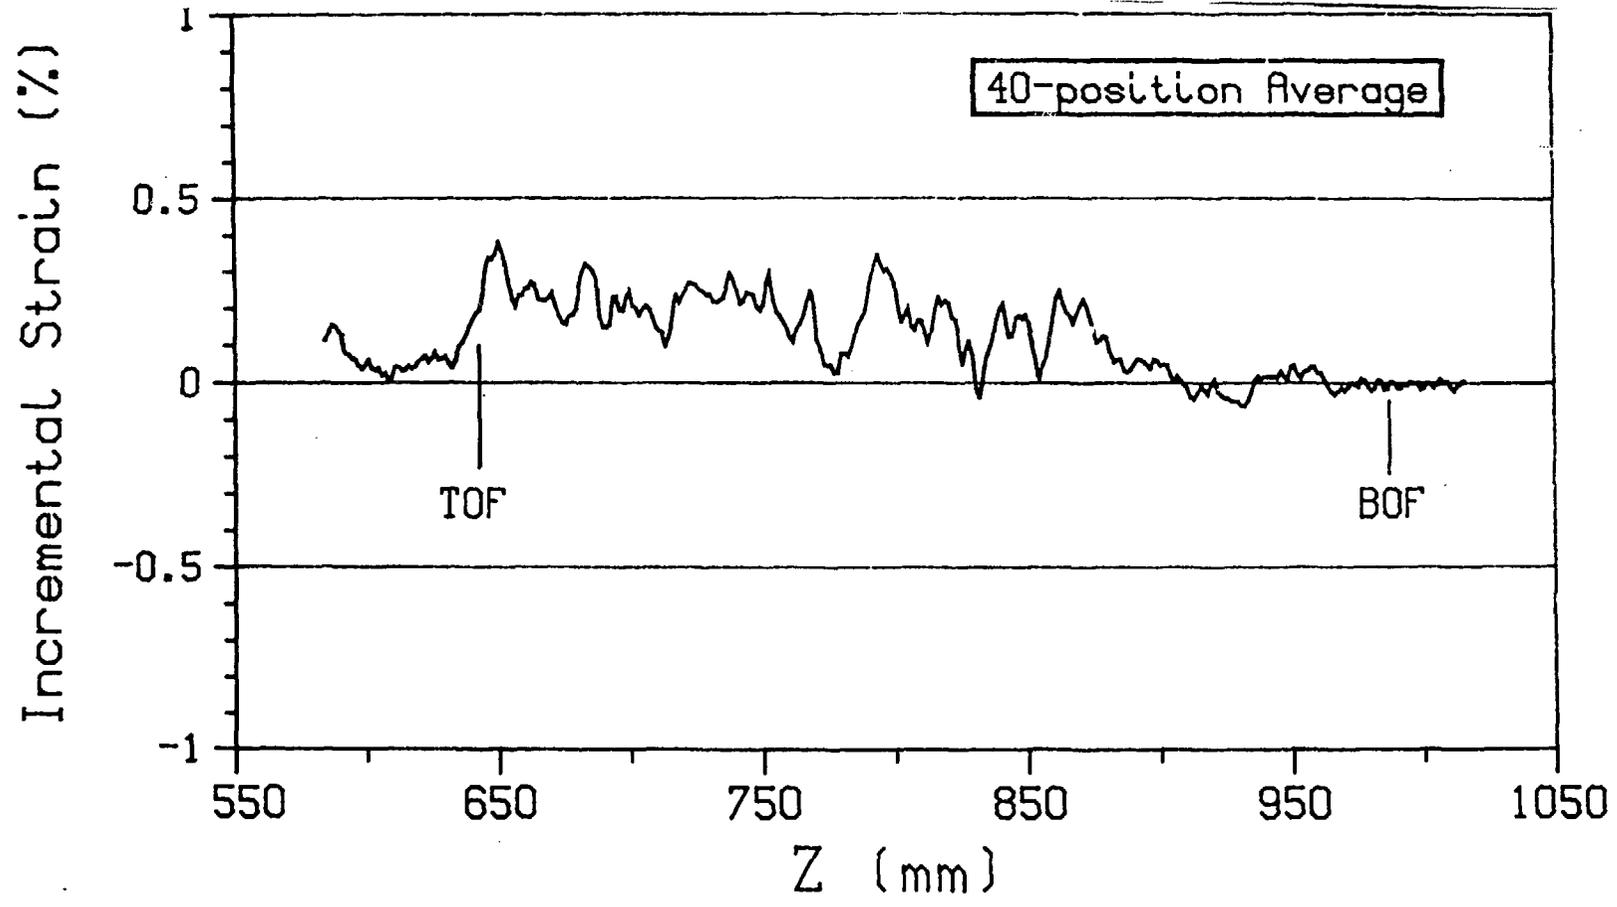
Figure 10. Profile of Incremental Strain Incurred in Pin P40-D103 During the TOPI-1B Transient.
