General-Purpose Heat Source Safety Verification Test Program: Edge-On Flyer Plate Tests

T. G. George

Los Alamos Los Alamos National Laboratory
Los Alamos, New Mexico 87545

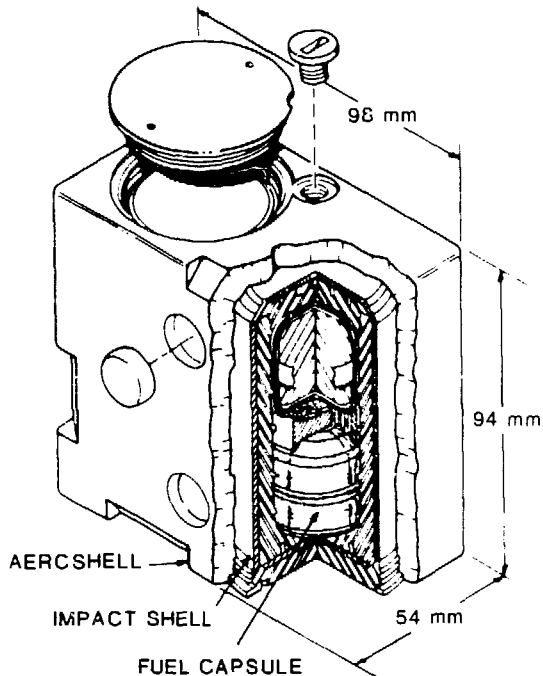
Fig. 1. Each GPHS module contains four $^{238}\text{PuO}_2$ -fueled capsules.

shell (GIS), and two GISs are contained within the FWPF aeroshell (Fig. 1).

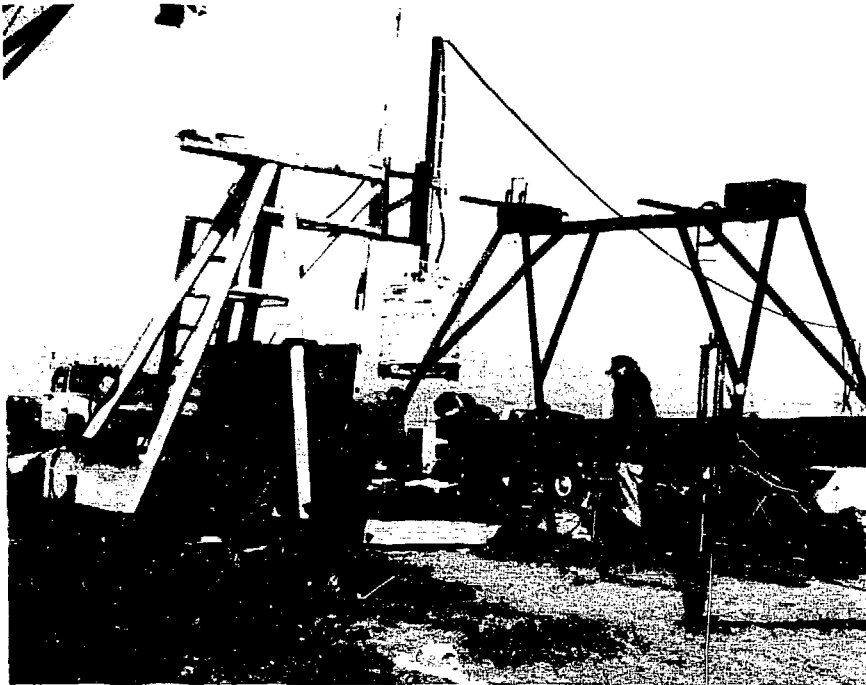
Fig. 3. The furnace could be rapidly raised and lowered over the module stack.

hanging beam (Fig. 3), so that it could be rapidly raised and lowered over the module stack. The catch box was suspended in a similar manner, so that it could be moved into position (25 mm behind the module stack) after the furnace had been raised. Two calibrated chromel-alumel thermocouples (stainless steel sheathed) monitored the temperature of the test assembly; one thermocouple was positioned between the upper bulk module and the target module, and the other was wired to the surface of the module stack.

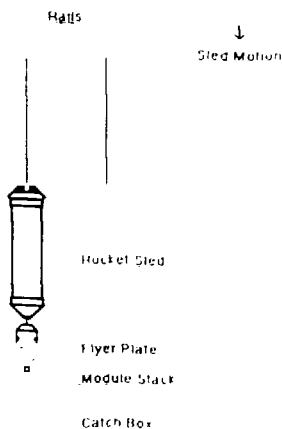
Fig. 4. The full-module EFP test setup.

The impact velocities specified for the full-module tests mandated the use of a monorail rocket sled (to minimize air resistance), driven by a single rocket. A schematic of the full-module test setup may be seen in Fig. 4.

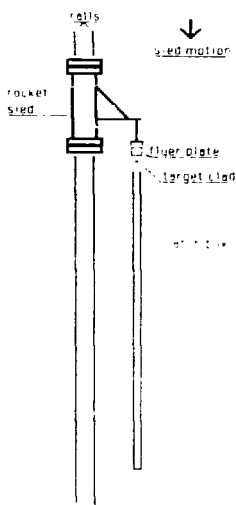
Fig. 5. The bare-capsule EFP test setup.

throughout each test. The flyer plate was carried on a long boom extending from the side of the sled (to prevent a sled/catch box collision). The test setup used in the bare-capsule tests is shown in Fig. 5.

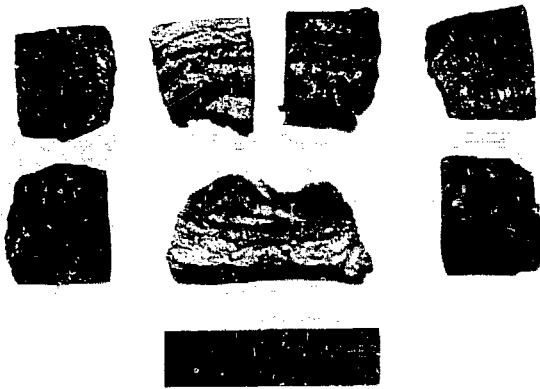
All the mass simulants were recovered in the catch box. Each simulant had been cleaved by the flyer plate (Fig. 8).

Fig. 8. The flyer plate cleaved all of the nickel mass simulants.

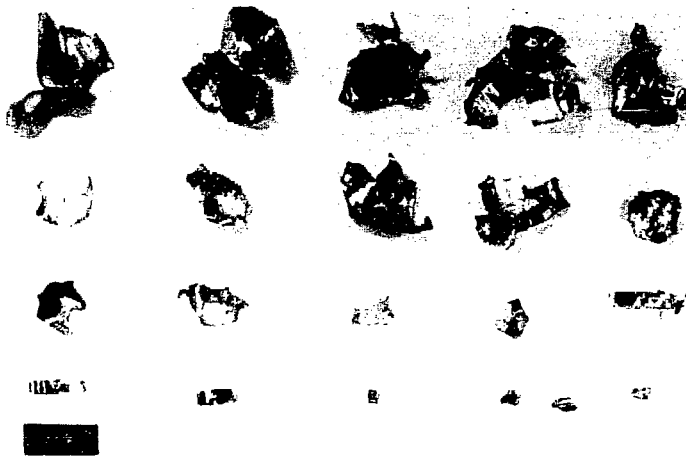
After the test, we examined the catch box contents and found enough iridium fragments to account for one fueled clad. A thorough search of the test site revealed numerous iridium fragments scattered within a 1-m radius of the furnace base. A total of 21 fragments were recovered (Fig. 9), amounting to 169.7 g (approximately 85% of the iridium originally contained within the target module). Fragments of the aeroshell and impact shells were also recovered in the target area (Fig. 10).

Fig. 9. Twenty-one iridium fragments were recovered from the EFP-2 test site.

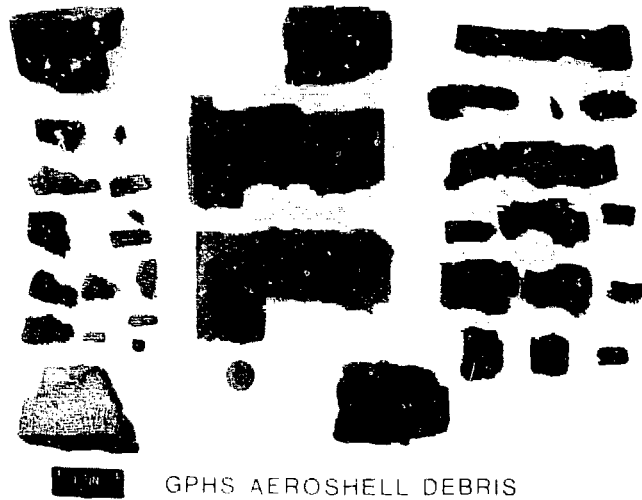
Fig. 10. Fragments of the EFP-2 aeroshell and impact shells were also recovered.

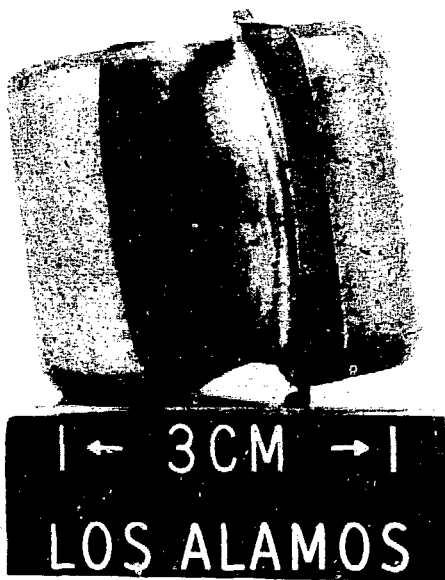
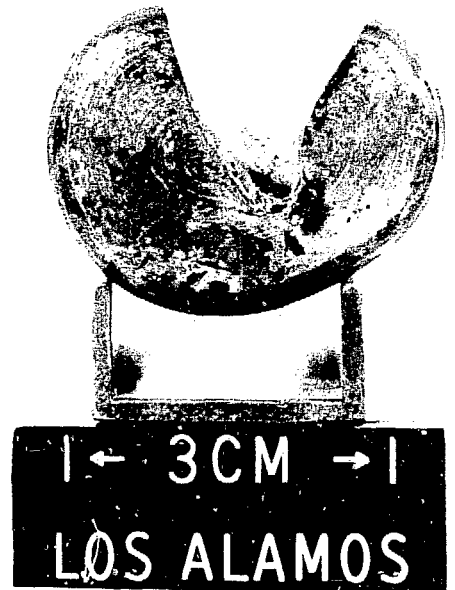
After the test, we recovered the copper slug (Fig. 11) from the catch box. The deformed flyer plate was discovered on the ground approximately 1 m from the catch box opening. Macroscopic examination revealed that the flyer plate had cleaved through 65% of the slug. The contact portion of the flyer plate was bent sharply downward (Fig. 12). Subsequent examination of flash radiographs verified that the plate struck the slug squarely along its axial centerline and was forced downward as it penetrated the copper (Fig. 13).

Fig. 11. The copper slug was recovered from the sawdust-filled catch box. (a) Impact face and (b) end; both at 1.5X.

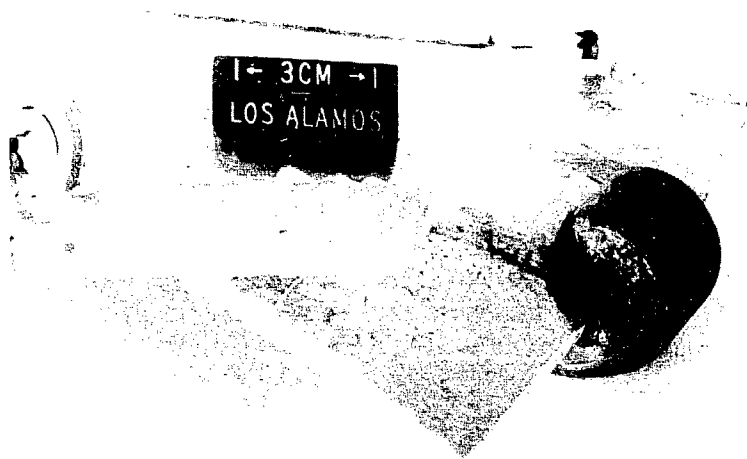
Fig. 12. The flyer plate cleaved through 65% of the copper slug.

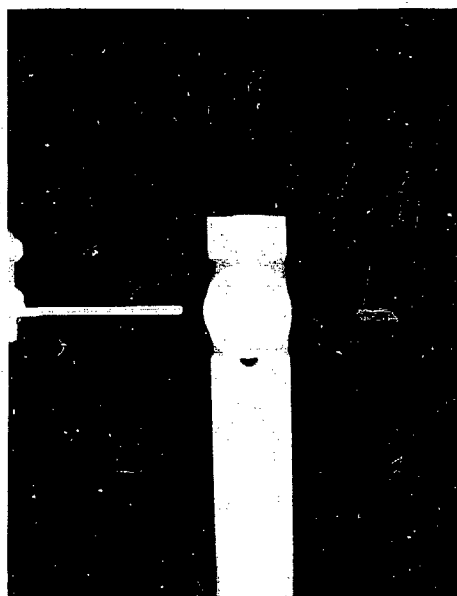
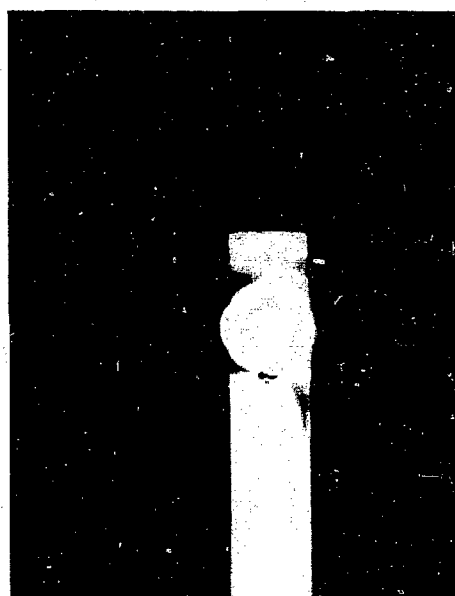
Fig. 13. Radiographs of the EFP-3 impact verify that the plate struck the copper slug along its axial centerline. (a) Preimpact alignment of plate and slug, and (b) double exposure showing positions at impact and just after.

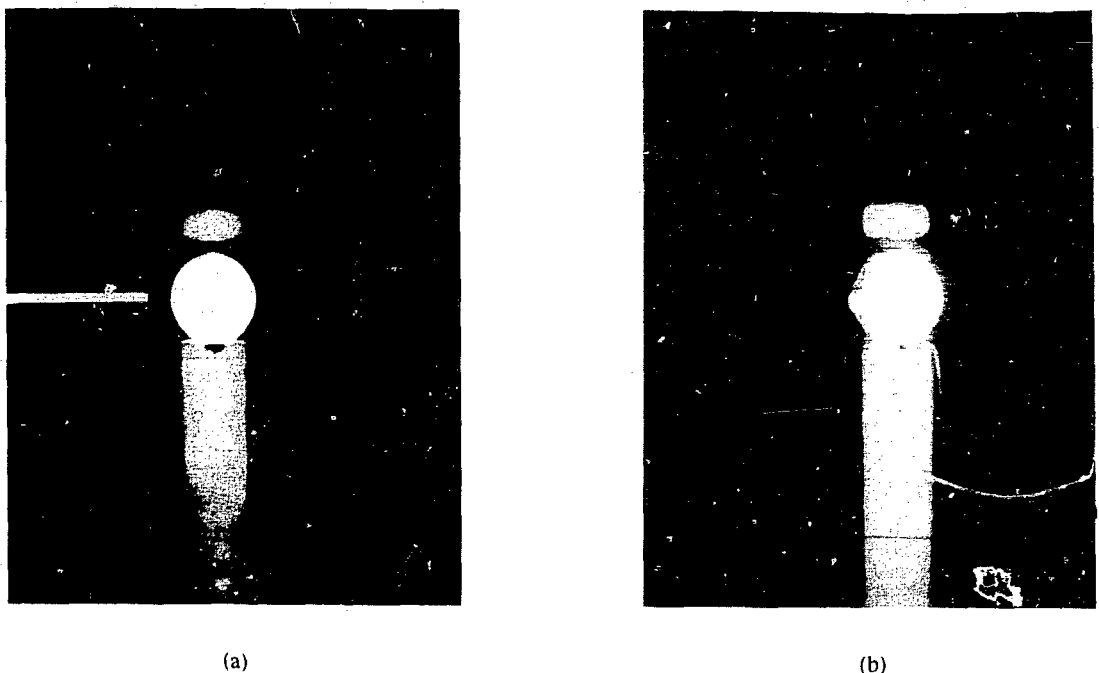
Unfortunately, one of the line charges designed to release the plate failed to detonate; the plate struck the capsule while still attached to the sled boom. Flash radiographs of the impact (Fig. 14) verified that the plate struck the capsule squarely along its axial centerline. As in the engineering test, the plate deflected downward after striking the capsule. The resulting plate geometry propelled the capsule forward and upward at a

Fig. 14. Radiographs of the EFP-4 impact verify that the plate struck capsule M-47 along its axial centerline. (a) Preimpact alignment of plate and capsule, and (b) double exposure showing positions at impact and just after.

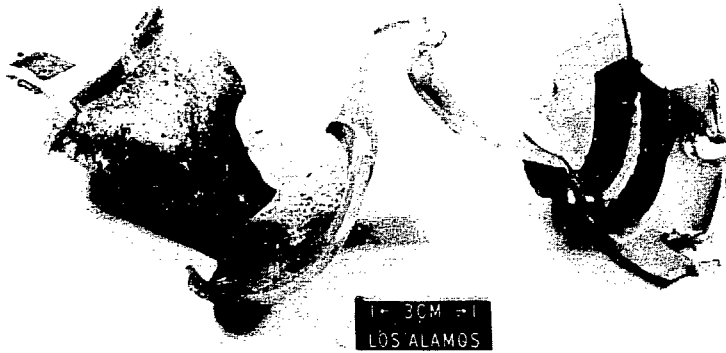
After striking the target, the flyer plate impacted the steel catch box. Because one line charge did not detonate, the plate fragmented (two pieces) as it ripped free of the sled boom (Fig. 16). Fortunately, the plate edge that struck the capsule remained attached to the largest fragment and was relatively undisturbed (Fig. 17). Both plate fragments were recovered within 1 m of the test platform.

Fig. 16. Impact with the steel catch box severely deformed the EFP-4 flyer plate.

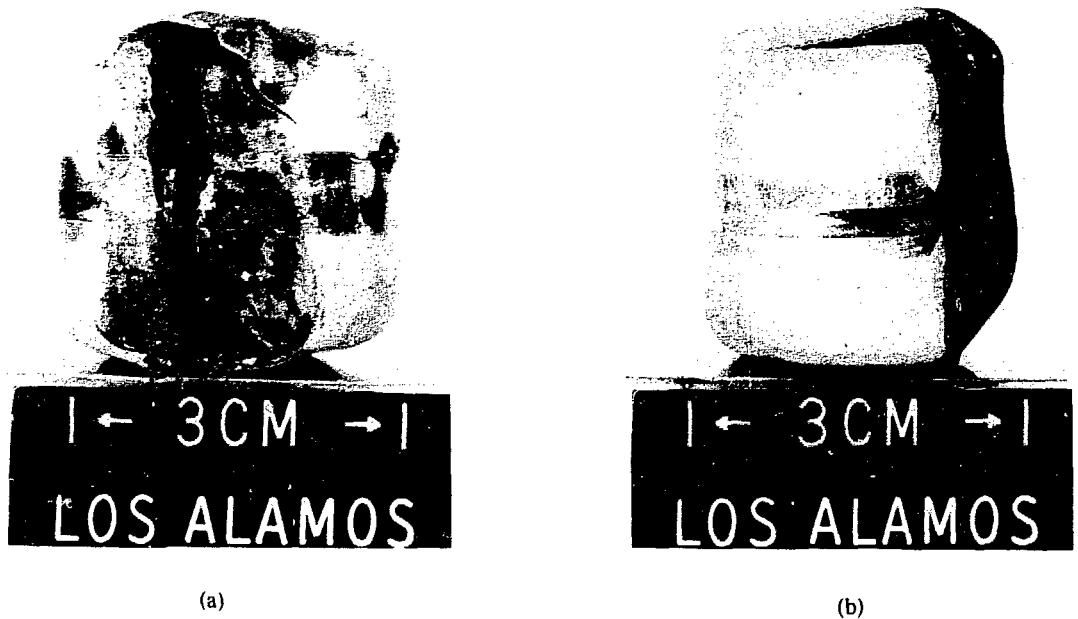
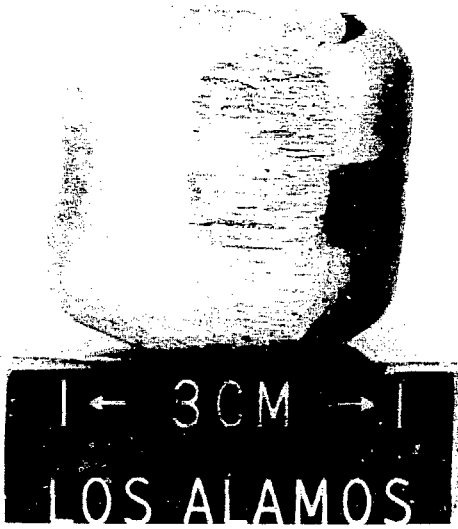
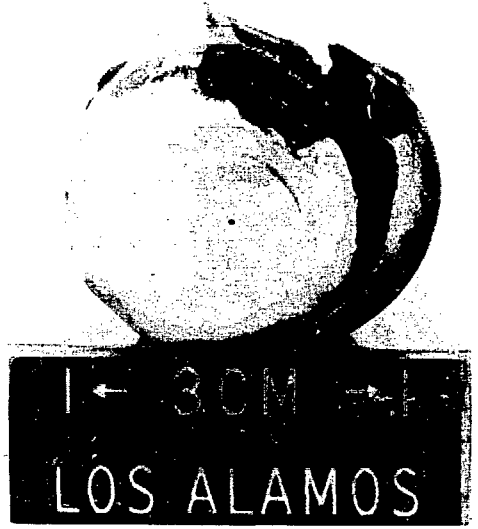
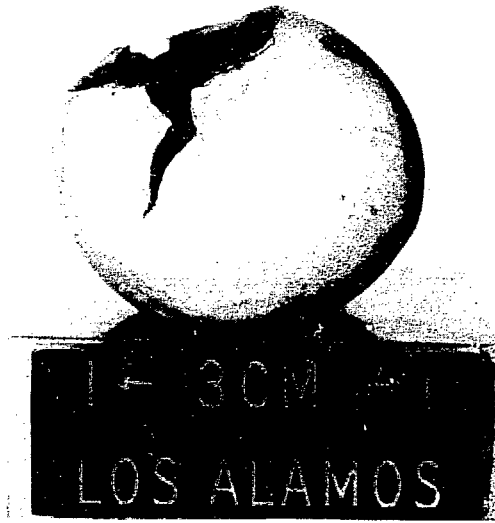
Macroscopic examination of the recovered capsule revealed that it was breached by an axial crack (64.0 × 5.3 mm) originating along the line of plate contact (Fig. 18). The breaching crack extended beyond the impact face and propagated along the circumferences of the vent and blind ends (Figs. 18d and 18e). Clad sections adjacent to the breach on the impact face were discolored by a grayish surface layer (Fig. 18a) that appeared to have resulted from an iridium/aluminum reaction. In addition, the trailing face of the capsule contained an area of deep striations (Fig. 18c) that apparently resulted from contact with the concrete track bed.

Fig. 18. Capsule M-7 was breached by a wide axial crack. (a) Impact face. (b) profile, (c) trailing face, (d) vent end, and (e) blind end; all at 1.5X.

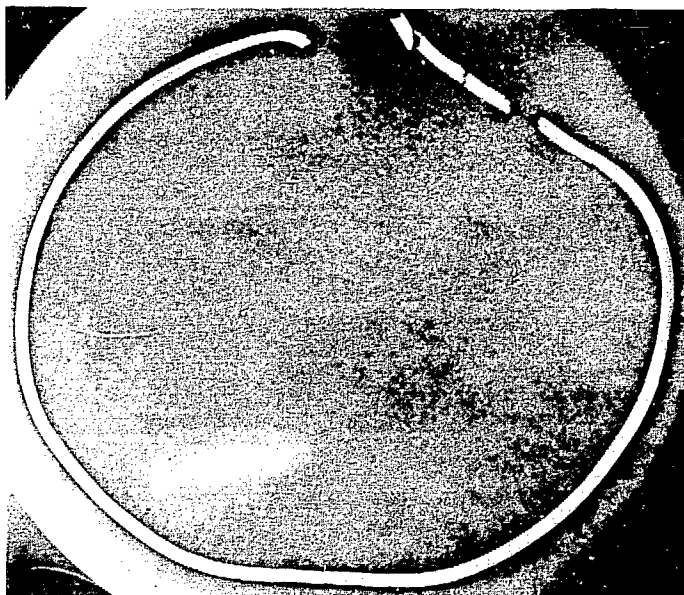
Microscopic examination of a transverse shield cup section (Fig. 19) revealed small penetrating cracks on one side of the main breach. All of the cracks had a brittle, intergranular appearance; the sections adjacent to the main breach were only slightly deformed (Fig. 20). Although no evidence of an iridium/aluminum reaction was observed in the main breach (Fig. 21), all of the other cracks were coated with a thin gray layer (Figs. 22 through 24). The gray coating was even observed within a narrow, (apparently) internal crack (Fig. 25). EDS (Energy Dispersive Spectrometry) analysis verified that the gray material was a compound of aluminum and iridium, with approximately equal amounts of each element. An electron micrograph of one crack is shown in Fig. 26a, and elemental dot maps (for aluminum and iridium) of the same area are shown in Figs. 26b and 26c.

Fig. 19. Several small cracks were visible in a section of the M-47 shield cup that contained the main breach; as polished, 4X.

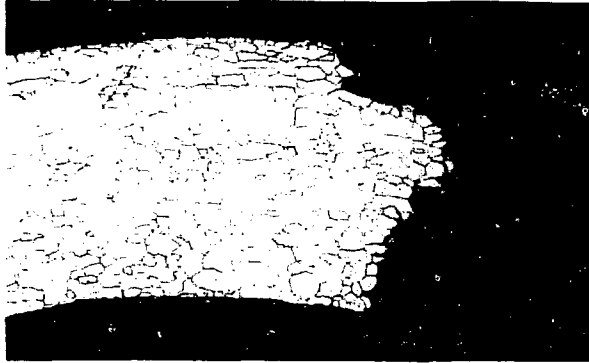
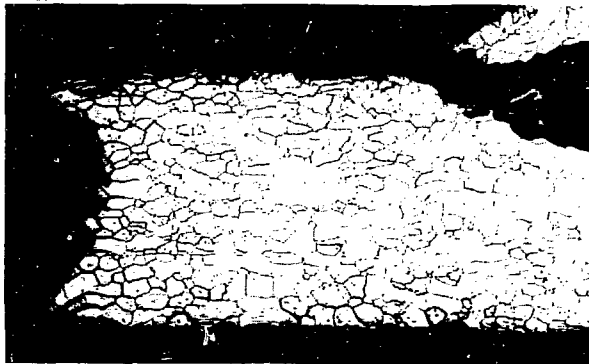
Fig. 20. The shield cup portion of the main breach had a brittle, intergranular appearance: both etched, 50X.

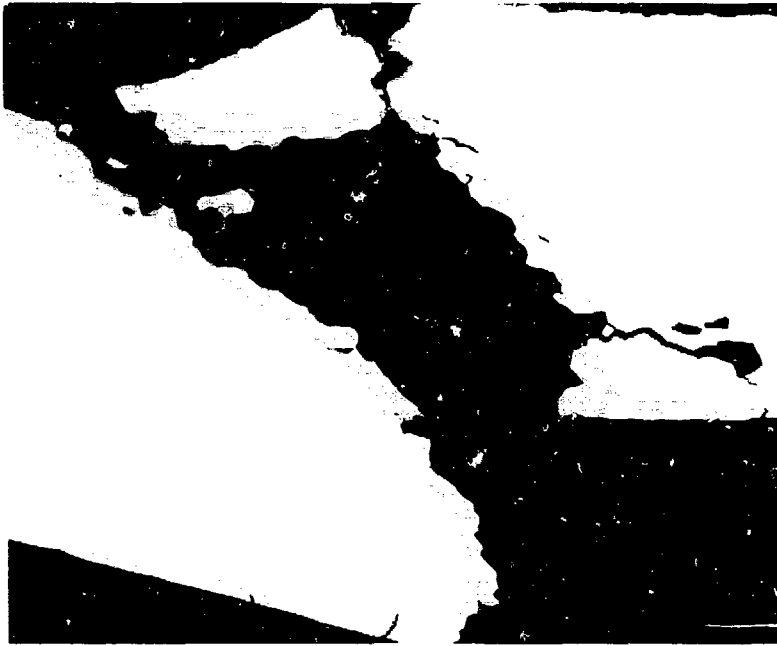
Fig. 22. A narrow crack adjacent to the main breach (immediately to the right) was coated with a layer of an iridium/aluminum reaction product; as polished, 100X.

The intermetallic deposits observed on the EFP-4 target clad (Figs. 22 through 25) suggest that the iridium/aluminum reaction can occur very rapidly. Although an energetic reaction has been previously observed between molten aluminum and solid iridium held in contact for relatively long periods, or arc-melted together,¹ there have never been any indications that this reaction could occur in the short contact time experienced in this test. A possible explanation of the test results is that, as the aluminum plate struck the clad, small plate fragments were abraded (possibly extruded) into cracks and rough spots on the iridium surface; as the clad spun up and away from the plate, the heated capsule melted the aluminum and allowed it to react.

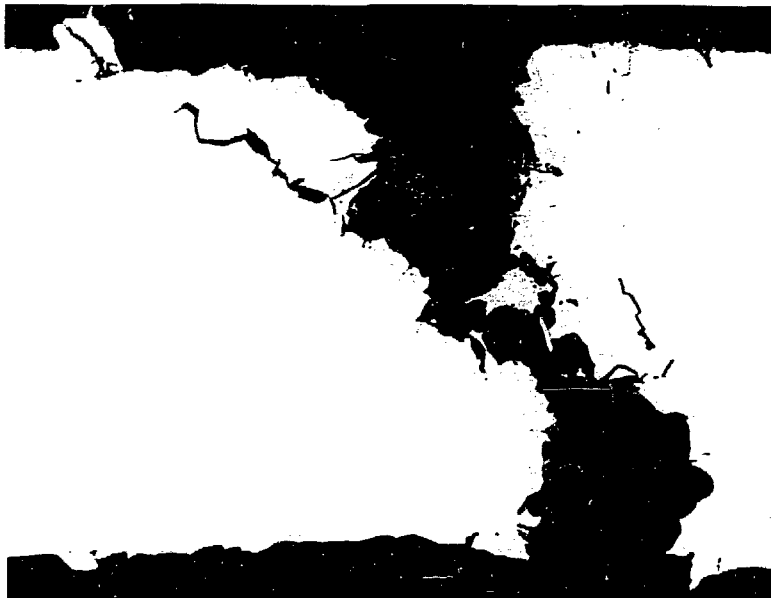
Fig. 23. A crack to the right of the narrow breach seen in Fig. 22 was also coated with a thin deposit of an iridium/aluminum reaction product; as polished, 100X.

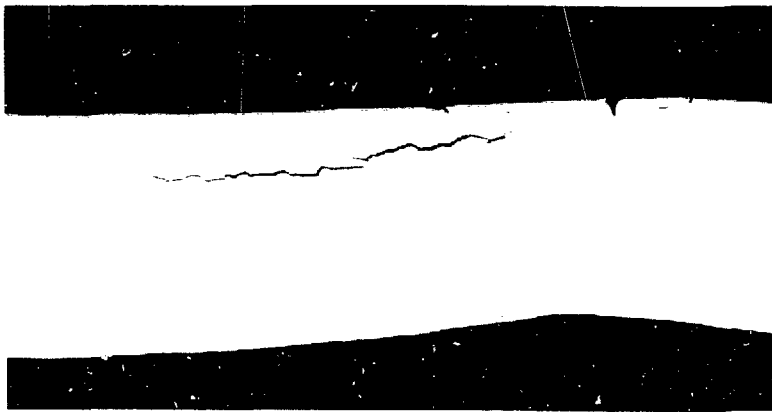
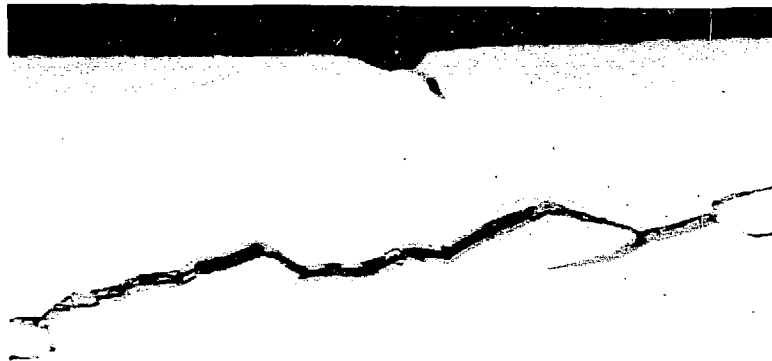
Fig. 25. Deposits of an iridium/aluminum reaction product were also observed inside an extremely narrow, delamination-type crack. (a) As polished, 50X; and (b) as polished, 250X.

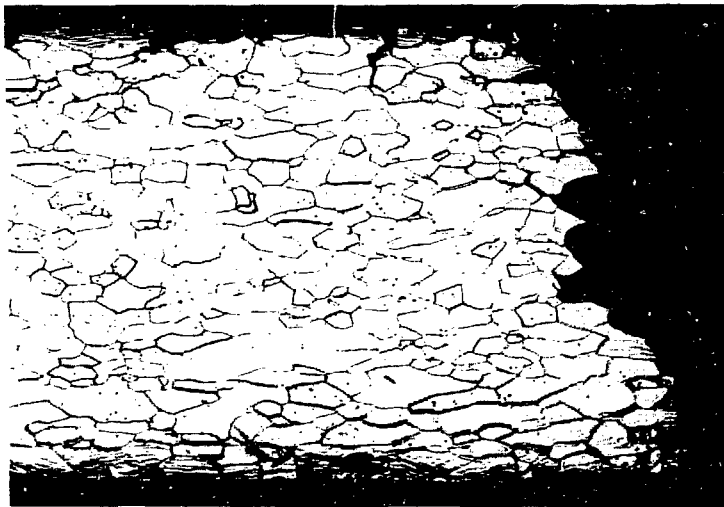
Examination of a transverse vent cup section revealed features similar to those observed in the shield cup. Several narrow cracks penetrated the capsule wall on one side of the main breach, and all of the cracks had a brittle, intergranular appearance. In this section however, even the main breach was coated with a thin layer of iridium/aluminum reaction product (Fig. 27).

Fig. 27. The vent cup portion of the main breach contained deposits of an iridium/aluminum reaction product. (a) As polished and (b) etched; 100X.
