**CORROSION OF NICKEL AND  
STAINLESS STEELS IN  
CONCENTRATED LITHIUM  
HYDROXIDE SOLUTIONS**

CFFTP G-9046  
June 1990

J.W. Graydon\* and D.W. Kirk\*

This is a preprint of a paper submitted to Corrosion.

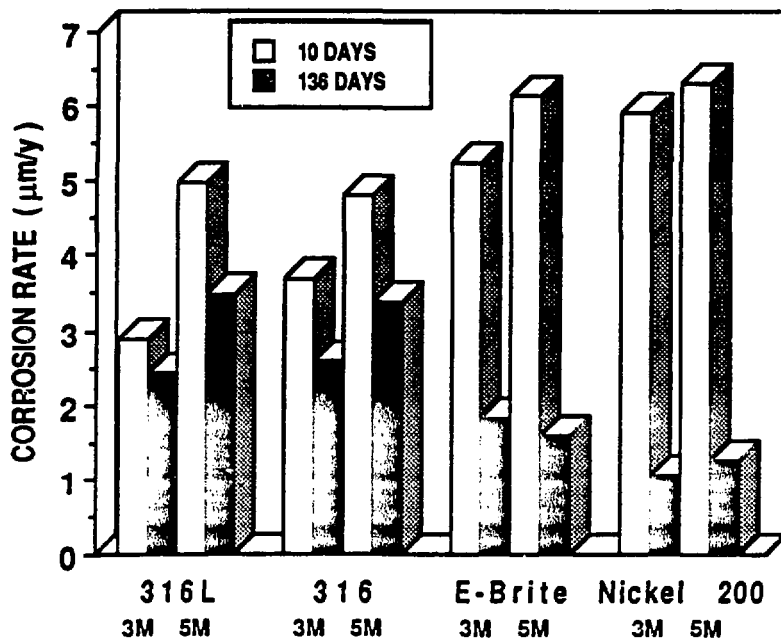
Figure 1. Corrosion rates of the four alloys in aqueous solutions of LiOH at 95°C under a hydrogen atmosphere. The effect of solution concentration (3 and 5 mol/L) and duration of corrosion (10 and 136 days) are shown.

The rates for each alloy in both 3 and 5 mol/L solutions were determined after 10 days of corrosion and after 136 days. The numerical results are included in Table 2 and are illustrated graphically in Figure 1. The salient feature of this corrosion data is that very low rates were found for all alloys. There is a decrease in corrosion rate with time, most notably for the E-Brite and Nickel 200. In seven of

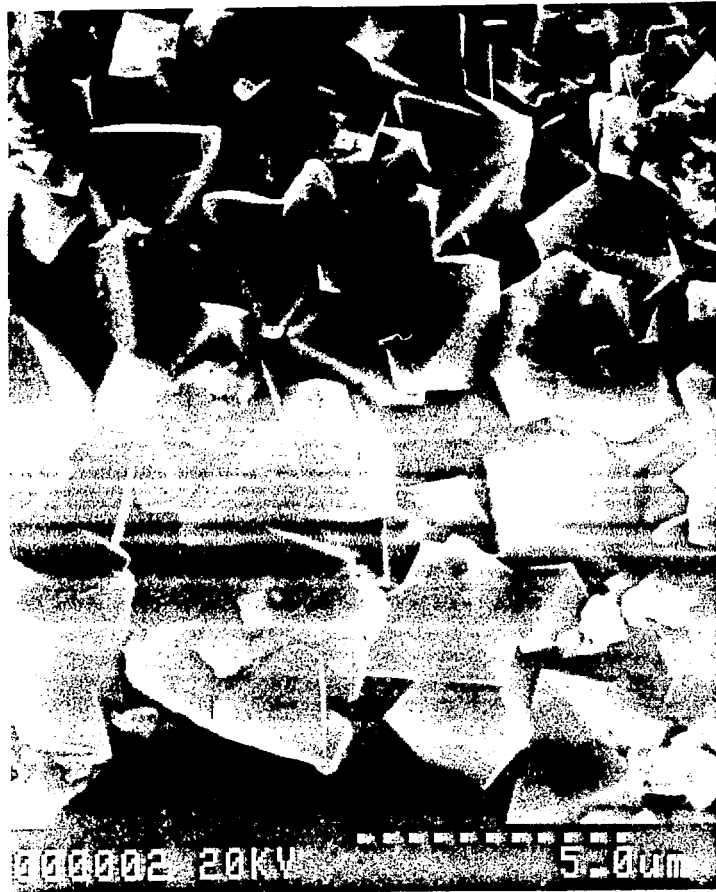
Figure 3. Scanning electron micrograph of optically opaque octahedral crystals of the spinel  $\text{LiFe}_5\text{O}_8$  on the surface of the same specimen as in Figure 2.

The surface was covered with a mixture of well-formed, opaque, octahedral crystals 2-3  $\mu\text{m}$  in size (Figure 3) and smaller, less well-formed, red-brown octahedral crystals. The latter were situated on top of the larger crystals (Figure 4) and their abundance was variable from specimen to specimen. In some areas both types of crystal formed a continuous layer, in other areas they covered only part of the surface, and in some places they had sloughed off either individually or *en masse* (e.g. Figure 2). Although strongly attached, some isolated crystals could be removed mechanically without breaking. A typical semi-quantitative analysis of a large, opaque crystal by x-ray spectrometer is listed in Table 5. Oxygen and lithium were not measured due to the low energy of their x-rays and low levels of manganese could not be detected since its x-ray peak was superimposed on the chromium  $K\beta$  peak. The analysis reveals an enrichment of Fe Ni and Si and a marked depletion of Cr compared to the composition of the underlying alloy.

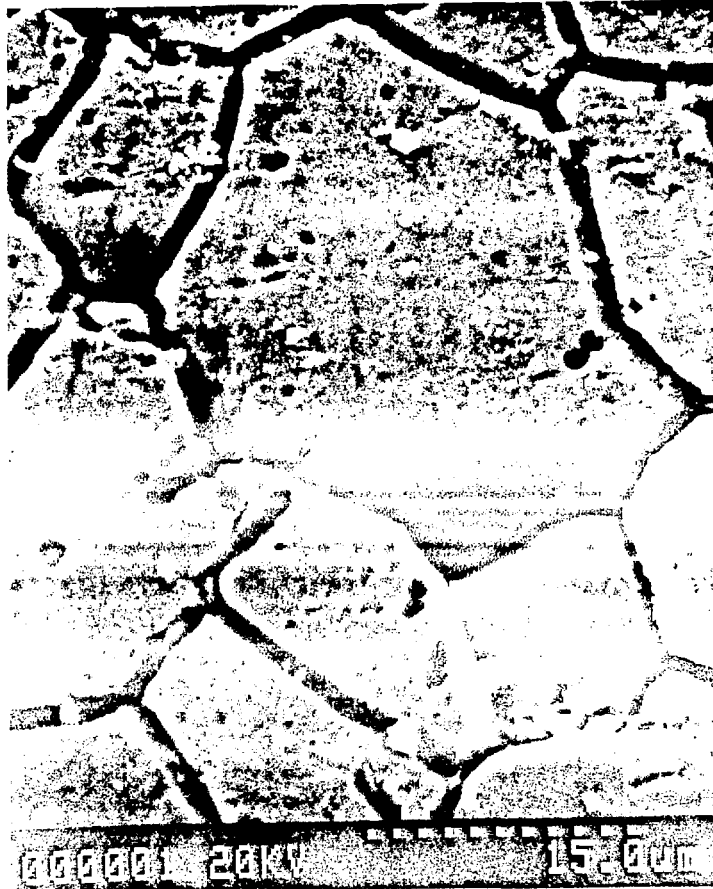
Figure 5. Surface of same specimen as in Figure 2 showing the character of the  $\text{Cr}_2\text{O}_3$  base layer, the uniform intergranular attack, and the depression where a grain has dropped out (lower right).

The base layer (Figure 5) was a featureless transparent coating displaying interference colors that indicated its thickness was about 170 nm. Although this layer did extend beneath the crystals, it was somewhat thinner there (80 nm). The

The corrosion crevices are entirely intergranular with a remarkably uniform width of 1.4  $\mu\text{m}$  at the surface and extend to a depth of about 4  $\mu\text{m}$ , gradually tapering inward (Figures 2, 5). This corrosion was enough to undermine a few of the smaller metal grains which then dropped out. No other type of selective corrosion such as pitting is evident.

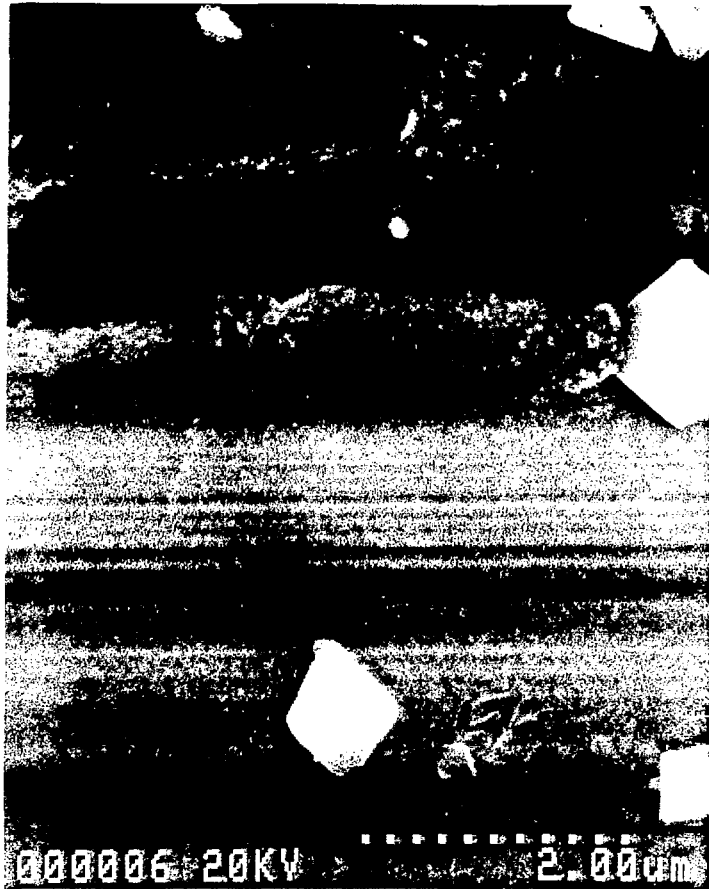
Figure 6. Detail of the surface of 316L in 5 mol/L showing a thin film of the base layer bridging the intergranular crevice at upper right. Also visible are the "scars" in this base layer where the octahedral crystals have sloughed off (upper left).

uppermost part of this layer bridges the intergranular crevices in places where it has not yet been fragmented (Figure 6). Although too thin for quantitative microanalysis, an x-ray map (Figure 7) shows that this layer is composed mainly of chromium. Since the layer is thin, there are a number of x-rays originating from the underlying metal and thus iron and nickel also show. The fact that the crevice is manifest in the iron and nickel maps by fewer spots while the chromium shows no similar decrease indicates that the chromium base layer extends down into the crevice, lining the side walls.

Both austenitic steels had identical corrosion rates and products. The corrosion resistance is provided by the thin, continuous, chromium-rich layer that is almost certainly  $\text{Cr}_2\text{O}_3$ . The complete absence of any lines from this phase in the diffraction pattern indicates a very small crystal size (likely < 10 nm) which is characteristic of oxide films formed directly by oxidation *in situ* rather than deposited from solution. The corrosion film at ten days formed a continuous coating on the metal and, even at 136 days, there are remnants of this initial layer bridging the

crevices (Figure 6). However, some time after 10 days of corrosion, the coating loses its protective ability at the grain boundaries leading to the formation of uniform intergranular crevices.
