FRIJOLITO WATERSHED: INTEGRATED INVESTIGATIONS OF A RAPIDLY ERODING PINYON-JUNIPER HILLSLOPE

Bradford P. Wilcox, EES-15
John Pitlick, University of Colorado
Craig D. Allen, Bandelier National Monument

Semiarid Hydrology Conference
Tucson, AZ
November 1-3, 1994

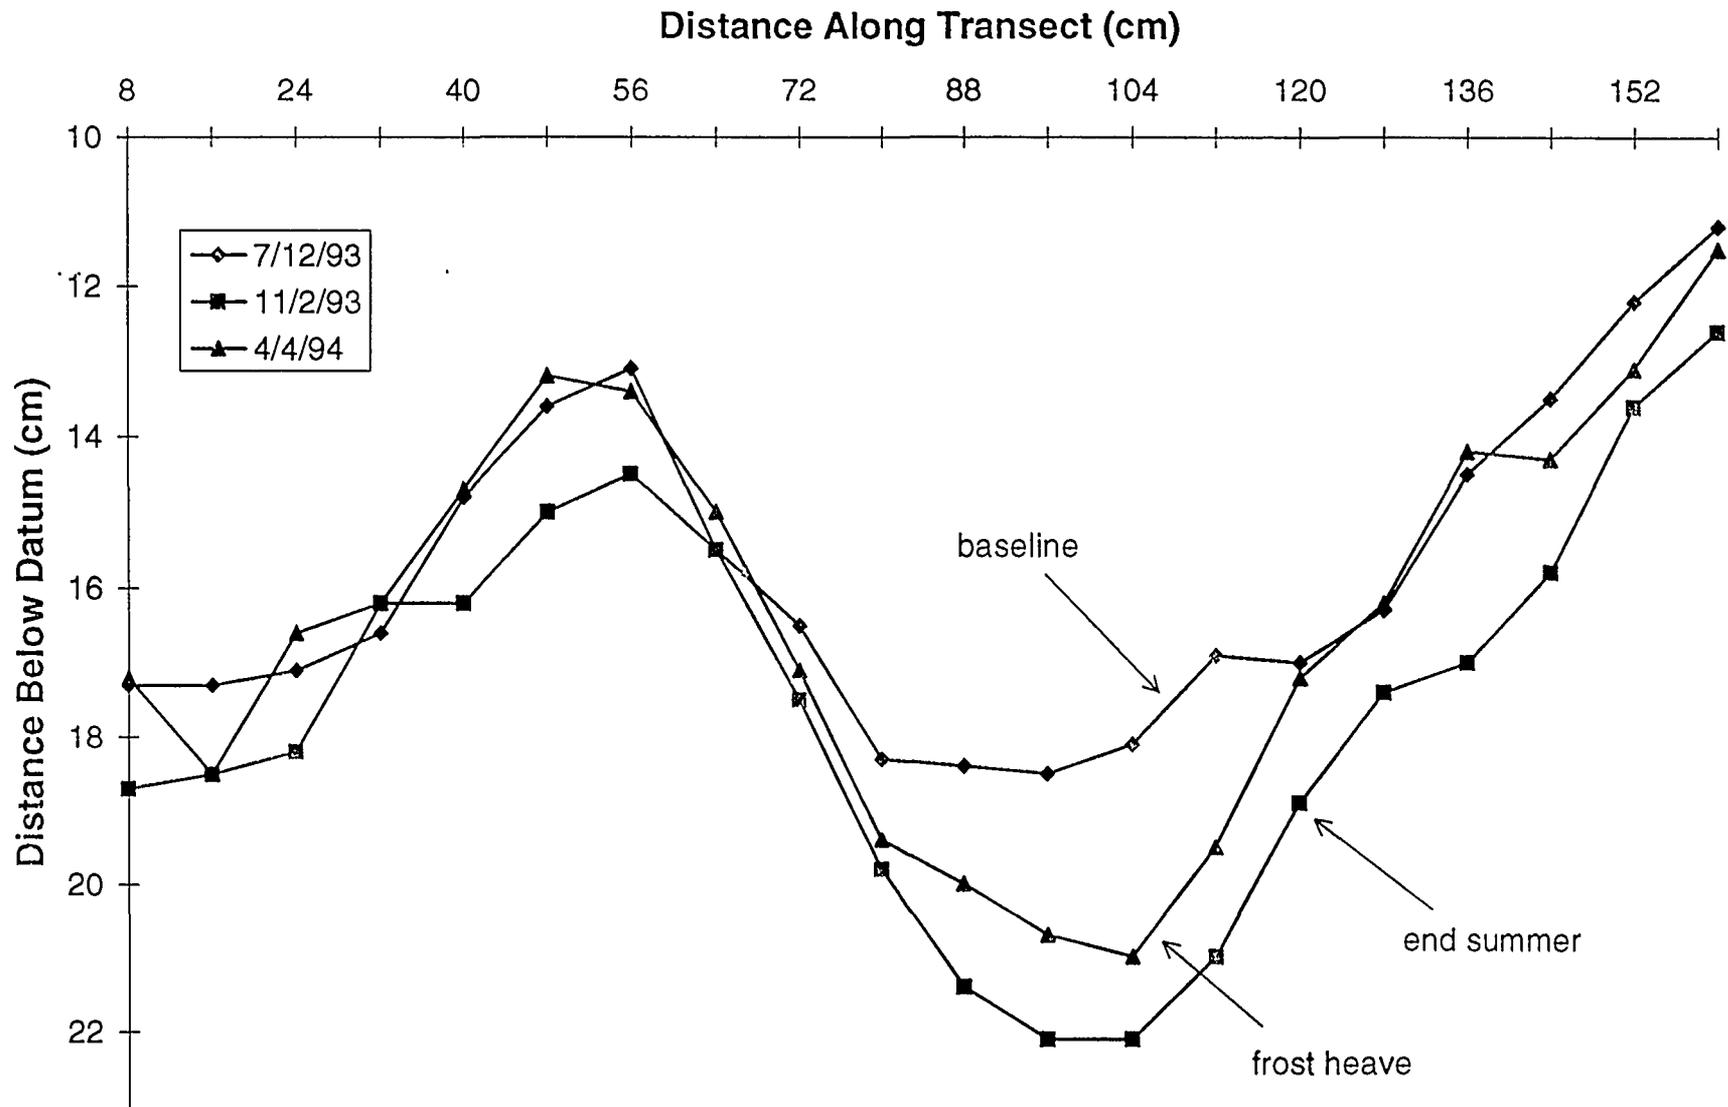
Figure 1. Microtopography measurements from one location on the catchment.

Microtopography-measurement sites: The microtopographic measurements show that in the summer of 1993, surface elevations changed substantially as a result of erosion and of frost heaving over the winter (Figure 1). Most of the soil erosion (or deposition) occurred in localized zones, which show changes in elevation of up to several centimeters. The average change in elevation at the 20 measurement sites that summer was -3.4 mm. Assuming this rate for the half of the catchment that is intercanopy space, we arrive at an average depth of erosion of 1.7 mm; this translates into 17 m^3 (or 25,500 kg). This is about

Microtopography measurements highlight the impact of frost heaving on surface elevation (Figure 1). During the one winter of observation, the surface rose an average of 7.8 mm. Measurements, made between the spring thaw and runoff-producing storms in the summer, indicate that the surface re-compacted about 5 mm as a result of raindrop impact. From the end of June until the beginning of September the surface deflated another 1.4 mm. This leads to the obvious question of how much surface deflation (during the time that runoff occurs) is due to recompaction by raindrops and how much is due to soil erosion. At this point our analyses are not complete enough and perhaps our measurements are not fine enough to answer that question. We cannot rule out the possibility that some of surface deflation measured in 1993 may have resulted from surface compaction by raindrops.
