The Inspection of a Radiologically Contaminated Pipeline Using a Teleoperated Pipe Crawler

A document prepared for INTERNATIONAL JOURNAL OF ROBOTICS AND AUTOMATION

THE INSPECTION OF A RADIOLOGICALLY CONTAMINATED PIPELINE USING A TELEOPERATED PIPE CRAWLER

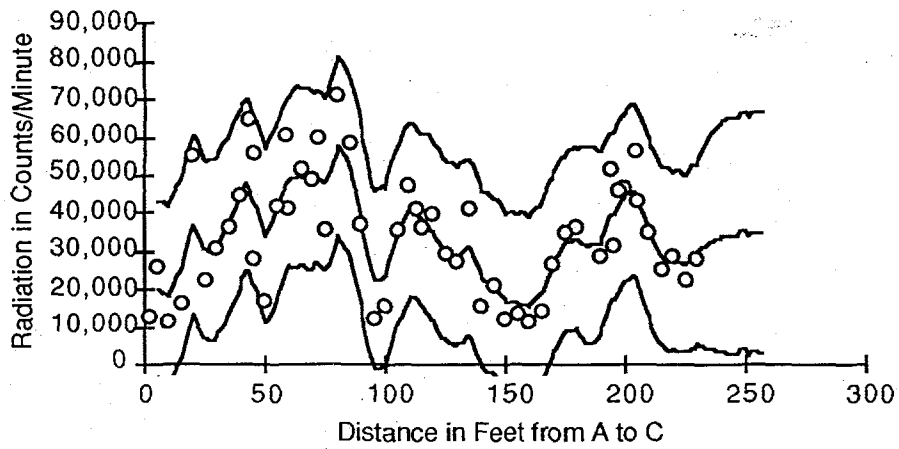
Figure 7. Radiation data, point A to point C

The data from diversion box A to manhole C contains 54 measurements. The measurements were taken from point A to point C and in the direction of effluent flow. The plot of the kriged values is shown below in Figure 7.

The crawler's side detector registered a mean radioactivity of 34,600 cpm which is much higher than any other mean value from the other sections of pipeline. The highest locally averaged radioactivity is 55,000 cpm at approximately 23.4 m (80 ft) into the pipeline. At this point, the upper confidence limit is 80,000 cpm. The

bottom detector shows a maximum locally averaged radioactivity of 6000 cpm at approximately 9.1 m (30 ft) from point A. The maximum upper confidence limit is approximately 9400 cpm. The bottom radiation levels were greatest between 6 m (20 ft) and 18.3 m (60 ft) from point A and decreased as the level of sediment accumulated in the pipeline.

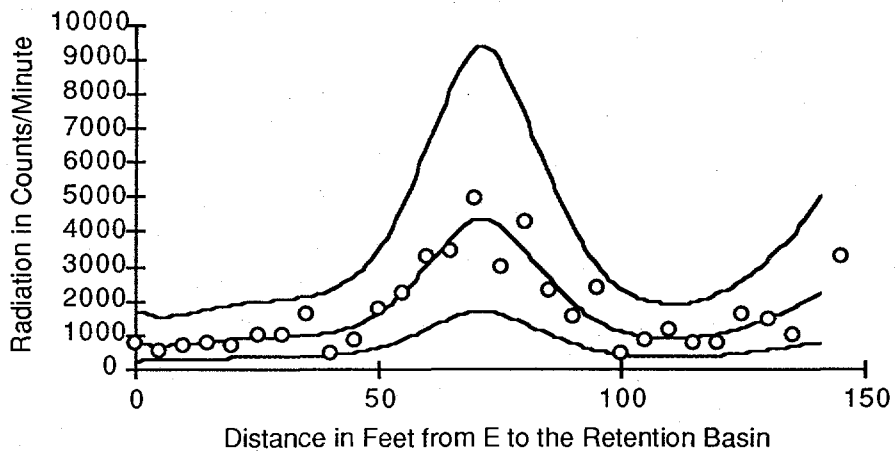
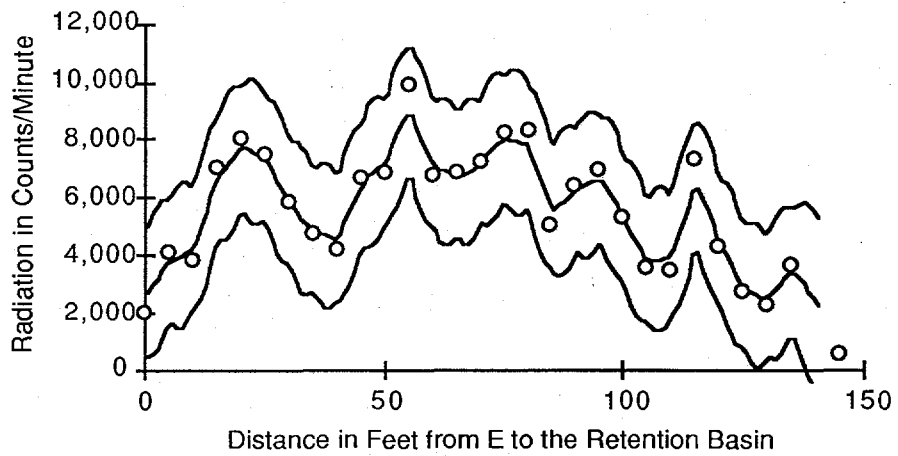
Figure 8. Radiation data, point E to the basin

The data from valve box E to the retention basin contains 29 measurements. The measurements were taken from point E to the retention basin and in the direction of effluent flow. The graph of the side detector shows a locally averaged peak radiation reading of 4400 cpm around 21 m (70 ft) from point E and decreases in both directions from this location. The upper confidence limit for the side detector is 9400 cpm. The graph of the bottom detector contains a number of peaks and valleys. The radiation level is lowest near the ends of the pipeline. A maximum locally averaged radioactivity reading of 8900 cpm occurs 16.7 m (55 ft) past point E in the direction of the retention basin. The upper confidence limit for the bottom detector is 11,000 cpm. No outlier values were found for this set of data points. The plot of the kriged values is shown below in Figure 8.

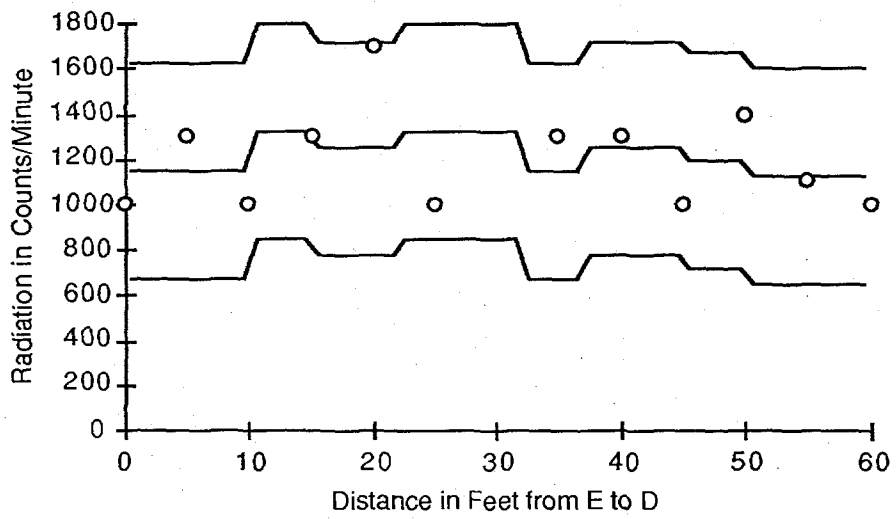
Figure 9. Radiation data, point E to point D

The data from point E to point D consists of 12 measurements. The measurements were taken from point E to point D and in the direction opposite to effluent flow. The entire section of pipeline from point E to point D could not be investigated due to the lack of a wall crawling surface in manhole C and the inability to use valve box D as an entry point. Only the side detector measurements were obtained. The small number of data points does not lend itself well to establishing any spatial relationships between the measurements. About all that can be said about these measurements is that they exhibit a lower radiation level as compared with the data measurements in

other sections of pipeline. The plot of the kriged values is shown below in Figure 9.

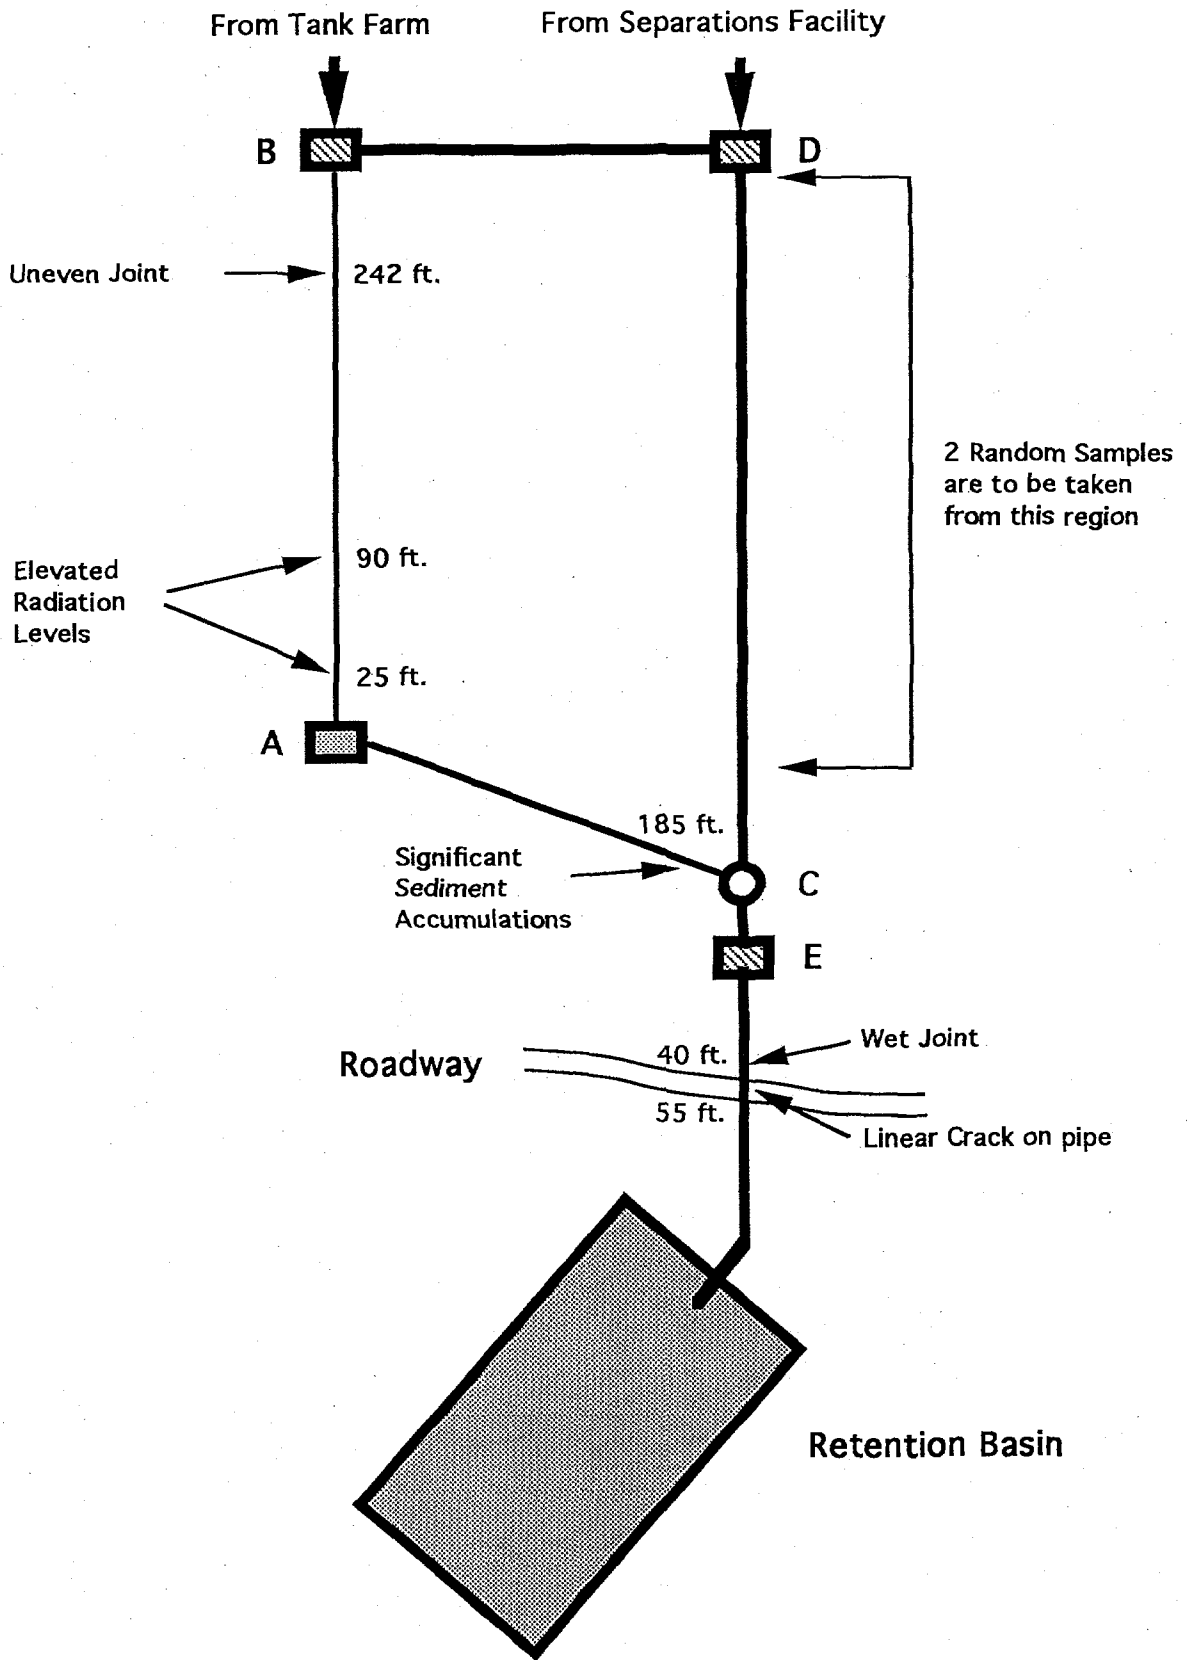
Figure 10. Soil sample locations

A pipe crawler system was deployed and functioned very well. The visual inspection revealed that the pipeline was generally in good condition. However, the crawler did find a few cracks, some possible joint failures, and some large sediment accumulations. Radiological data was also obtained. A statistical analysis of the radiation data was performed and it revealed several areas along the pipeline that exhibited elevated radiation levels. A diagram of the retention basin and the abandoned pipeline system is shown in Figure 10. The diagram shows the areas where soil samples will be taken to determine if contamination migrated out of the pipeline and into the surrounding soil.

The internal pipeline inspection provided quantitative data from which an informed, reasonable decision could be made about the number of soil samples required for further characterization of the abandoned pipeline system. The pipe crawler investigation reduced the number of soil samples from 300 to 8.
