WAPD-T-3055

Stress Corrosion Cracking Behavior of Alloy 600 in High Temperature Water

G. L. Webb and M. G. Burke

To be Presented at Seventh International Symposium on Environmental
Degradation of Materials in Nuclear Power Systems - Water Reactors
Breckenridge, CO, August 6-10, 1995

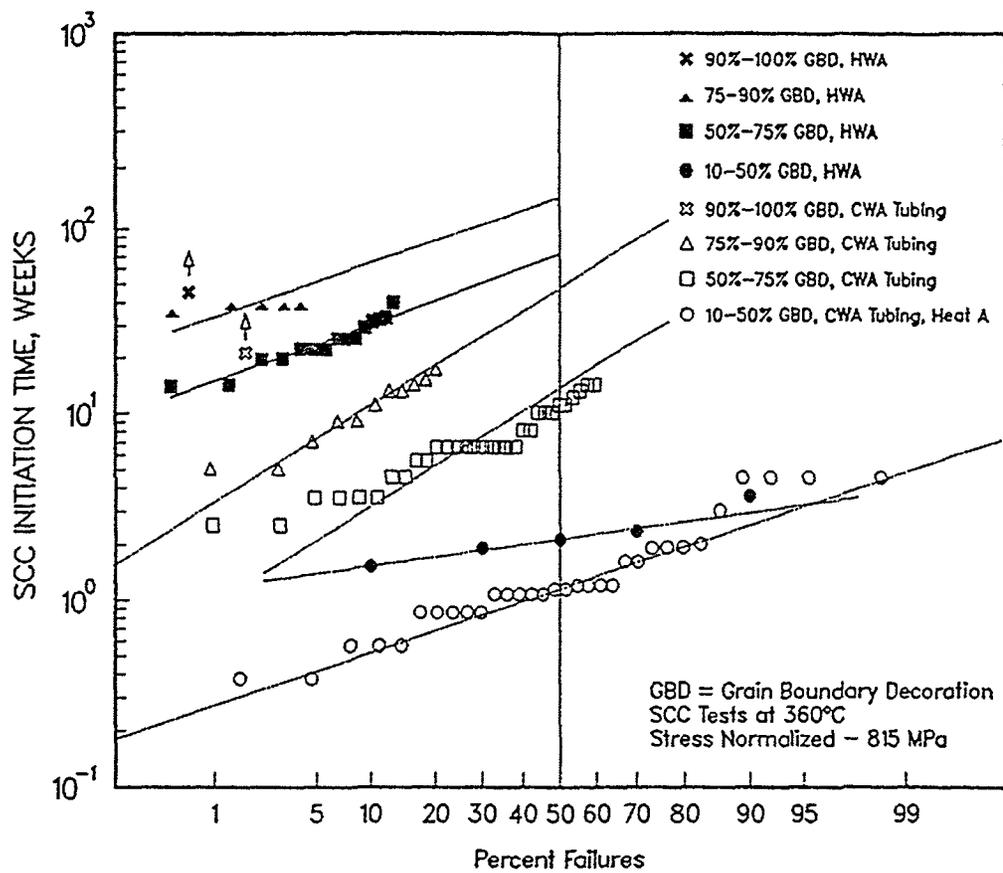
Figure 1: Cumulative Distribution Function failure plot of Alloy 600 SCC data, corrected for stress

The SCC test data, normalized to a common applied stress, are shown in Figure 1. All the SCC test data were normalized to a common test stress of 815 MPa, which is the stress determined for the STUB specimens taken from tubing from Heat A⁵. Estimates of the as-tested stresses on the various groups of specimens (i.e., ring forgings, tubing) were made based on the yield strength of the material and the measured specimen strain. A yield strength of 204 MPa, which is consistent with the yield strength values measured for these materials, was used for determining stresses in all materials that were annealed at $> 1010^{\circ}\text{C}$. These estimated stresses are about 580 MPa for ring forging DUB specimens and 680 MPa for STUB specimens. The failure times were adjusted by using the previously determined stress exponent for SCC initiation of -5.7. For example, the failure times for ring forging DUB specimens were reduced by a factor of $(815/580)^{5.7} \approx 7$. No failures were observed in tubing with 90-100% grain boundary decoration, although tests were discontinued after a short time (42 weeks), or in ring forging

material with > 90% grain boundary decoration after 300 weeks. These data are indicated by arrows in the figure. All of the failures in HWA material, regardless of the degree of grain boundary decoration, occurred in the material that was final annealed at between 1010° and 1040°C.

The results plotted in Figure 1 show that there is a difference in SCC susceptibility between CWA and HWA materials, even after normalizing for the differences in stresses between the materials and specimen types. For a given microstructure and stress, HWA materials are more resistant to SCC initiation than CWA materials.

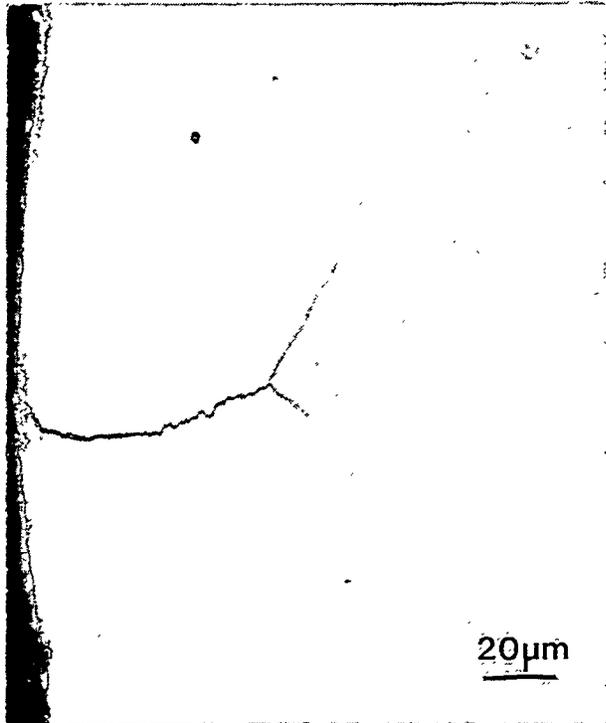
Figure 2(a): Microcrack in as-polished SCC specimen

Destructive examinations (DE) were undertaken on some of the DUB specimens from ring forgings to determine if small cracks were occurring that were not visible during the normal visual examinations. Based on extensive previous experience with testing of STUB specimens of tubing, no small cracks were anticipated. Specimens were selected at random from those remaining in test at the completion of 255, 273, and 296 weeks. The specimens were sectioned longitudinally and mounted so that both an edge and centerline could be examined in the as-polished condition at a magnification of 200X or greater. When many small cracks of a uniform size were found, especially in the high temperature processed ring forging materials, they were called microcracks to differentiate them from the large cracks detectable by 30X visual examination. A typical microcrack is shown in Figure 2.

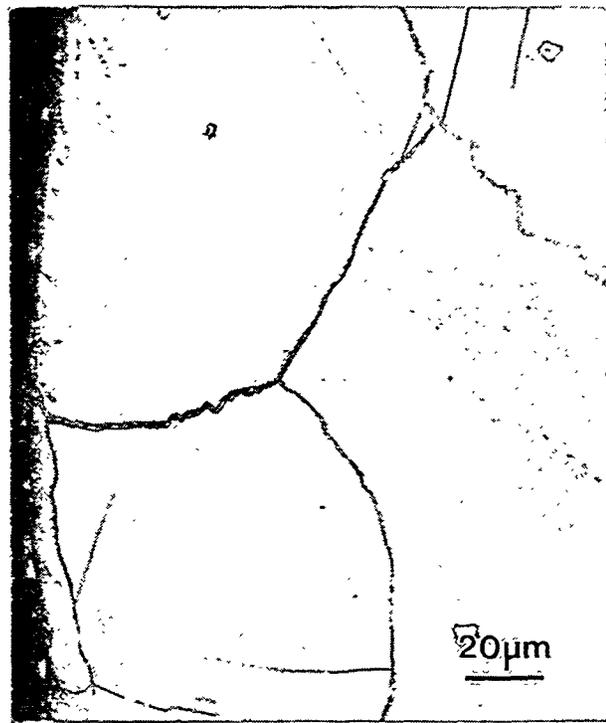
Figure 2(b): Microcrack in Orthophosphoric acid etched SCC specimen

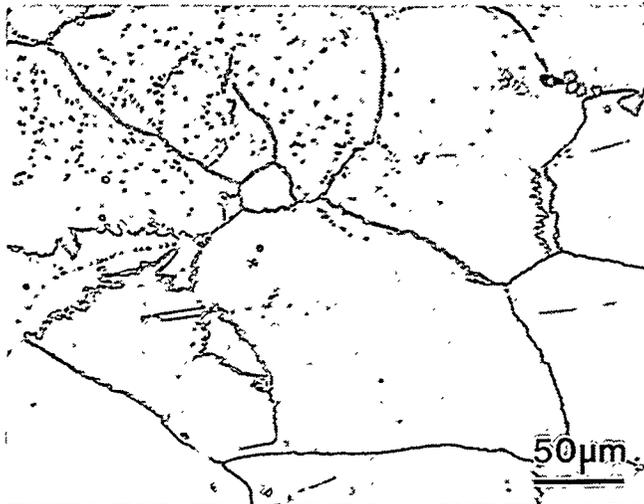
Figure 3(a): Heat B in High Temperature Processed Condition - Orthophosphoric Acid Etch

The grain size of the high-temperature processed forging material sample, final-annealed at 1060°C for 2h, was approximately 200 μm, as compared to the ≈ 100 μm grain size of the low-temperature processed forging Heat B sample that was final-annealed for 1h at 1024°C. The low-temperature processed forging material from Heat C, which received a final anneal at 1050°C for 2h, also had an average grain size of ≈ 100 μm. The yield strengths for these three material conditions, although not strictly related to the grain size and microstructure, were significantly different and are listed in Table 1. The general microstructure of these materials is presented in Figure 3.

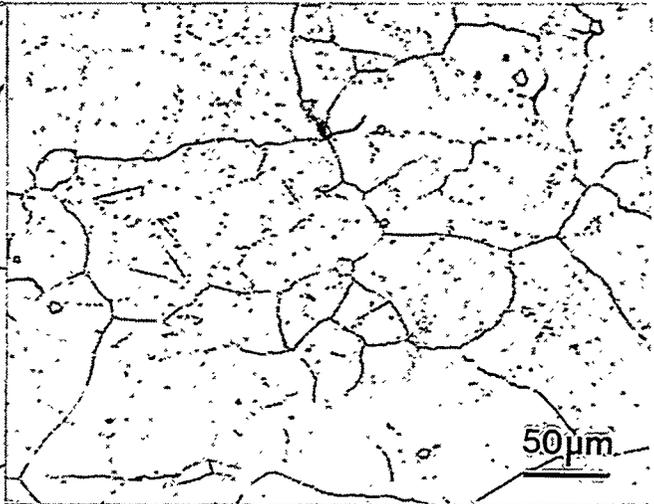
Figure 3 (b): Heat B in Conventional Processed Condition - Orthophosphoric Acid Etch

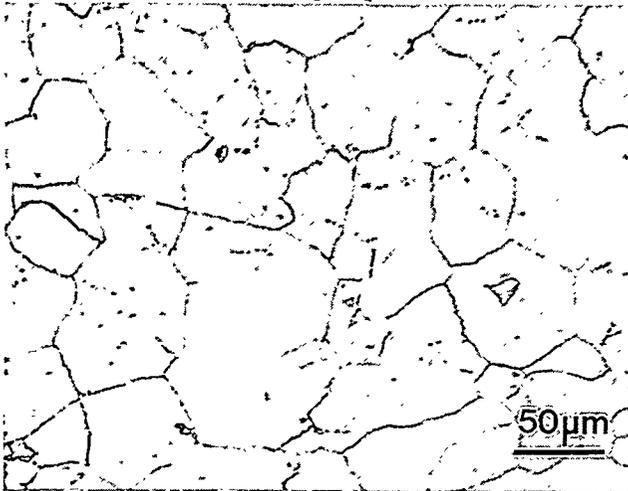
Figure 3(c): Heat C in Conventional Processed Condition - Orthophosphoric Acid Etch

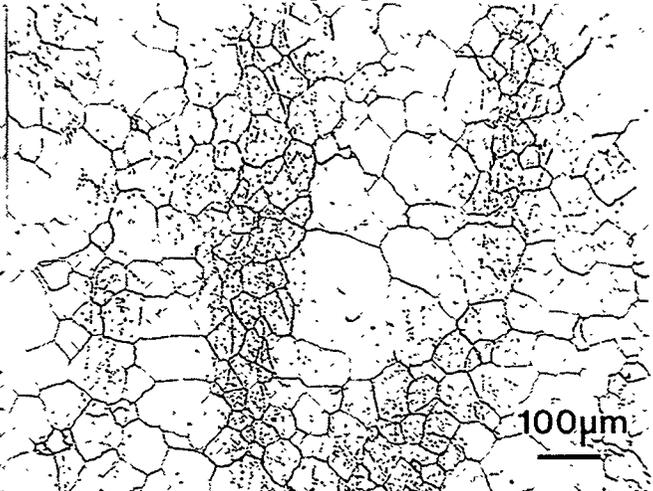
Figure 4: Example of banding in a ring rolled forging.

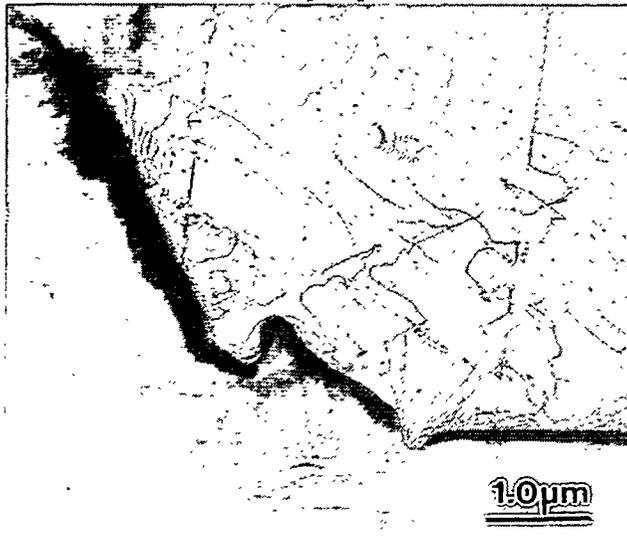
Figure 5: Transmission electron micrograph of the predominant M_7C_3 carbides observed in the forged material final-annealed at 1060°C for 2h.

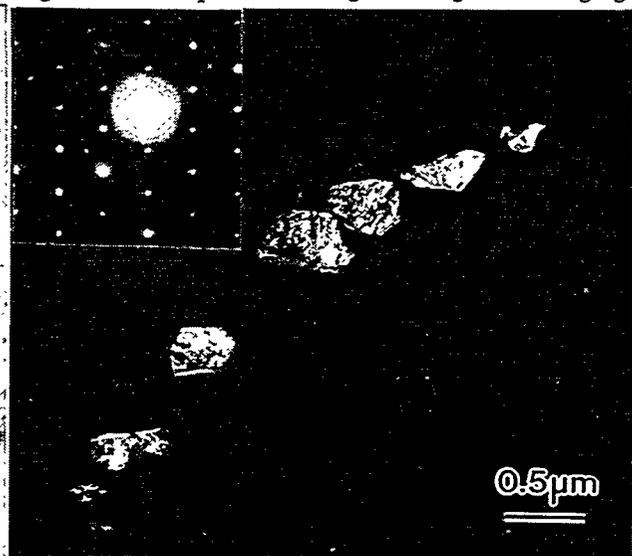
Figure 6: Dark-field transmission electron micrograph and associated selected area diffraction pattern of fine $M_{23}C_6$ carbides observed at some grain boundaries in material final-annealed at 1060°C .

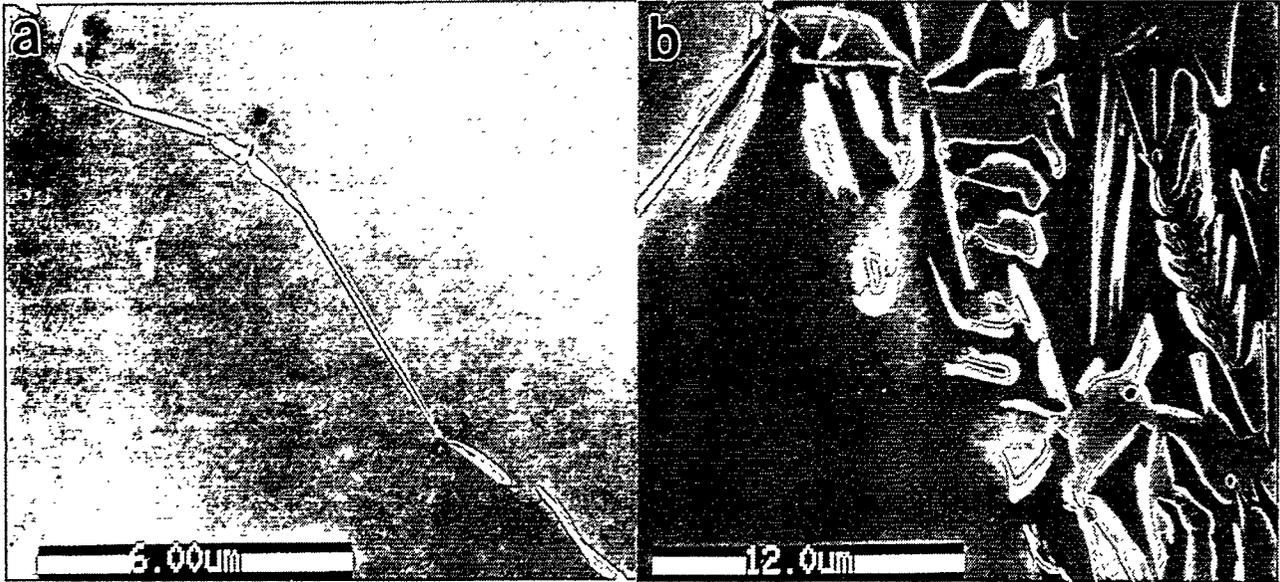
Figure 7: Secondary electron images of the high-temperature processed forging material (final anneal at 1060°C) showing the (a) "semi-continuous" and (b) dendritic-type morphologies of the M_7C_3 carbides observed.

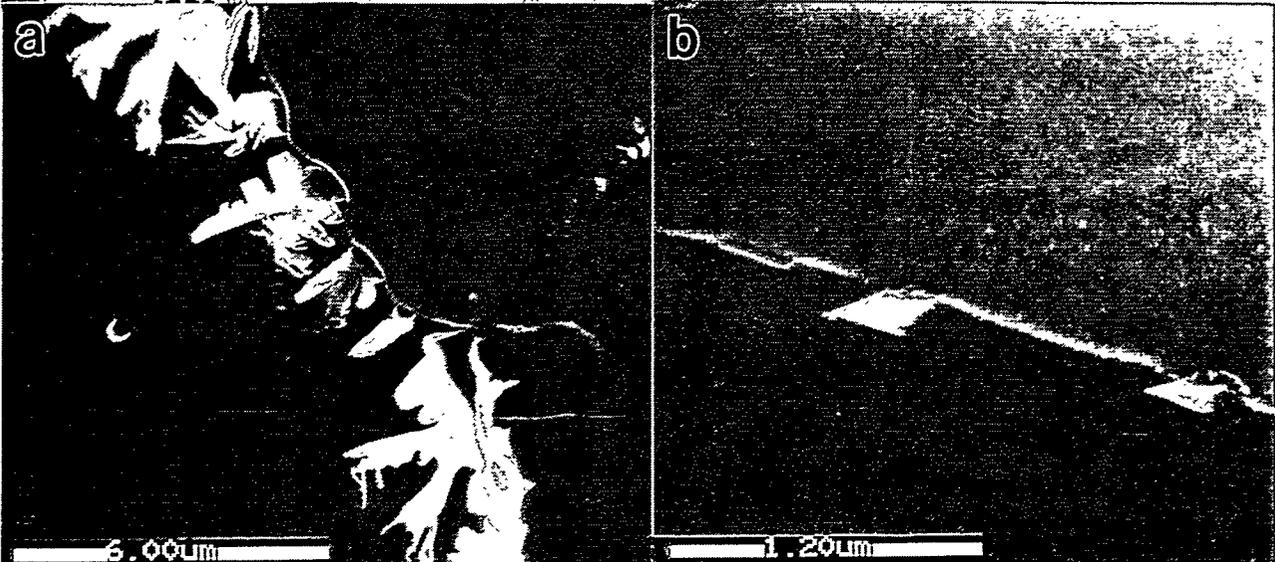
Figure 9: Secondary electron micrographs showing the presence of both (a) coarse, dendritic M_7C_3 carbides and (b) fine discrete $M_{23}C_6$ carbides in specimens final-annealed at 1024°C for 1h.

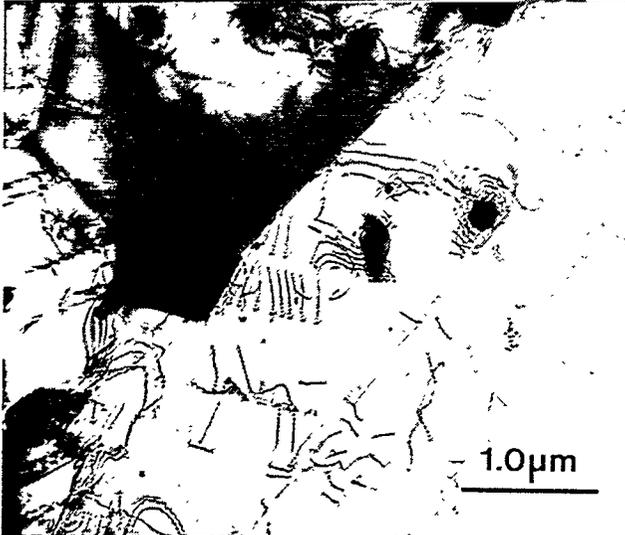
Figure 11: Transmission electron micrographs showing the two intragranular M_7C_3 carbide morphologies (globular and faceted) observed in the samples final-annealed at 1024°C for 1h.

This material was also characterized by extensive intragranular M_7C_3 precipitation. Two carbide morphologies were observed for the intragranular precipitates: globular and faceted, Figure 11. Examination of the faceted carbides indicates that there are multiple habit planes with the matrix, and the crystallographic morphology suggests that this carbide formed upon cooling from the final anneal temperature. The globular M_7C_3 precipitates appear to have formed during prior thermo-mechanical processing, and were not fully dissolved during the final anneal. Both intergranular and intragranular carbide morphologies are shown in the SEM micrographs of Figure 12.

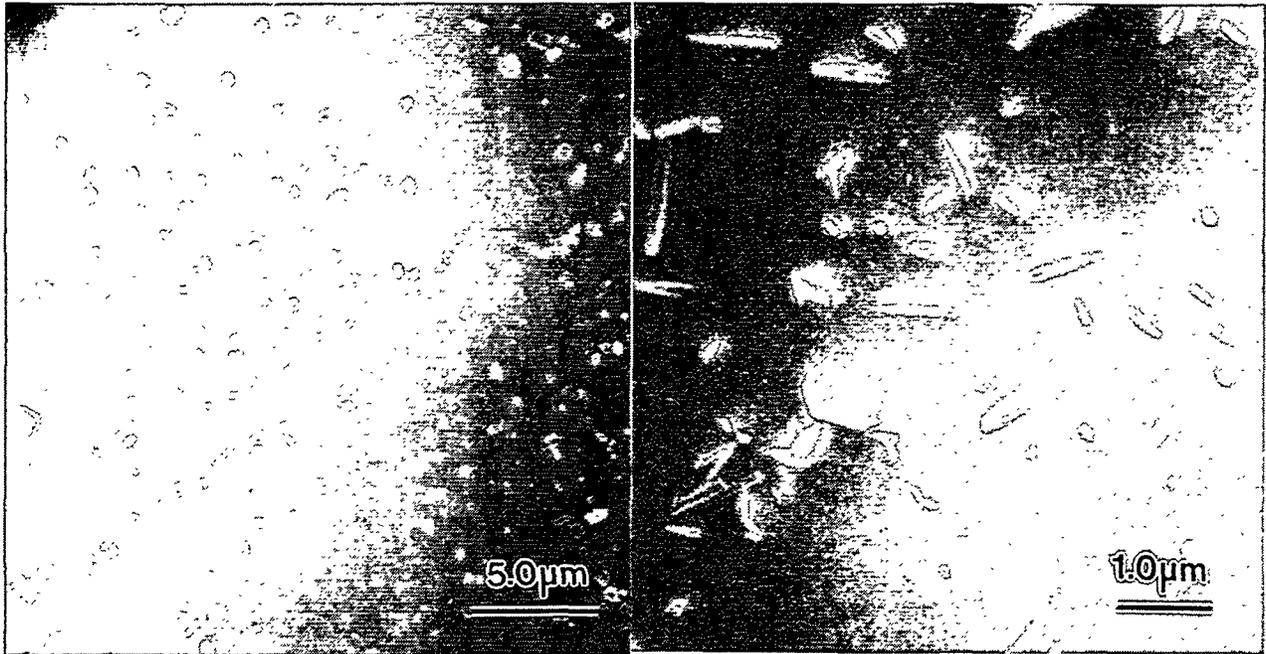
Figure 12: SEM images obtained from material final-annealed at 1024°C for 1h. Note the high proportion of intragranular M_7C_3 carbides.

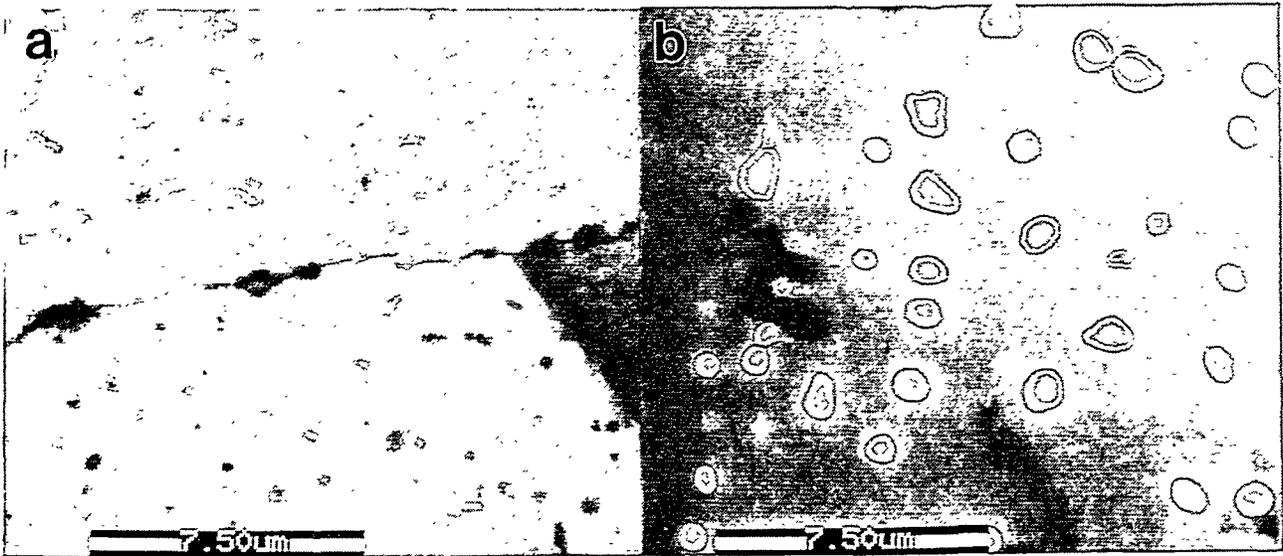
Figure 13: (a) STEM and (b) SEM images showing the extent of intergranular and intragranular carbide precipitation in conventionally-processed A600 forging with a final anneal at 1050°C for 2h.
