# Selection of Replacement Material for the Failed Surface Level Gauge Wire in Hanford Waste Tanks

R. P. Anantatmula  
Westinghouse Hanford Company

Date Published  
October 1995

## SELECTION OF ENRAF GAUGE WIRE MATERIAL COMPATIBLE WITH THE HANFORD WASTE TANK ENVIRONMENT

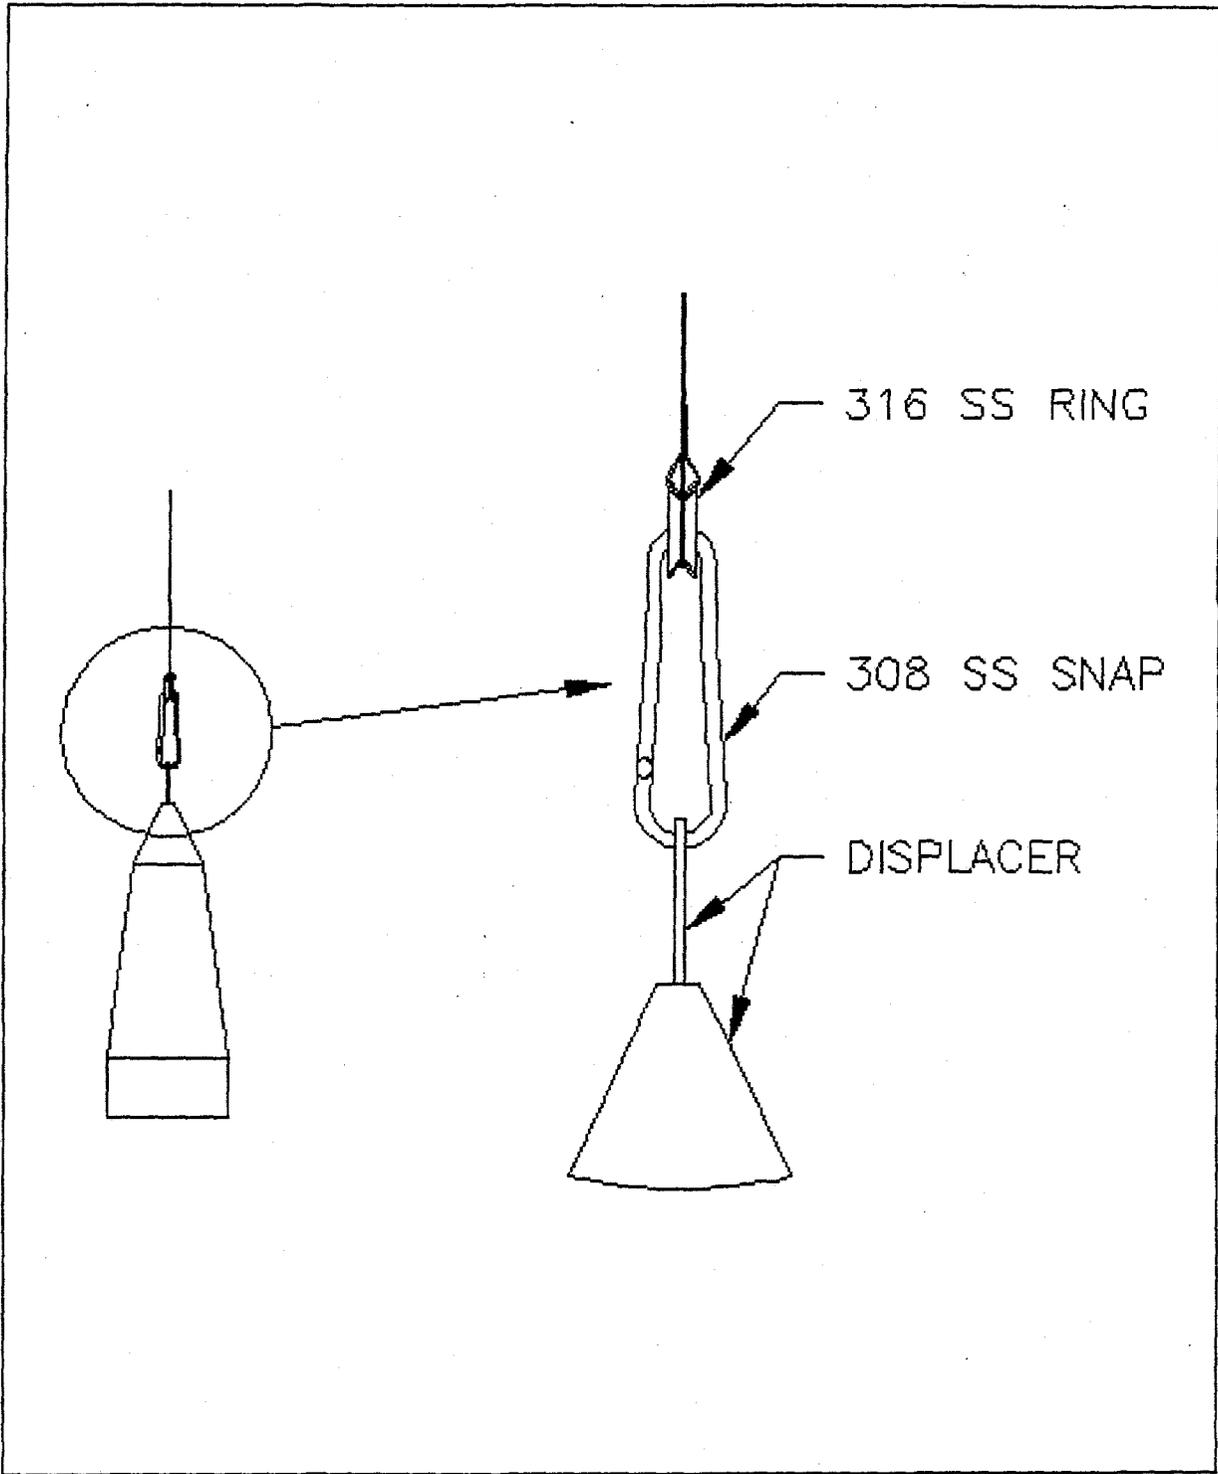
FIGURE 1 - ENRAF gauge 316 ring and displacer assembly

Galvanic corrosion is also possible if droplets of waste vapor condense on the noble metal alloy wire and drip down to the groove of the 316 ring (See Figure 1). The bottom end of the wire is wrapped onto this groove in order to eliminate kinking of the wire when the displacer touches the waste surface. Since the waste vapors condensing on the wire in the vapor space are quite benign, we may assume the corrosion behavior to be similar to the corrosion experienced in the atmosphere, viz., <1 mpy for the 316 coupled to the noble metal alloy. Non-destructive inspection of the 304L components indicated the corrosion to be negligible and the wall thicknesses of the components were still within allowable specifications. The failure of the ring may still occur in a relatively short period of time from a chloride-assisted corrosion mechanism. Thus, once again, the ENRAF gauge assembly should be periodically examined to monitor the degradation of the 316 ring. It should be pointed out, however, that the design of the gauge assembly (See Figure 1) is such that it will preclude dropping of the polyethylene displacer onto the tank waste in case of ring failure.

The choice of noble metal alloy wire creates a galvanic couple between the 316 material components of the ENRAF gauge and the wire. The 316 components are the ring that is attached to the bottom end of the noble metal alloy wire (resides in the tank above the waste surface) and the drum on which the excess wire is spooled (situated outside the tank on the ground above).
