Imaging Data Analyses for Hazardous Waste Applications

Final Report

December 1995

By
Environmental Research Institute of Michigan
Ann Arbor, Michigan

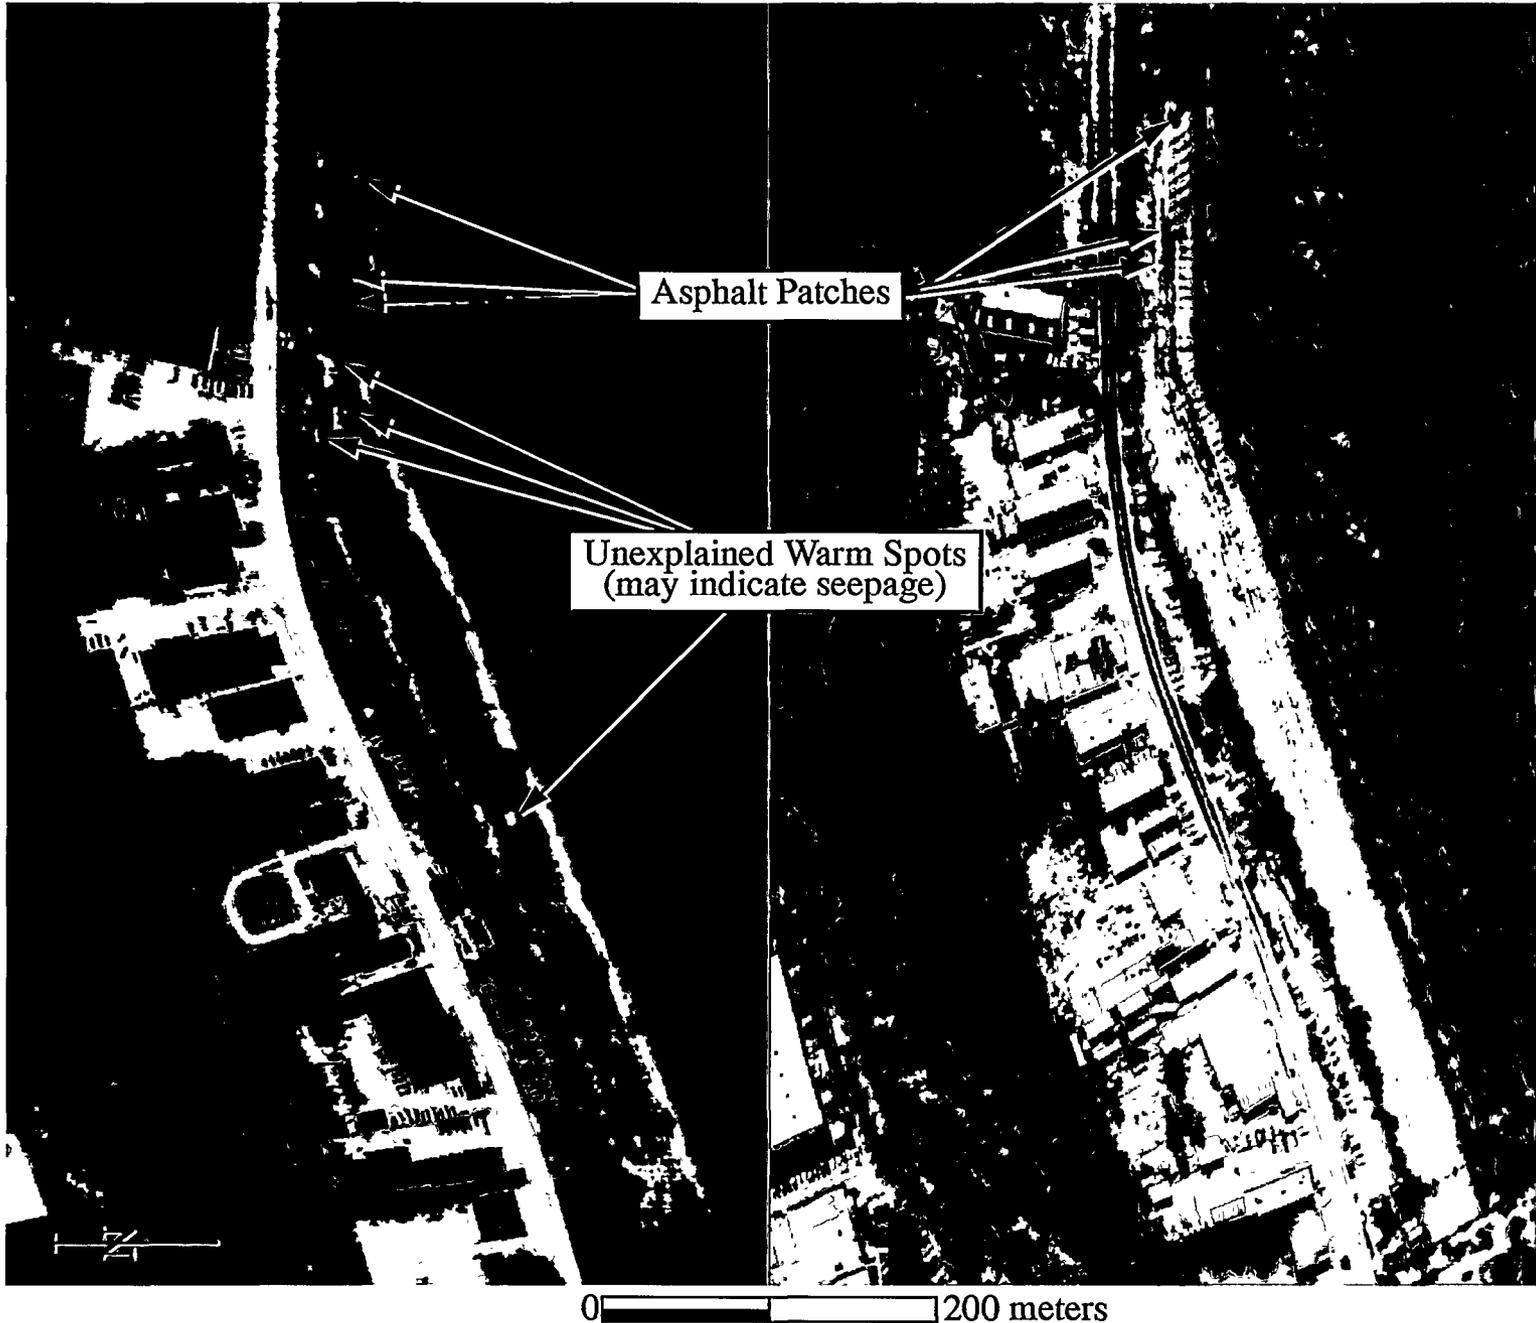
Figure 6

INFERENCE The top three arrows point to warm spots that are easily explained by different patch material added to the asphalt. The other arrows point to anomalies for which nothing unusual is present on the ground. RSL overflowed this cap several times over a period of days in 1994 and the anomalies were consistently seen. Thus, it is suspected that these are areas where water has leaked through cracks in the cap. The patches are visible in the Natural Color Composite and the thermal image, but there is nothing visible in the Natural Color Composite image to explain the "anomalous warm spots".

Nighttime Thermal & Daytime Images of Asphalt Closure Cap (Mason Site, TA-21)

REMOTE SENSING CONCEPT Warm thermal anomalies appear light or bright on the image. Warm areas could be caused by a variety of things such as water or other material seeping through cracks in the asphalt, by having different surface material such as patching, or from other causes below the surface. Again, taking a thermal image of this area is much less expensive than taking numerous ground temperature samples. In a Natural Color Composite image, patching from different material would show but differences only in temperature would not.

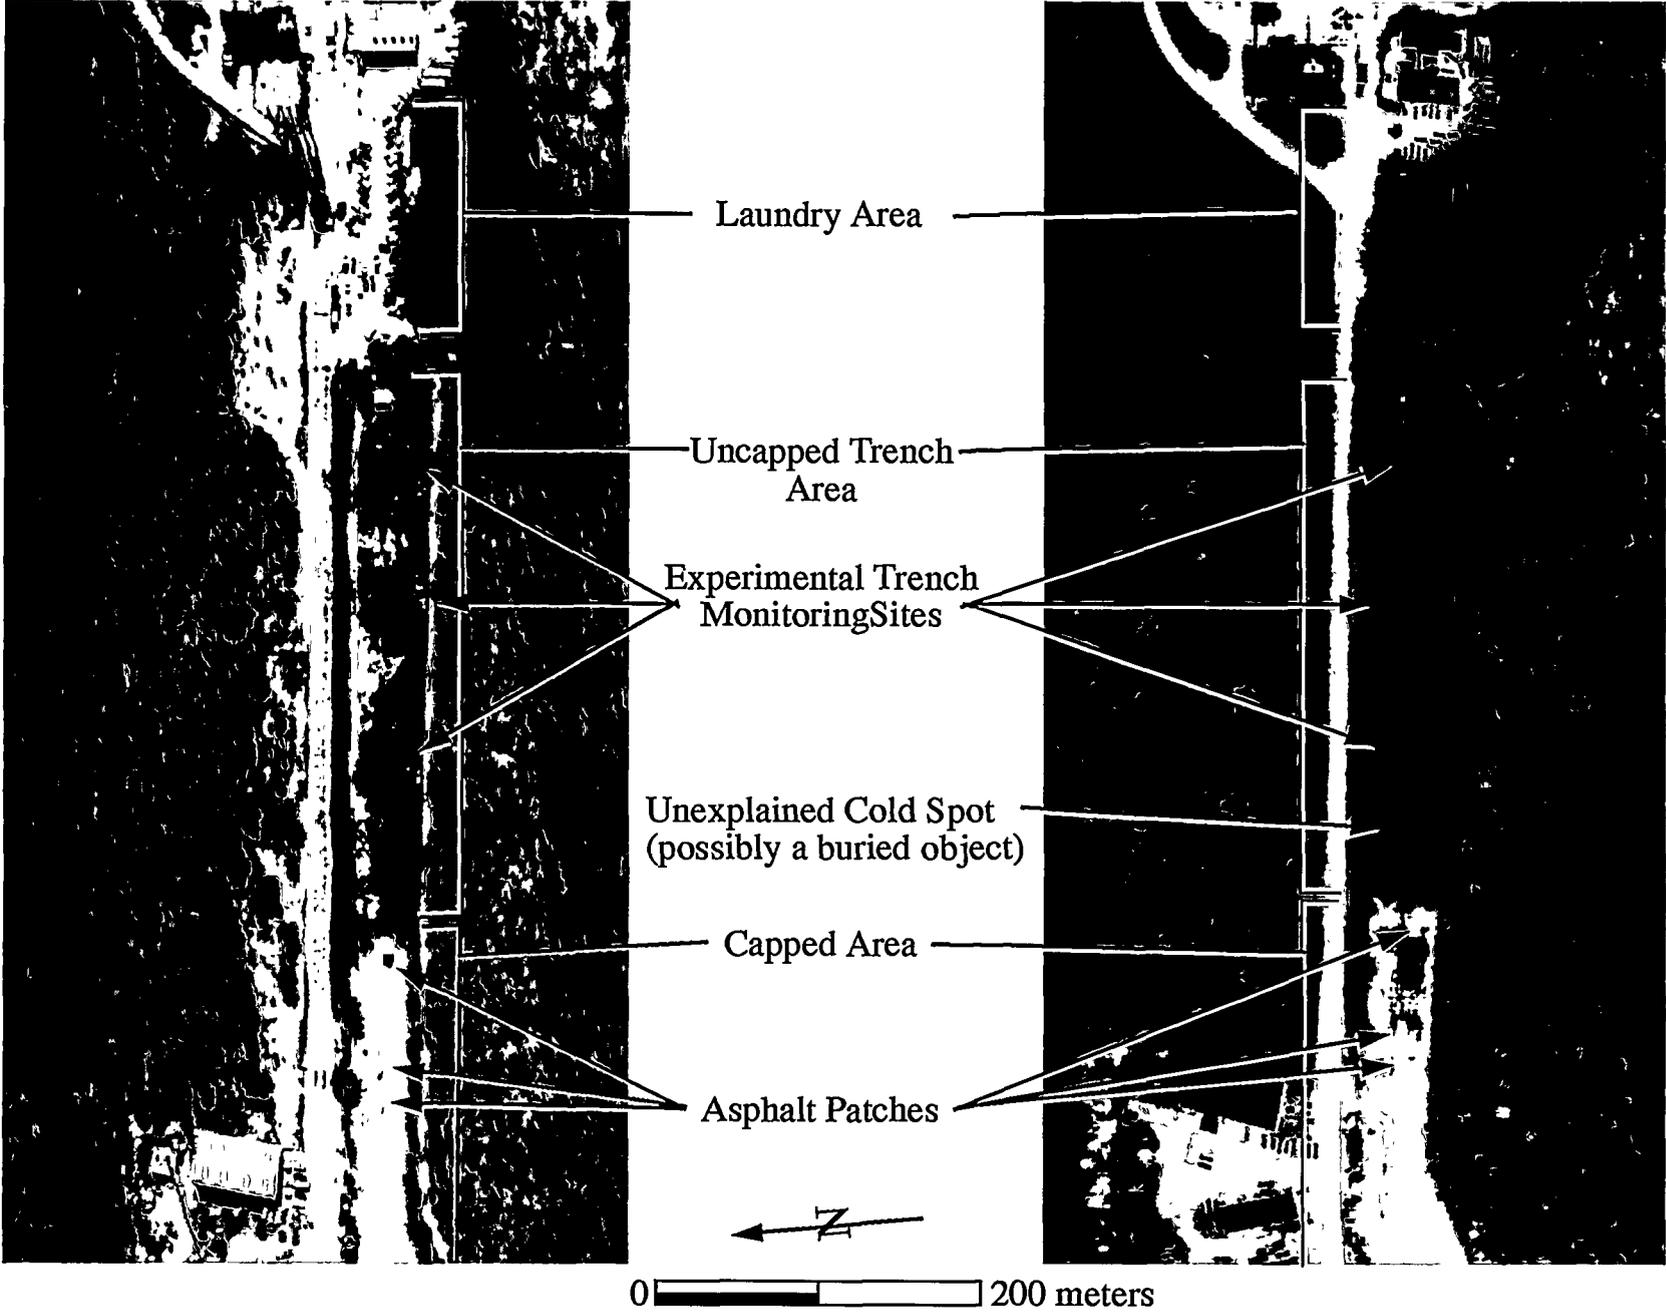
Figure 7

INFERENCE No anomalies are seen near the old laundry or in the uncapped area. One unexplained cold spot was found in a clearing. This could indicate the location of a buried object of some sort. The mechanism behind this signature would be the same as for the Rofer Site, TA-6. The asphalt patching that produced the anomalies previously seen are shown at the bottom of these images.

Natural Color Composite and Nighttime Thermal Image of Laundry Area and Adjacent Burial Areas (Mason Site, TA-21)

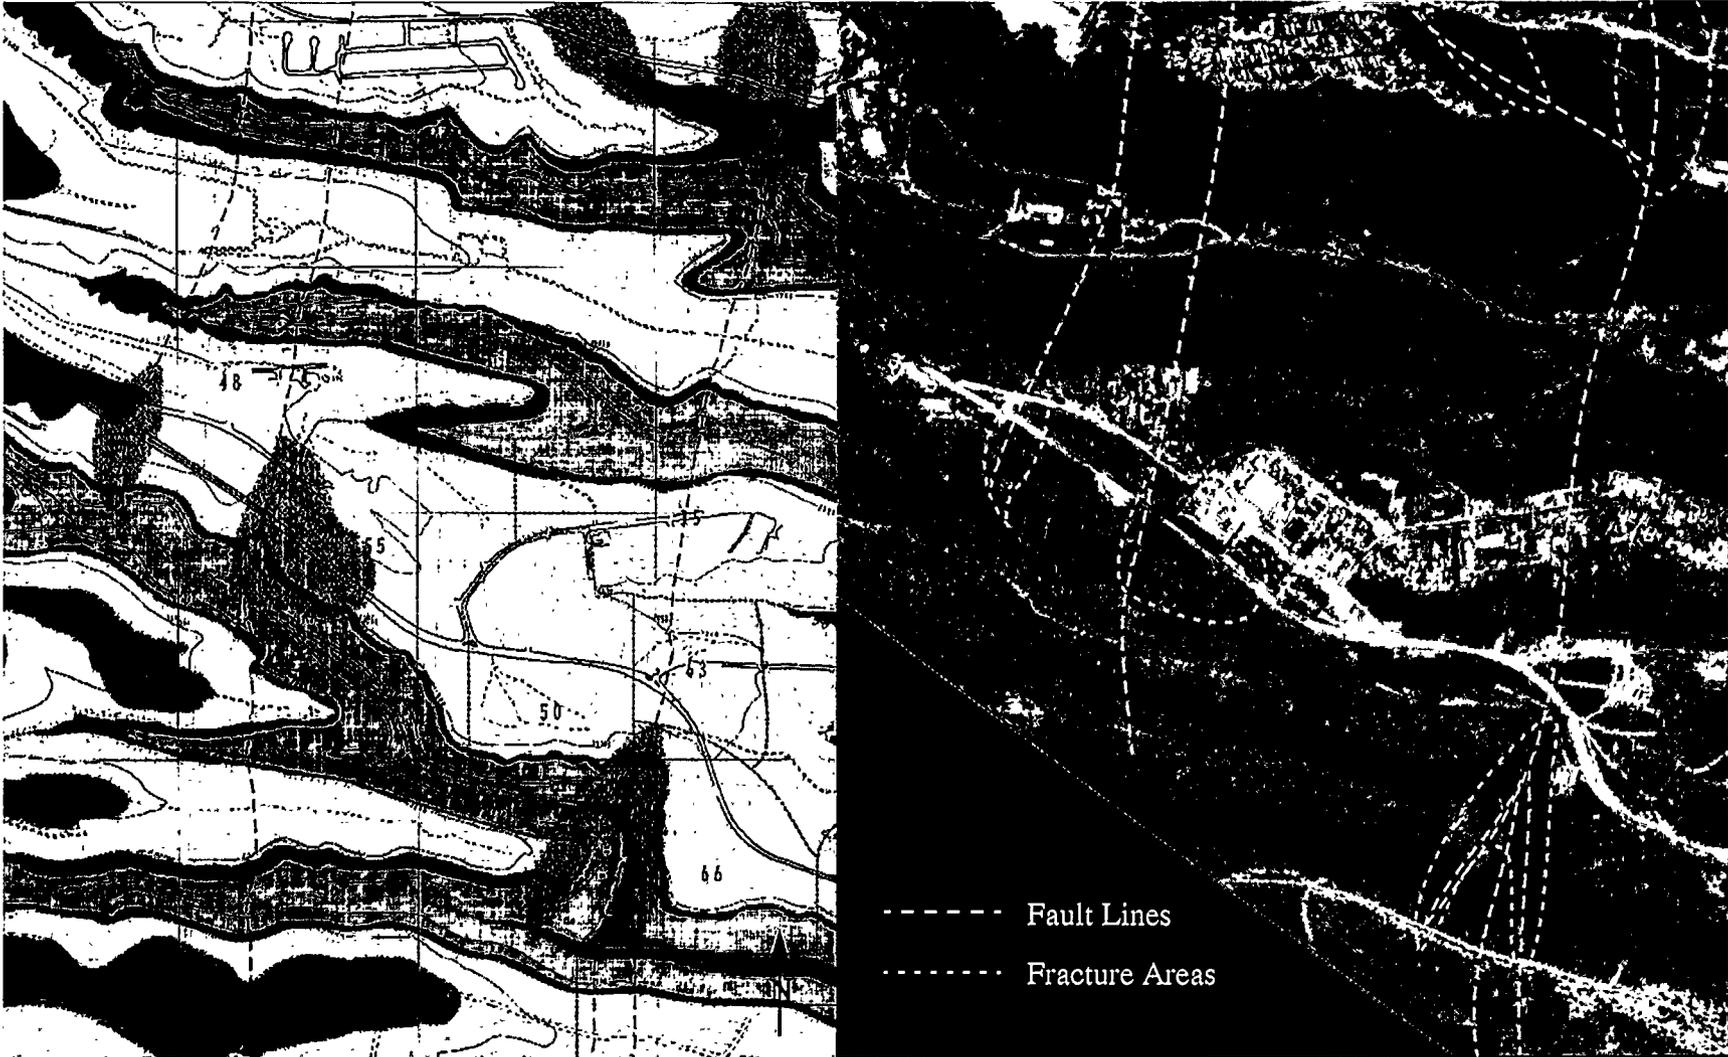
Figure 10
25

DESCRIPTION OF IMAGERY The geologic map is shown on the left of Figure 10 with faults shown as black dotted lines and fractures as brown areas. To its right is a Daedalus False Color Composite of the area between TA-48 and TA-50. After analyzing signatures of the faults and fractures using several band combinations, revised estimates from the geologic map were made. These are shown on the False Color Composite in white (fault times) and yellow (fracture areas).

INFERENCE The fault and fracture lines shown on the geologic map were mostly verified on the imagery. There were a few minor corrections that can be seen by comparing the graphics, left-to-right.

Comparison of Daedalus Imagery to Geologic Map of Mortandad Canyon (Koch Site, TA-48)

REMOTE SENSING CONCEPT Except where buildings are present, faults and fractures are normally visible on imagery using the various Daedalus bands collected in 1994 and are normally visible on aerial photography as well. The addition of spectral imagery to analysis normally done with aerial photography is known to increase accuracy and speed in making such maps. The resolution of the data collected was adequate for detection, however the image shown in Figure 10 is of lower resolution than was used for detection, to permit display of revised lines on a larger area.
