ENVIRONMENTAL WASTE SITE CHARACTERIZATION  
UTILIZING AERIAL PHOTOGRAPHS AND SATELLITE  
IMAGERY: THREE SITES IN NEW MEXICO, USA

ED VAN EECKHOUT, EES-3  
PAUL POPE, EES-3  
NAOMI BECKER, EES-3  
BOB WELLS, EES-3

XVIII ISPRS CONFERENCE, VIENNA, AUSTRIA

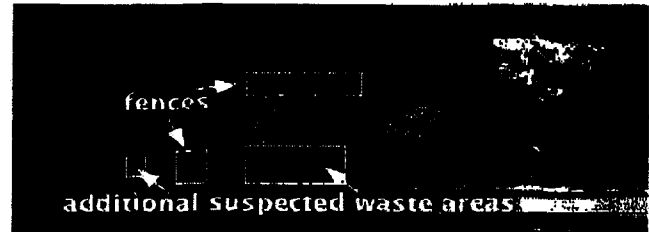
Fig. 4(a). 1991 orthophoto of MDA-F.

Figure 4(a) shows a 1991 orthophoto of the MDA-F area, with boundaries of suspected trenches overlaid on the photo. Based on these boundaries, a magnetic survey area was defined as shown on Fig. 4(b), which is a photograph from the 1958 era. Note that the pits and trenches appear to extend beyond the fence lines shown in Fig. 4(a). Because it seemed that the pits and trenches did extend farther than originally thought, a study to evaluate historical photographs of the area was initiated.
