**THE POST-IRRADIATION EXAMINATION OF CANDU TYPE FUEL
IRRADIATED IN THE INSTITUTE FOR NUCLEAR RESEARCH TRIGA
REACTOR**

I.L.TUTURICI, M. PARVAN, R.DOBRIN, M.POPOV, R.RADULESCU, V.TOMA

Romanian Power Authority, Nuclear Energy Group
Institute for Nuclear Research, 0300 Pitesti, P.O.B. 78, Romania

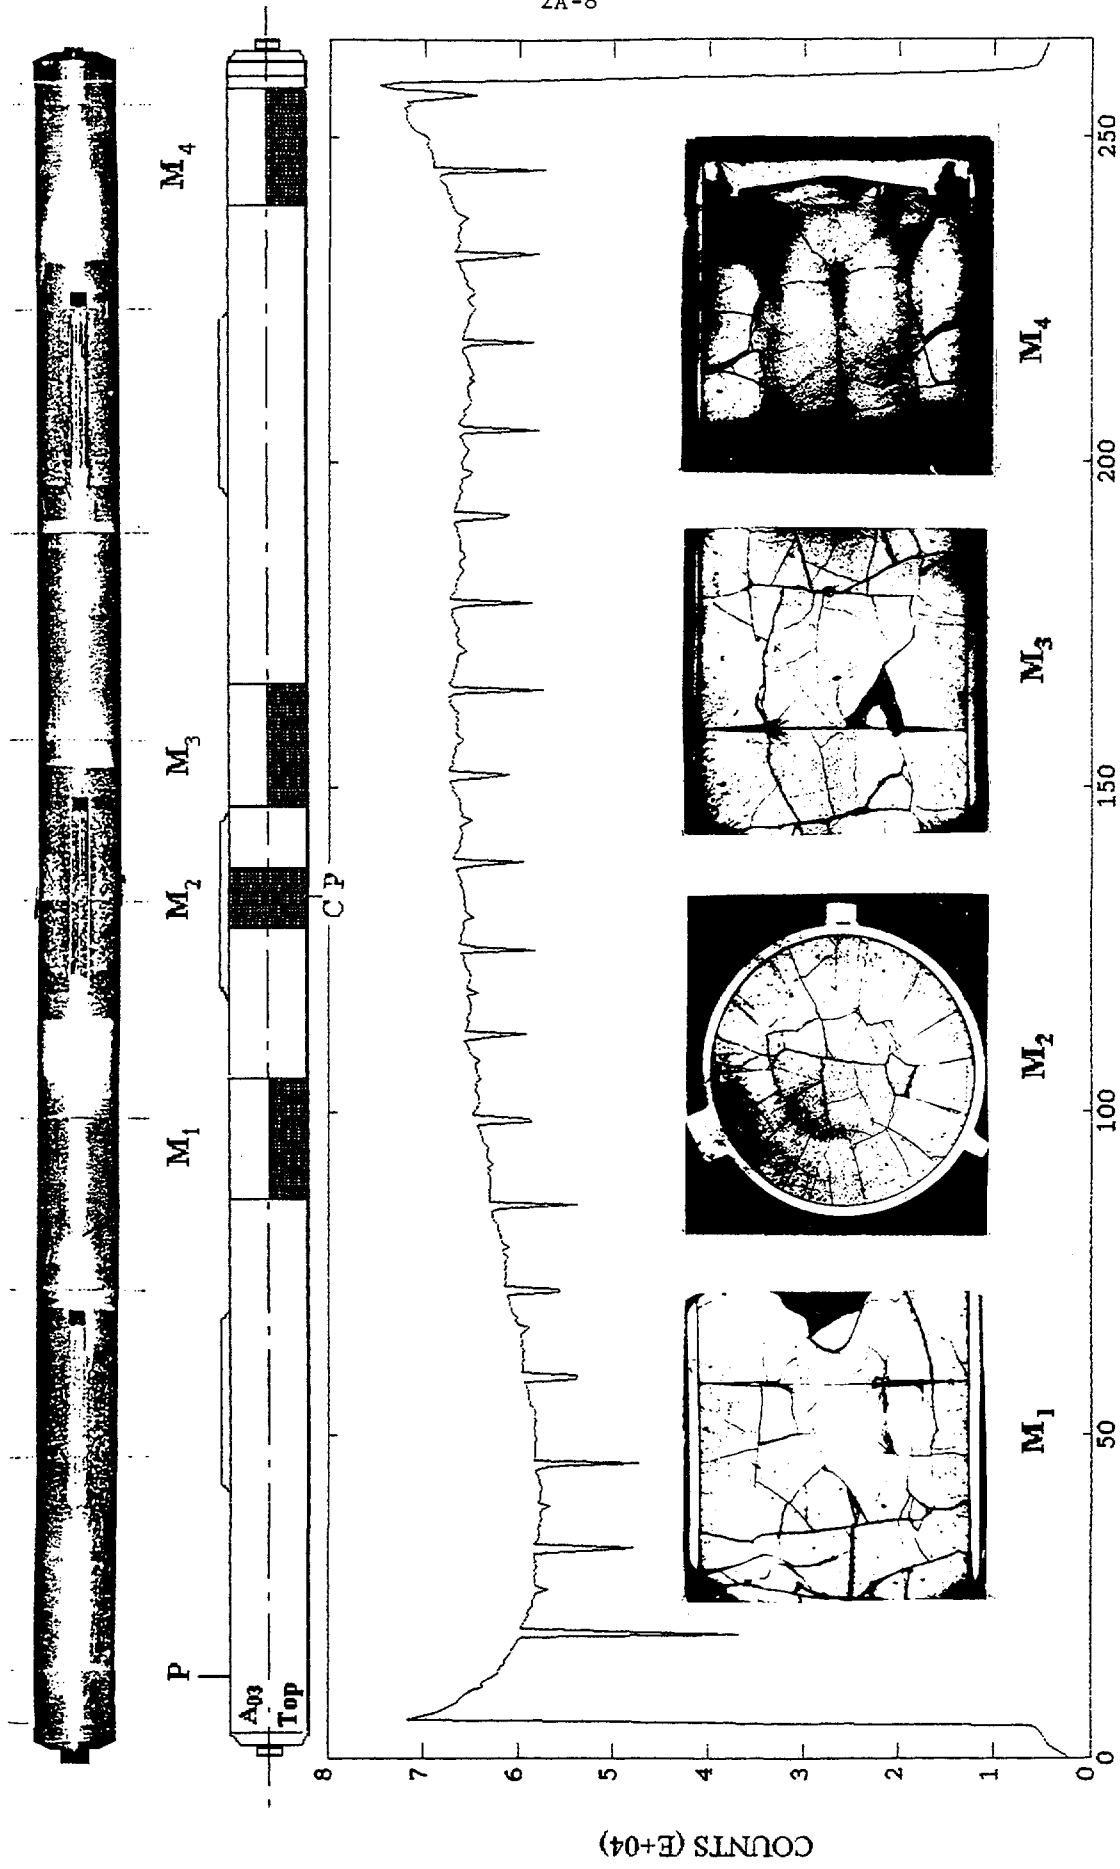
Fig. 1 Axial gamma scan from A₀₃ fuel rod. Integral profile.

Visual control and photography. (see Fig.1) The control operation was done along the fuel element axis and the outer surface was photographed at three azimuthal positions (0°, 120° and 240°). The control has no revealed particular items to be considered later (i.e. defects, deposits, corrosion effects and excessive dimensional changes). The obtained images, show clearly that corrosion rate in the heat affected zone of the brazed appendices, containing preponderantly the beta structural phase of zirconium, was higher than on the rest of the sheath.

Axial gamma scanning (see Fig.1). This operation was used for axial discrete acquisition of specific gamma spectra of Cs-137 (661.643 keV), Zr-95 (724.23 keV) and La-140 (1596.17 keV), shown as integral activity axial profile. In this scope a collimator slit opening of 0.0005 m and a discrete displacement 0.0005 mm were used. The calibration for energy is performed using standard Co-60 and Cs-137 sources, while the calibration for efficiency uses Sb-124 and Cs-137 sources. The increase of activity at the ends of the fuel column is caused by the end peaking of the neutron flux. Based on the fact that no axial migration of Cs-137 was observed and that radionuclide is a long life and has practically the same fission yield both for U-235 and Pu-239, burnup calculation has been done by using the measured activity.

Metallography and ceramography. Metallographic and ceramographic examination was based on the cutting plan shown in Fig.1. Four metallographic samples M1, M2, M3, M4 were prepared and examined. The sample cutting and preparation follows a typical procedure, based on resin impregnation of the fuel element, slow speed diamond disk precise cutting, sample embedment in cold curing resin, metallographic preparation, ultrasonic bath cleaning and surface quality inspection by a periscope.

General view of the sample (see Fig.1). In this scope macrography was performed at 3x magnification and the corresponding images are shown in Fig.1. Due to the end flux picking, the M4 sample (bottom end of the fuel element) shows serious restructuring with central hole and with the central part of fuel pellet displaced toward the end plug, while the other three samples show a typical irradiated fuel macrostructure.

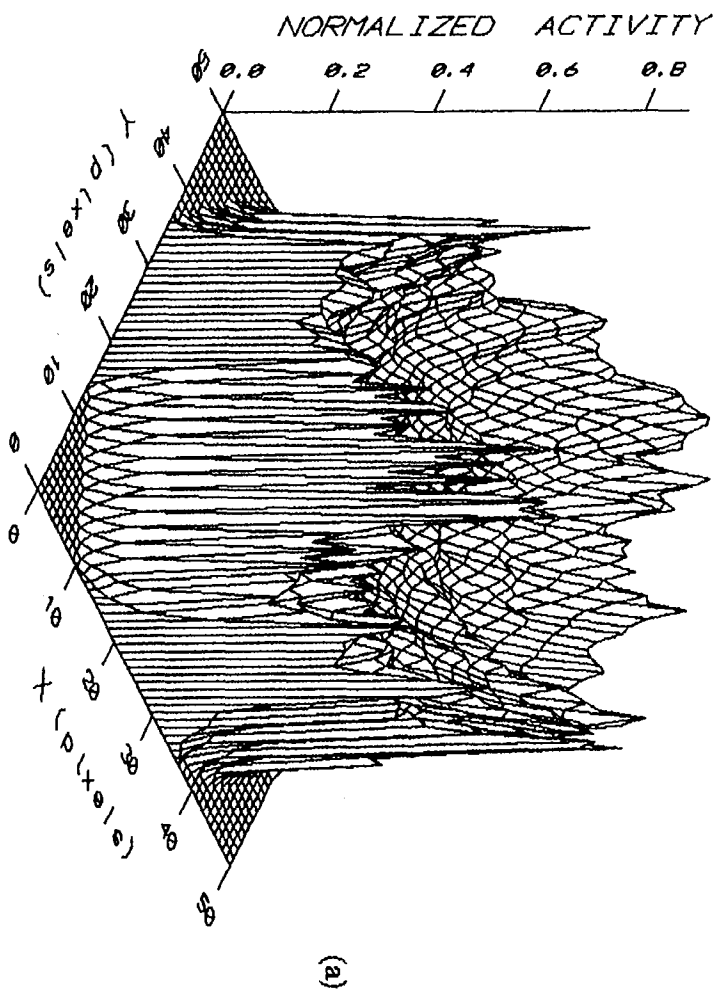
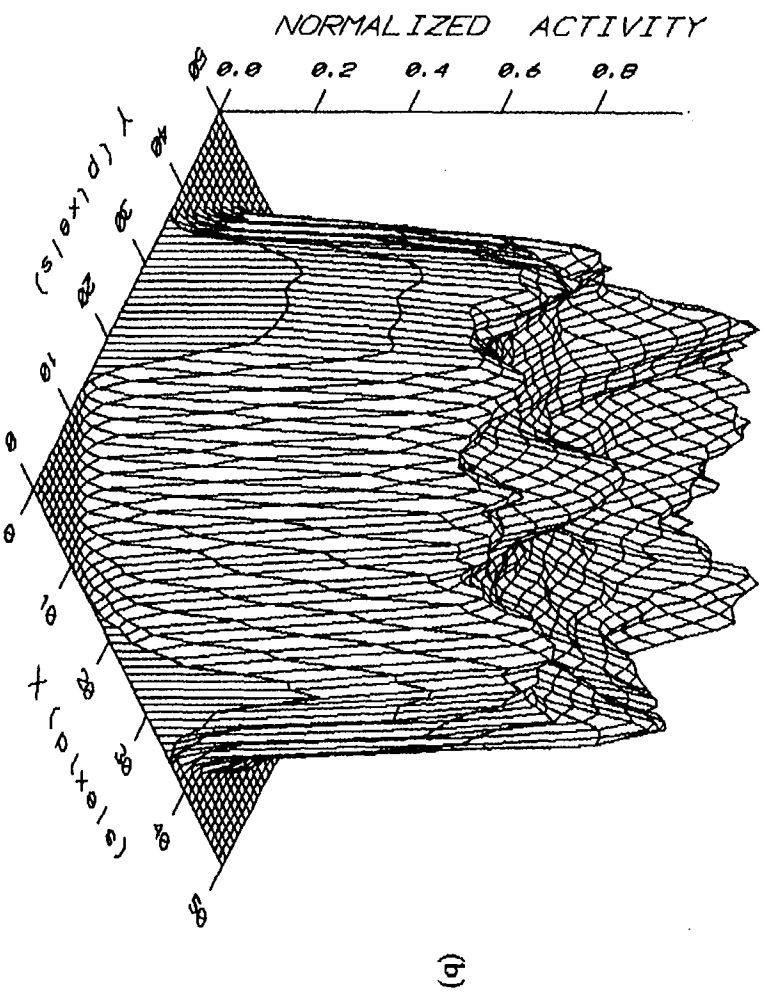
Fig. 2 Reconstruction of the ¹³⁷Cs and ¹⁴⁰La distribution in the cross section of the fuel rod

a - ¹³⁷Cs
b - ¹⁴⁰La

Tomographic 3-D examination (see Fig.2). In order to obtain the spatial distribution of activity of Cs-137 and La-140, in a cross section of the fuel element, the measured radial profiles were used in conjunction with a method of tomographic reconstruction based on a maximum entropy algorithm [2]. The radial gamma spectra acquisitions were done at five angular positions (0°, 72°, 144°, 216°, 288°) and at a regular movement of 0.00025 mm of the element in front of the collimator, having a slit of 0.005 m in height and of 0.00025 m in the aperture. The distribution of La-140 shows some agglomeration of this radionuclide in the centre of the fuel pellet.

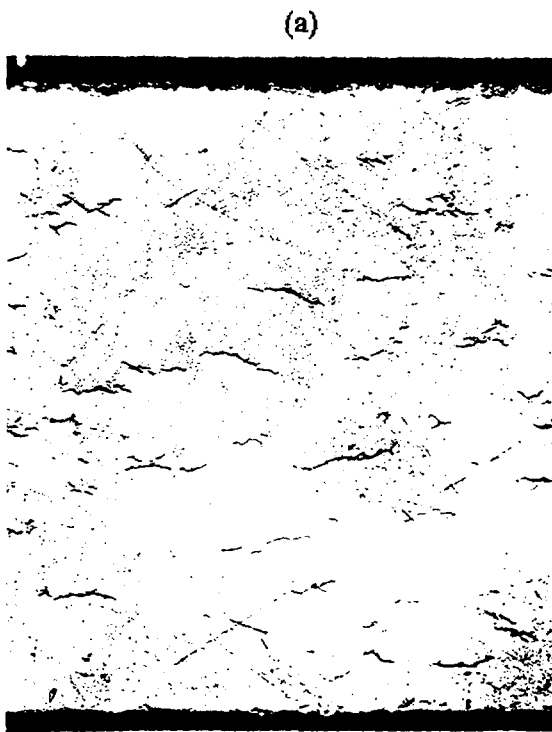
(a) Hydride plates (200 x)

Cladding structure (see Fig.3b). The hydriding condition of the cladding is shown on M2 sample. A content of hydrogen of about 80 ppm was estimated by means of hydruration charts.

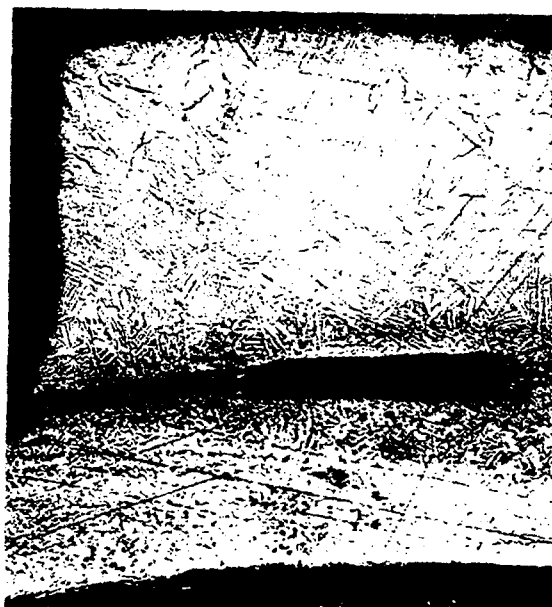
(c) Pore in pad-clad brazed zone (65 x)

Fig 3 Clad microscopic examination

Condition of brazed and welded zones (see Fig.3c). The condition of brazed zones (plugs, bearing pads, spacers) was also extensively examined. A brazing defect was found on sample M2 at the interface between the bearing pad and the cladding. The end plug weld was found as satisfactory. The Vickers hardness values obtained were about 260-280 units in the HAZ and about 220-240 units at great distance from this zone.

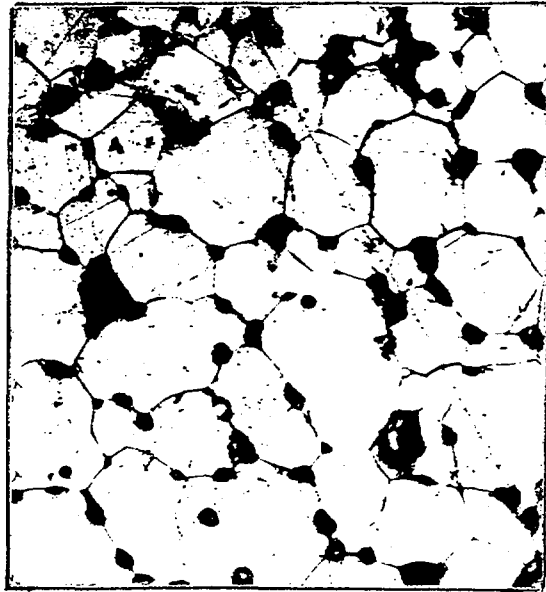
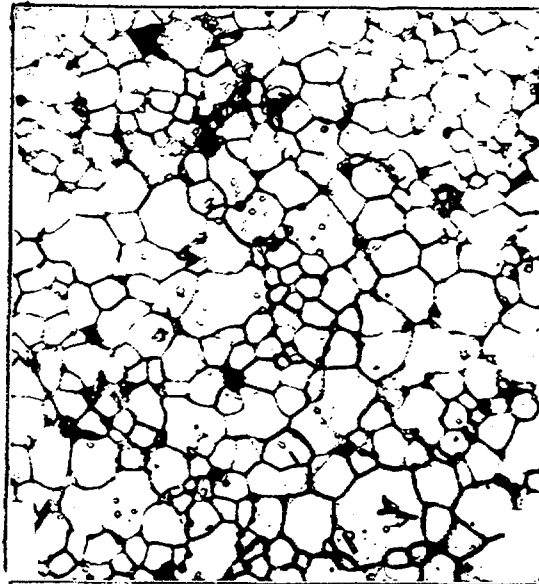
Fig. 4 Fuel microstructure (500x)
a - Equiaxed grown grains
b - As sintered grains

Uranium Dioxide Microstructure (see Fig. 4a and 4b). The UO_2 microstructure was revealed by chemical attack with a mixture of H_2SO_4 and H_2O_2 . Three of the metallographic samples (M1, M2, M3) contain only two zone structure, equiaxed grown grains and as-sintered grains. The M4 sample had shown a three zone structure with columnar, equiaxed and as-sintered grains zones. The measurement of the radii of the two zones on M2 sample indicated the following values:

- Equiaxed grown grains radius [mm]: 3.1 ± 0.02
- Pellet radius [mm]: 6.13 ± 0.02

The evaluation of the grain size has been done by the use of the interception method [3]. The obtained equivalent ASTM numbers for grain size were:

- Grains, as sintered [micrometers]: 7.9 ± 0.1
- Grains, equiaxed [micrometers]: 20 ± 0.2
