VALIDATING EDDY CURRENT ARRAY PROBES FOR INSPECTING STEAM GENERATOR TUBES

S.P. Sullivan, V.S. Cecco, L.S. Obrutsky, J.R. Lakhan
and A.H. Park

Atomic Energy of Canada Limited
Chalk River Laboratories
Chalk River, ON K0J 1J0

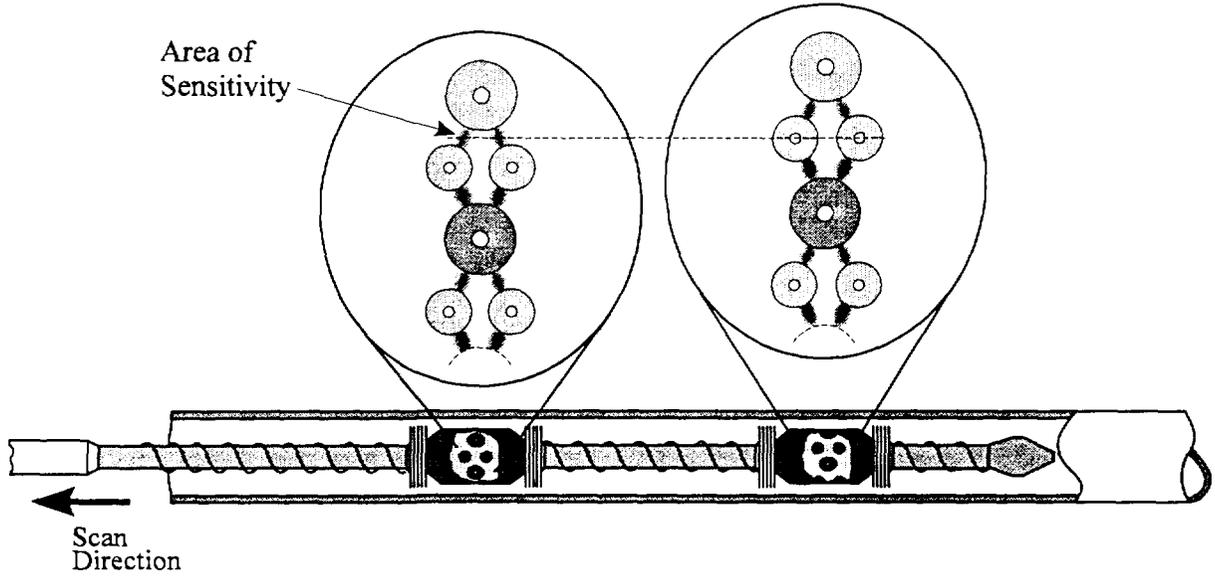
Figure 1: C3 probe showing coil configuration.

A new transmit-receive eddy current array probe, denoted as C3 (Cecco-3), was developed for this application [3]. This probe consisted of two circumferential arrays of transmit (active) and receive (passive) coils, as shown in Figure 1. The transmit-receive configuration was chosen because computer modelling showed that transmit-receive probes were several times more sensitive to cracks than lift-off (coil to tube wall proximity variations due to tube deformation) and magnetite deposit variations. Calculated signals from cracks, lift-off and magnetite deposits are shown in Figure 2 for pancake impedance and transmit-receive eddy current probes. These results clearly show that the signal (from the crack)-to-noise (from lift-off and deposits) ratio is several times better when using a transmit-receive probe than when using a pancake impedance probe with coils of the same size.

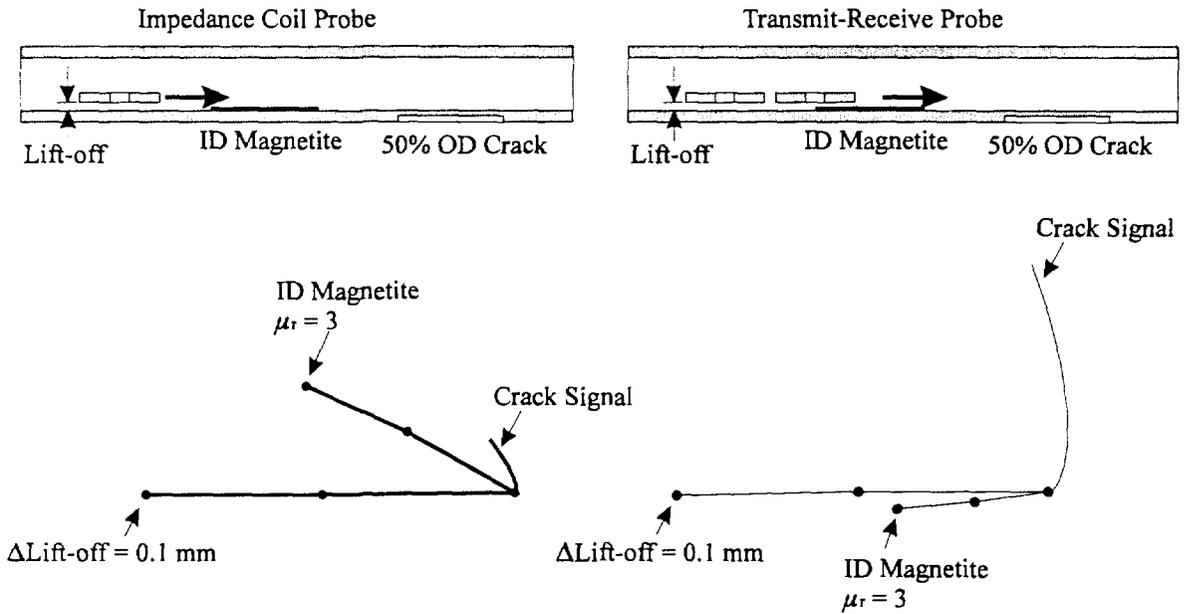
Figure 2: Computer modelling results comparing signal (from a crack)-to-noise (from probe lift-off or ID magnetite deposit) for a pancake impedance coil probe and a transmit-receive eddy current probe.

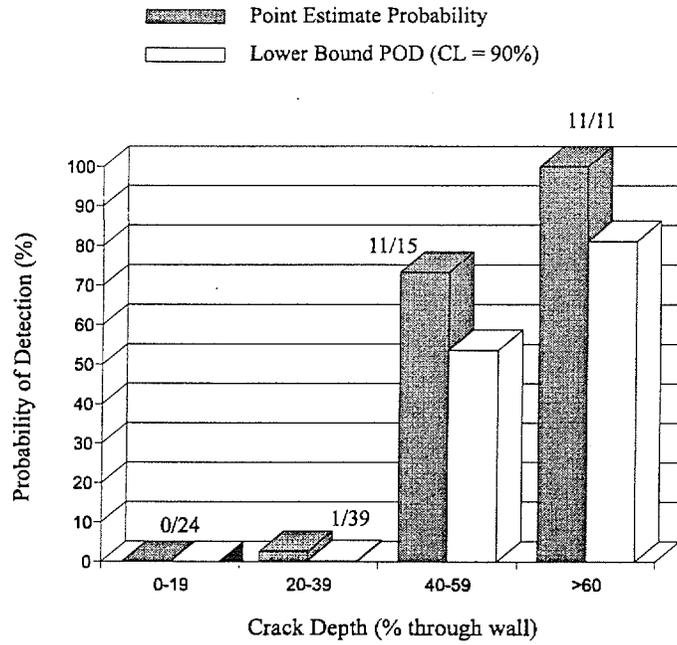
Figure 3: POD histogram for C3 probe detecting ODSCC in Bruce A-NGS SG tubes.

The new C3 probe was validated by using it to scan several hundred SG tubes at BNGS-2, removing over 100 U-bend sections of the inspected tubes, and destructively analyzing the removed tubes in a laboratory. Probability-of-detection (POD) histograms based on the comparison of the inspection results with the laboratory measurements are shown in Figure 3. A depth-sizing accuracy plot is shown in Figure 4.

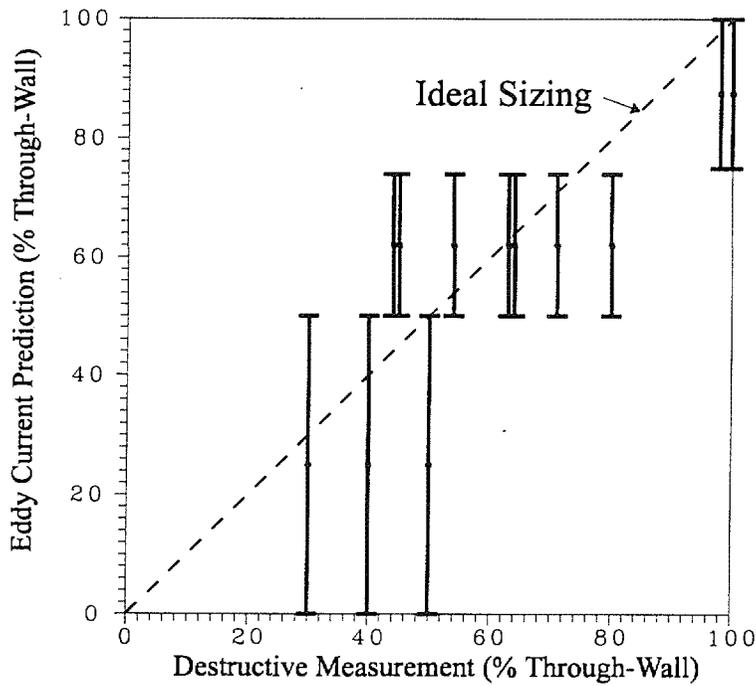
Figure 4: Sizing accuracy plot for C3 probe detecting ODSCC in CANDU SG tubes which were subsequently removed and analyzed destructively.

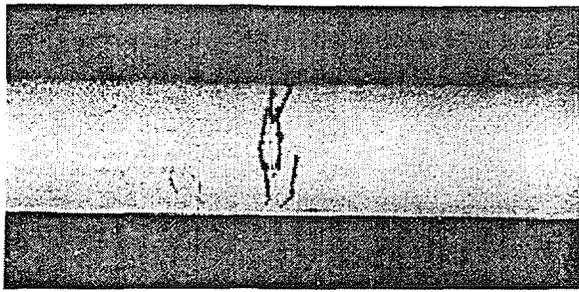
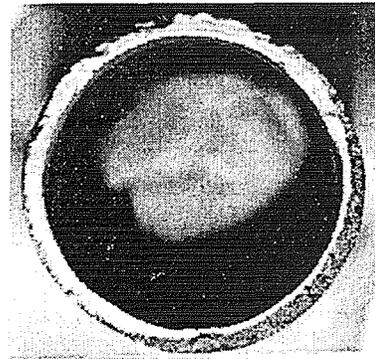
Figure 5: (a) Dye penetrant photograph of a SG tube sample with laboratory-induced ODSCC. (b) Fracture cross section of a circumferential ODSCC in a SG tube.

One alternative to technique validation based on tubes removed from in-service SGs is to prepare samples in the laboratory with properties that simulate the field conditions encountered in inspections. For CANDU SG tubes, methods have been developed that produce ODS (circumferential and axial) in Inconel 600, pitting in Monel 400, and fretting wear. Figure 5 shows a dye penetrant image and a fracture surface of an Inconel 600 tube with laboratory-induced SCC. The darkened area on the fracture surface outlines the circumferentially oriented crack. Figure 6 shows a comparison of a pit found in a Monel 400 tube section removed from an in-service SG, and a laboratory-simulated pit. The two through-wall pits have similar diameters and volumes.

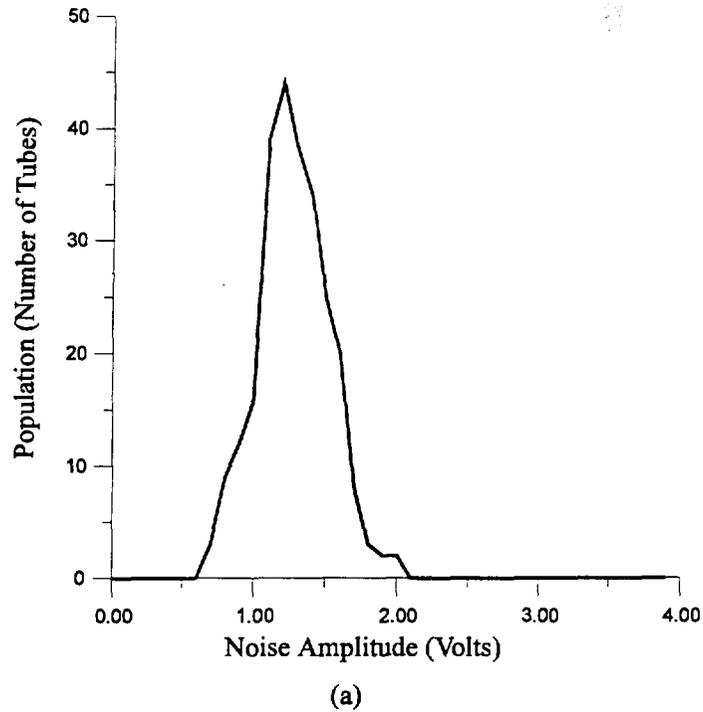
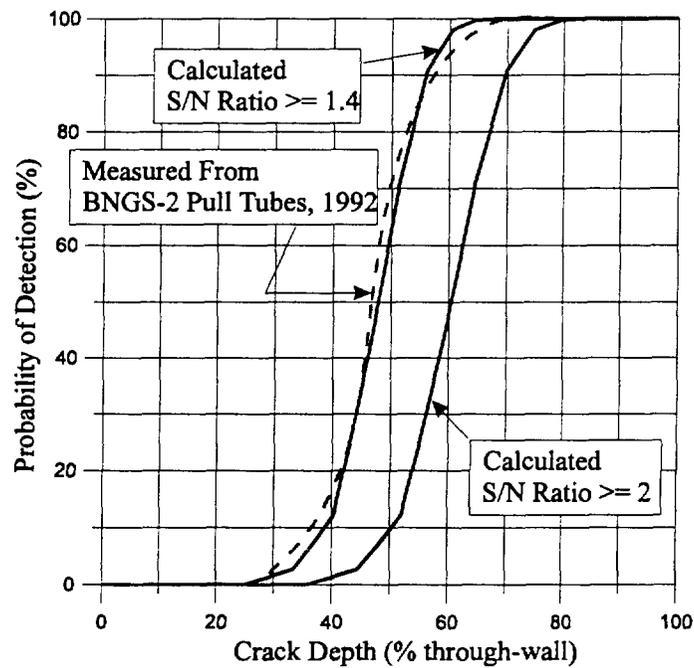
Figure 7: (a) Noise distribution plotted for 4 T/R unit C3 probes at the HU1 support plate locations in BNGS-2 SG tubes. (b) POD curves for 4 T/R unit C3 probes detecting circumferential ODSCC at the HU1 support plate locations in BNGS-2 SG tubes.

To validate this method of calculating POD, the background distortion of signals from 4 transmit-receive (T/R) unit C3 probes was quantified. Figure 7(a) shows a plot of the noise distribution. From this plot, POD curves, shown in Figure 7(b), were plotted for signal-to-noise ratios of 1.4 and 2. Superimposed is the POD curve that was derived by comparing eddy current predictions with destructive analysis of tubes removed from BNGS-2 in 1992. The plot shows that this is a reasonable technique for making conservative estimates of POD curves.
