THERMAL FLUCTUATION PROBLEMS ENCOUNTERED IN LMFRs

Thermal Fluctuation Problems encountered in LMFRs

FRAMATOME Direction NOVATOME : O. GELINEAU - M.SPERANDIO
CEA DRN Cadarache : Ph. MARTIN
EDF CLI : J.B. RICARD
CEA Centrale PHENIX : L. MARTIN
CEA DTA SRMA Saclay : A. BOUGAULT

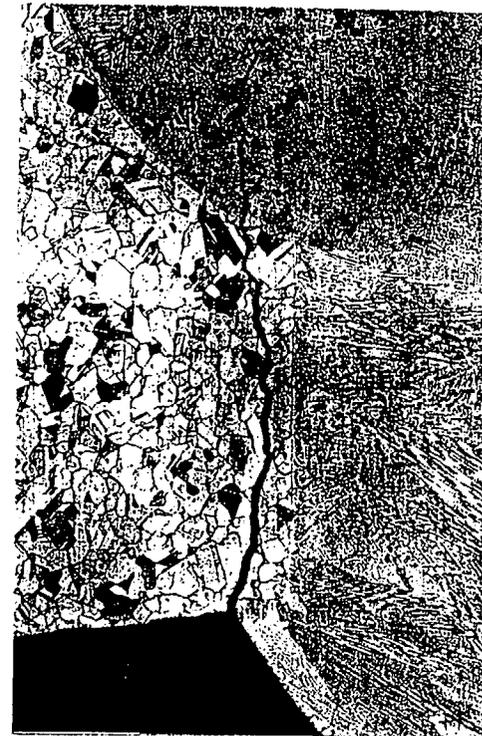
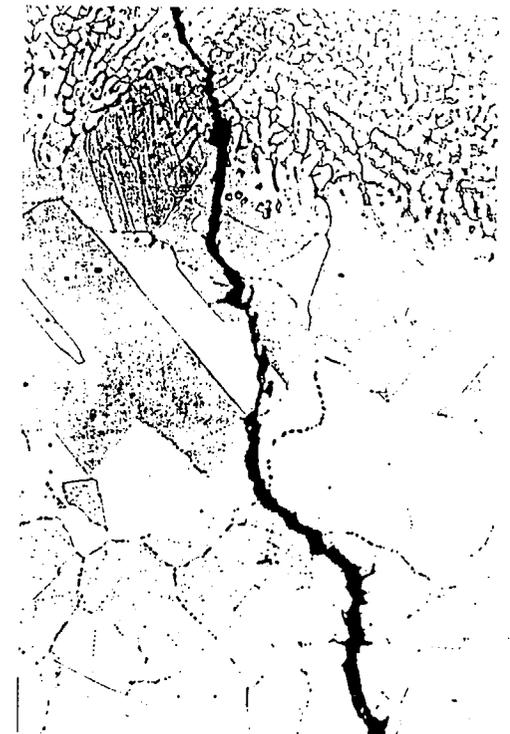
FIGURE 8 : SPX tee junction - metallurgical examination of cracks

The metallurgical examination of the crack, which showed a number of striations of 10⁴ to 10⁶, was consistent with the numerical results (figure 8).

Cracks at the edges of the weld seam

Propagation through the
heat-affected zone

Transgranular propagation
