Sodium Leak at Monju (II)  
- Sodium leak, burning and aerosol behavior -

T.Funada and Y.Yamagishi  
Technical Development Division, Monju Construction Office, PNC  
2-1, Shiraki, Tsuruga-shi, Fukui-ken, Japan

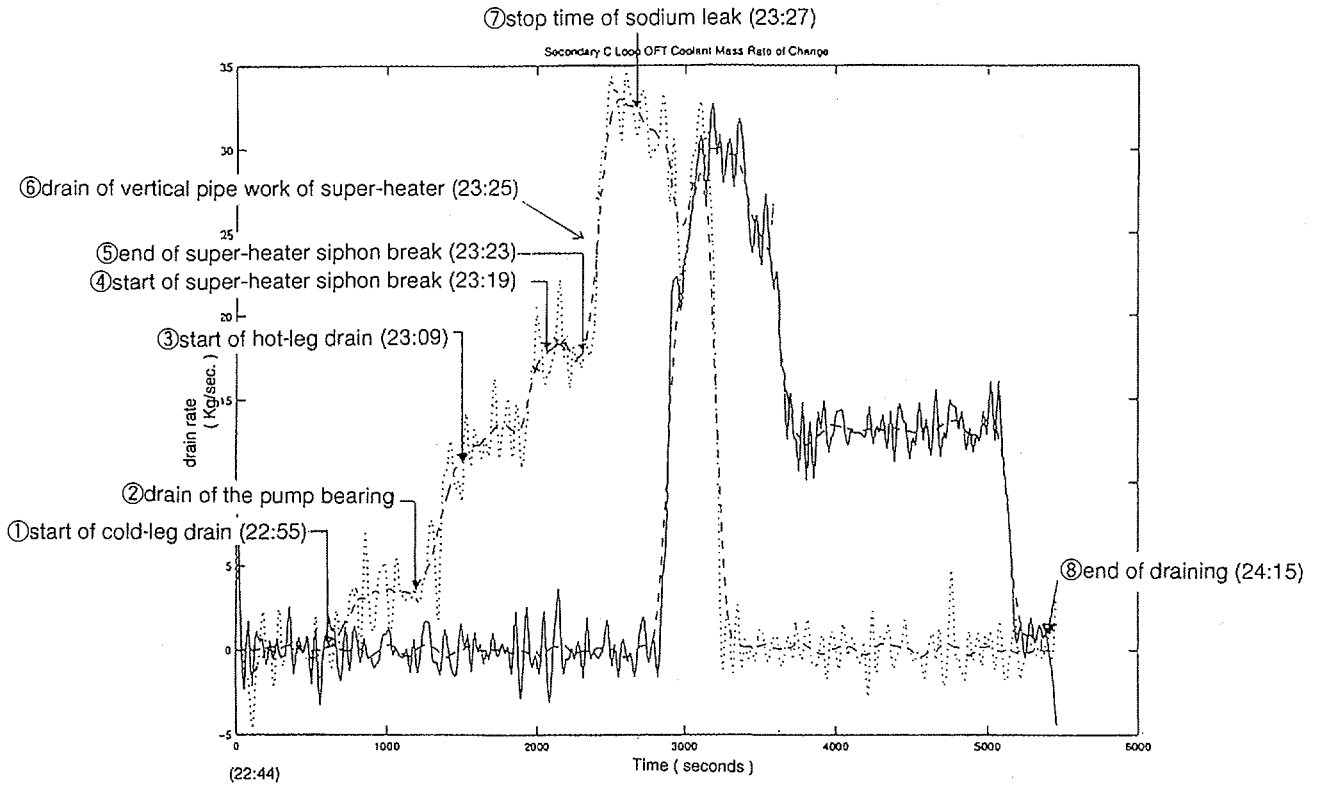
Fig.3 Sodium over-flow tank level changes during draining

It was estimated the leak stopped at 23:27 by the analysis of the drain rate and drain mode of the loop C from the MIDAS data, as shown in Fig.3. The duration of the leak was 220 minutes from 19:47 to 23:27.

The total amount of sodium leaked was calculated as  $640 \pm 42$  kg, considering the sodium pressure at the leak site during the drain.

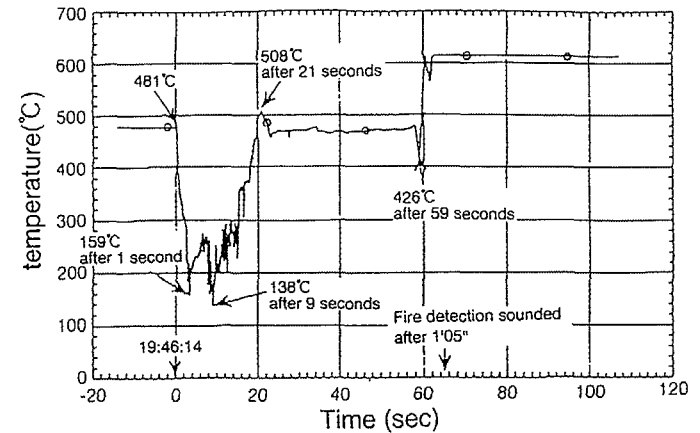
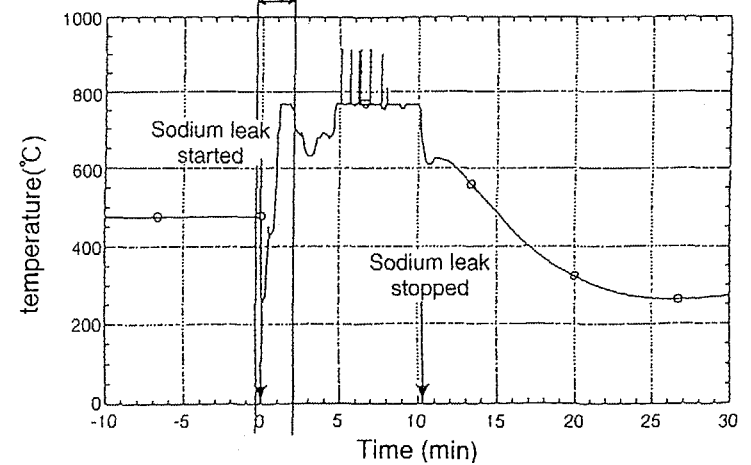
Fig.6 Comparison of temperature indications with the sodium leak experiment

The output of the failed thermocouple during the initial period of the leak is shown in Fig.6, compared with that of the sodium leak experiment, conducted at Oarai Engineering Center of PNC. The temperature variation of the thermocouples between Monju and leak experiment agrees well, which indicates;

- The sodium leaked in the thermocouple well decreased the electric insulation between compensation wires which were short-circuited.(①-④)
- The leak rate was very small during the first 35-40 seconds and then increased to a constant rate of 50 g/sec within a few minutes.

Temperature trace of the loop C-IHX secondary outlet of Monju

Temperature trace of the sodium leak experiment

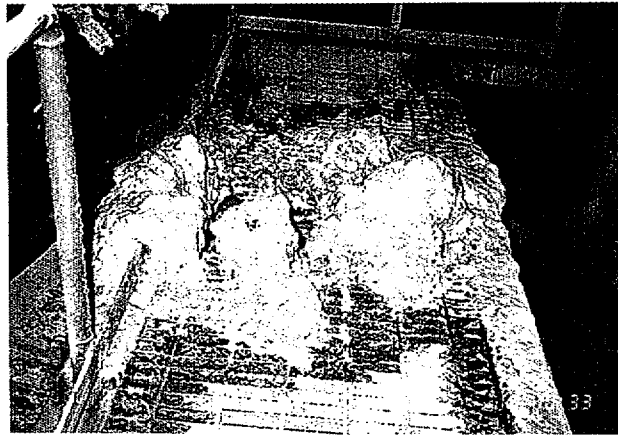
Fig.7 Sodium chemical compounds formed under neath site of the leak.

The sodium chemical compound deposits(about 310 kg-equivalent Na

metal) were formed underneath the site of the leak, mainly on the floor liner as shown in Fig.7. The main chemical composition of the compounds was  $\text{Na}_2\text{O}$  (~90 wt%). The sodium oxide deposits of the floor liner seemed to protect the liner from high temperature chemical corrosion reactions involving leaked sodium.

The kidney-shaped sodium deposit on the floor shown in Fig. 7 is explained as a result of changes of sodium fall path when the duct was damaged.

Thermocouple box and pipe hanger

Ventilation duct

Walkway grating

Floor liner

From metallurgical microstructure examinations, the maximum temperature at the grating( 3.0 mm thick steel, which had a 42 cm x 39 cm damaged hole) was estimated to be 1000-1150°C.

The maximum temperature of the floor liner was 650-750°C. The liner(6.1-6.2 mm, steel) was reduced in thickness by 0.5-1.5 mm.
