## UNEXPECTED LEVELS AND MOVEMENT OF RADON IN A LARGE WAREHOUSE

### Abstract

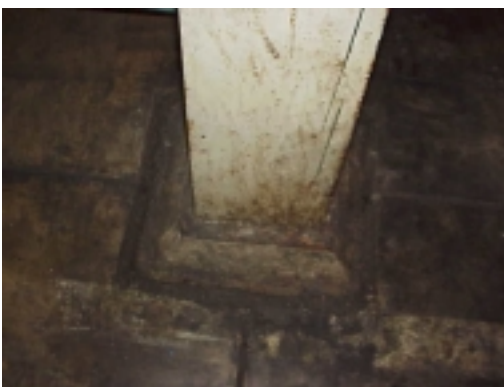
This general warehouse was built in 1955 on floating concrete slabs. Metal pillars support the roof. The original fibrous materials in the expansion joint between the floor slabs has decayed and become filled with debris, through which soil-gas laden with radon can pass easily (Picture 1). Rows of windows beneath the roof are in leaky conditions and contribute to the natural ventilation of the building.

**Picture 1: Expansion joints around pillars and between slabs**

Where is the radon coming from? Smoke from hand-held pencils identified upward movement of air coming up through the debris-filled expansion joints between the floor slabs and from joints between the support pillars and the floor (Picture 1). This air of subslab origin is the radon-rich source of the measured radon. The subsequently measured soil-gas pressure (micrometer) under the slab of (+) 18 Pa confirmed that air moves from underground to inside the warehouse where it lingers in an oval shaped-dome. Soil-gas measurements under the slab with Pylon Lucas Cell found on average, radon at 700 pCi/L.

The elevated radon is explained by the ingress of radon laden air from beneath the floor slabs through expansion joints between the floor slabs and where the support posts for the roof meet the floor. The local geology of north-central Tennessee includes porous limestone known as karst, which provides a nearly inexhaustible reservoir of radon-rich soil gas to buildings whose foundations abut the porous bedrock. Our previous studies of houses with radon problems in the south eastern United States have implicated radon bearing karst as a common culprit<sup>1</sup>.

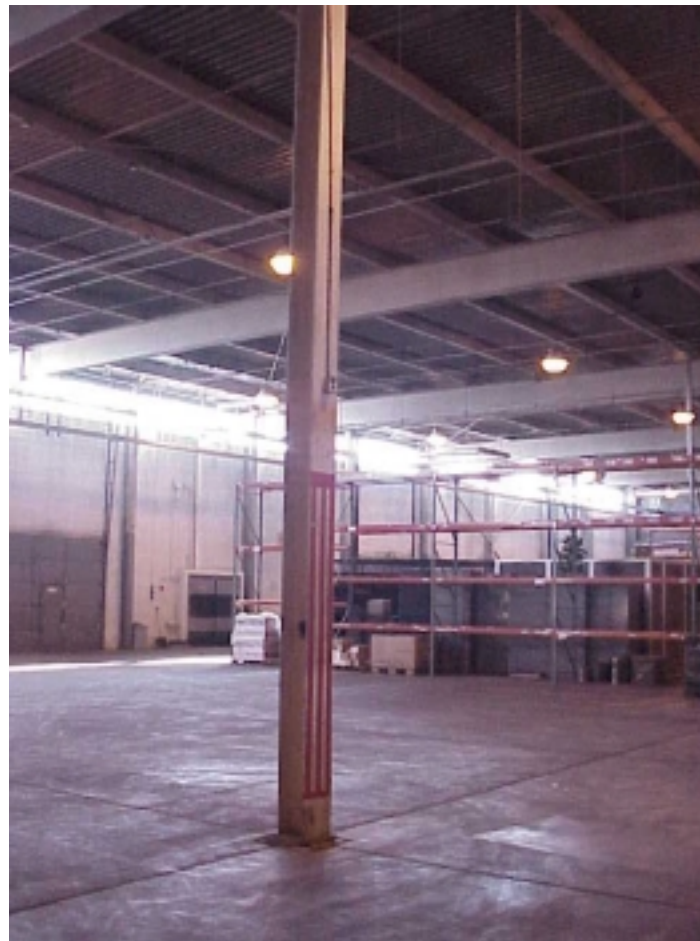
Bay A, which had the highest radon level of the four bays, was chosen for more detailed study; the interior layout is shown in Picture 2. Two-day measurements during October of 1999, made with collocated duplicate electrets at 24 locations, produced the results shown in Figure 1. Distinctly higher levels of radon exist along the center line of pillars numbered 3 through 6. Real-time measurements were made at each of these 4 pillars during the period February-March of 2000. The data obtained for Pillar 3 are reproduced in Figure 2. The radon level varied by only a factor of two, even as the bay doors were being opened and closed during the workday, or closed for the night with the exhaust fans turned off. Some of the lower radon readings coincided with outside temperatures of 0°C or less; marked as <0 in Figure 2.

**Picture 2: Pillar 4 in Bay A**

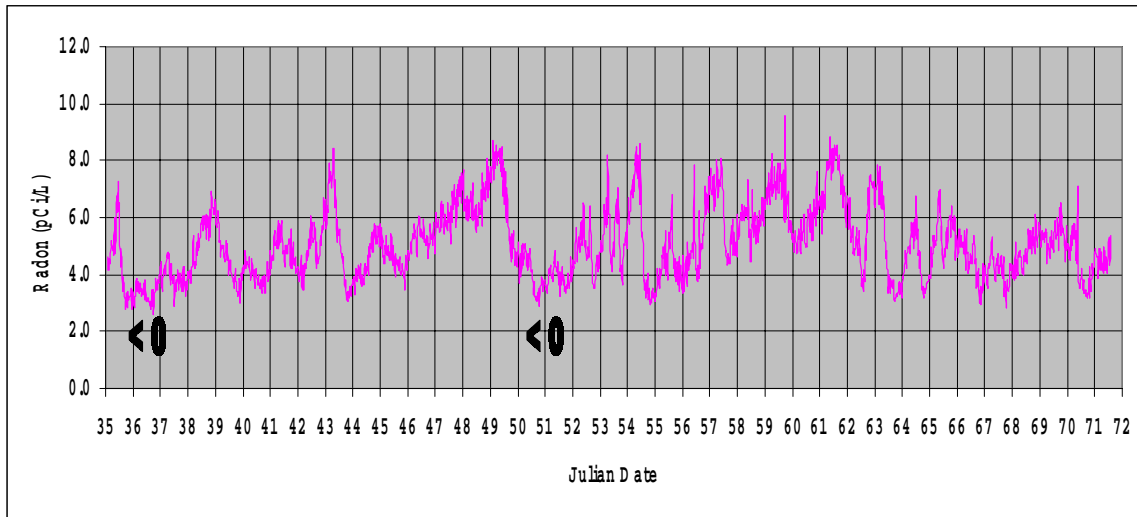
**Figure 2: Real-time radon levels at the base of Pillar 3, Bay A**

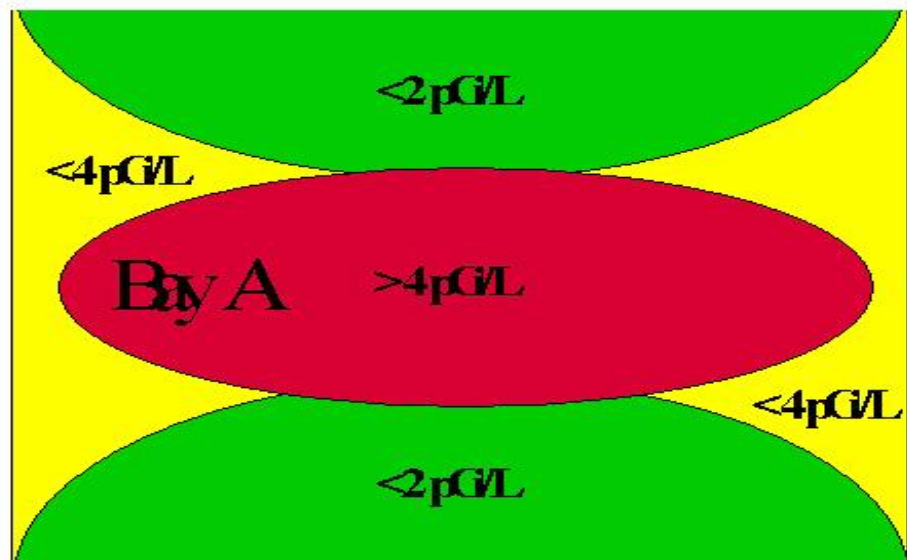
The final set of radon measurements were made in Bay A during the period April-June of 2000. First the floor of Bay A was divided into a grid of 50 units, each of area 250m<sup>2</sup>. Flow-cell measurements, were made for 4 hours within each unit during the workday over a period of 40 days. The spatial distribution of radon is shown in Figure 3. It is thus firmly established that

elevated radon above 4 pCi/l occurs in a centrally located, oval shaped zone. Second, the variation of radon between the floor and the roof was measured with the aid of a scissor lift, and in real-time (Pylon Lucas Cell). The radon decreased gradually upwards from the floor until it was the same as that measured by the outer walls (1-2 pCi/L). One can thus say that the central, oval zone of radon is also domed shaped.

**Figure 3. Generalized spatial distribution at floor level in Bay A**

The final stage of our work at this site was successful radon mitigation; it was achieved by the installation and operation of subslab depressurization units, 6 to each bay and a total of 24 systems for the whole building.
