A REAL-TIME MONITORING SYSTEM FOR THE ASSESSMENT OF STABILITY AND PERFORMANCE OF IN ABANDONED ROOM & PILLAR LIGNITE MINES

AYDAN, Ömer¹, TANO, Hisataka², SAKAMOTO, Akio³, YAMADA, Noritoshi³, SUGIURA, Kenrou³

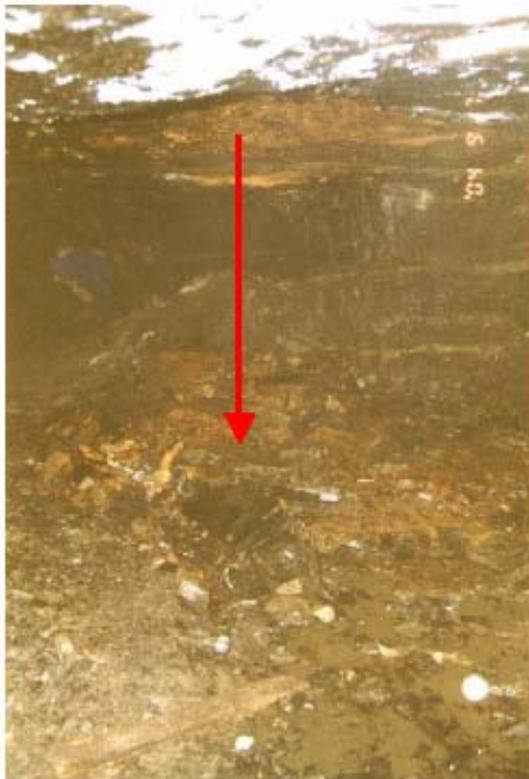
(a) Roof collapse between March 23 and May 17

Figure 3: Some views of instability in the abandoned lignite mine

Besides instrumental monitoring, the visual inspection and photographing of the abandoned mine were carried out periodically. Since the data download is carried out at intervals of two-months period, the visual inspections and photographing of certain locations were done at each time of data download. The first remarkable collapse was observed when the authors visited the mine on May 14, 2004 after the visit on March 23, 2004. Since the collapse was not observed during the visit to the mine on March 23, 2004, it should have take place during the period between these two visits. The collapsed area (3m x 2m) was bounded by pillars denoted PL3, PL4, PR3 and PR4, and 25cm thick sandstone roof layer was fallen down as seen in Figure 3(a).

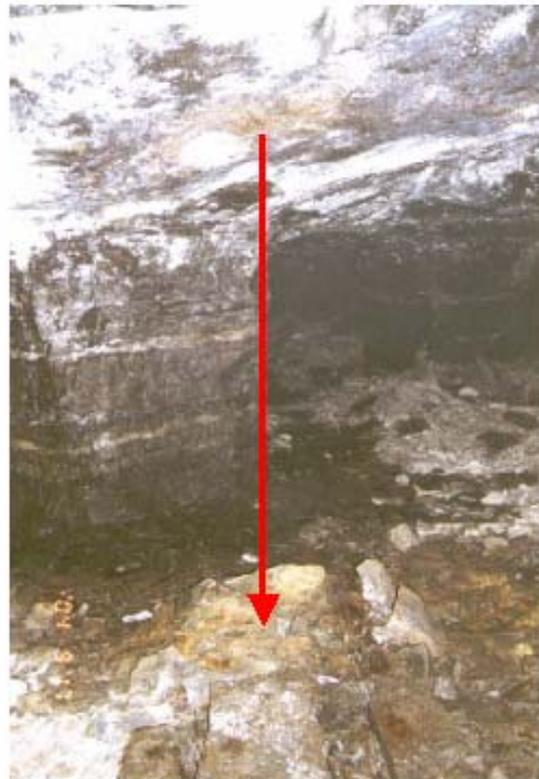
(b) Roof Collapse due to Tokaido-oki earthquake

There was no remarkable collapse within the area of instrumentation until the earthquake on September 5, 2004. The authors visited the mine on September 17 and there were some notable roof collapses as seen in Figure 3(b). However, there was no remarkable collapse induced by the Komaki earthquake on January 9, 2005. Besides these major collapses in the mine, rock mass in the roof and pillars continues to degradate. The degradation of rock mass occurs in the form of flaking of rock pieces from the roof and pillars fall due to cyclic saturation and drying. Furthermore, some cracks in pillars continue to open up.

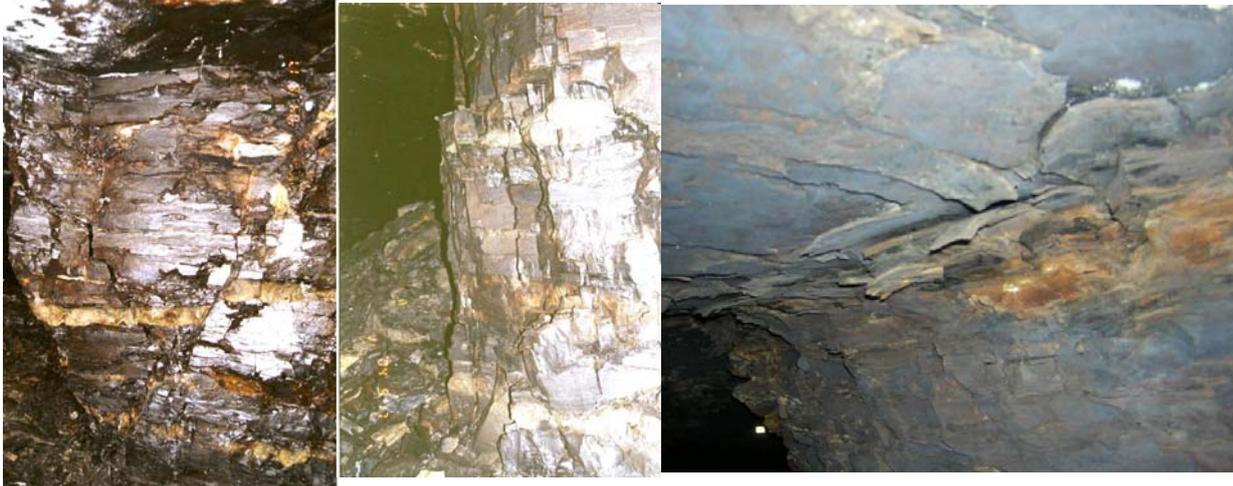
Figure 4: Some fracturing, crack opening in pillars and flaking of roof layers

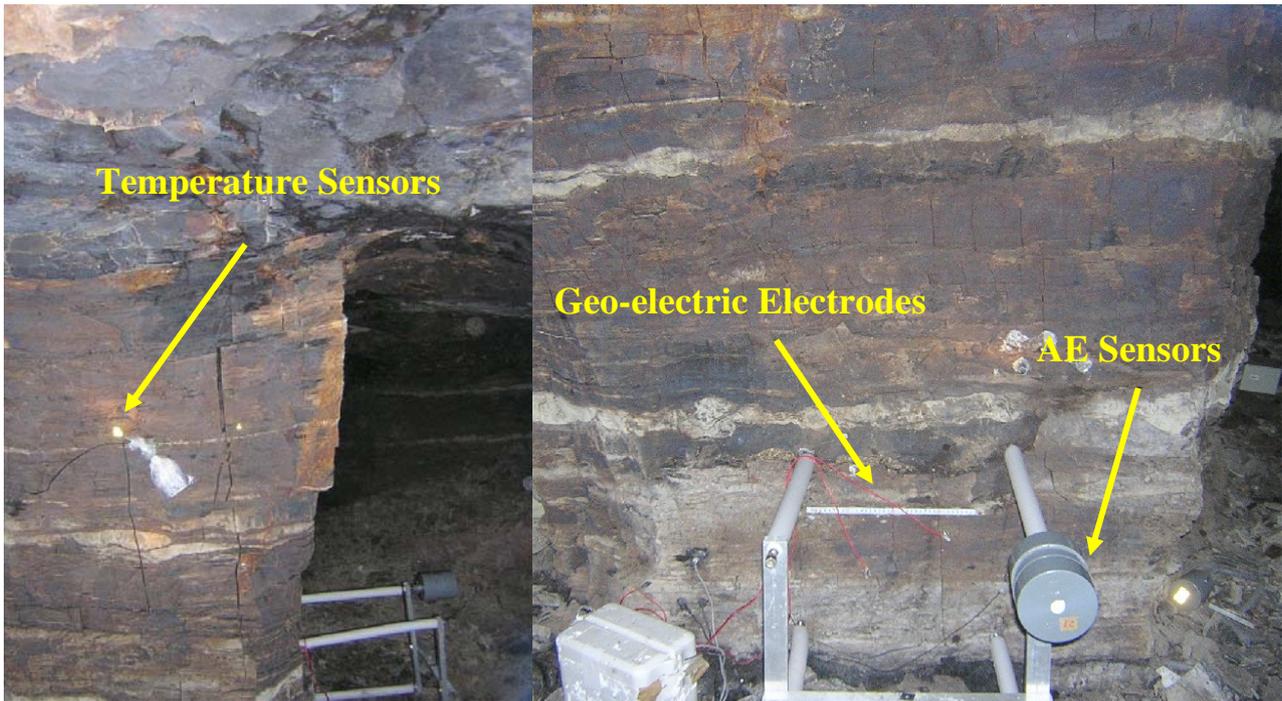
Figure 10: Instrumented pillar LP5.

Pillars resemble to the samples under uniaxial compression tests in laboratory. A geo-electric potential measuring device was recently installed in the pillar denoted LP5 in addition to temperature and acoustic emission measurements. Compared with the initial state of this pillar, vertical cracks in this pillar were open up further. The geo-electrical potentials were measured in vertical (UD) and horizontal (NS) directions. Figure 10 shows the instrumented pillar LP5. Figure
