**DAMAGE EVALUATION AND REHABILITATION OF THE MONTORIO MEDIEVAL
TOWER AFTER THE SEPTEMBER 14TH, 2003 EARTHQUAKE**

Maurizio Indirli¹, Bruno Carpani²
ENEA, Ente per le Nuove tecnologie, l'Energia e l'Ambiente, Bologna, Italy,

December 2006

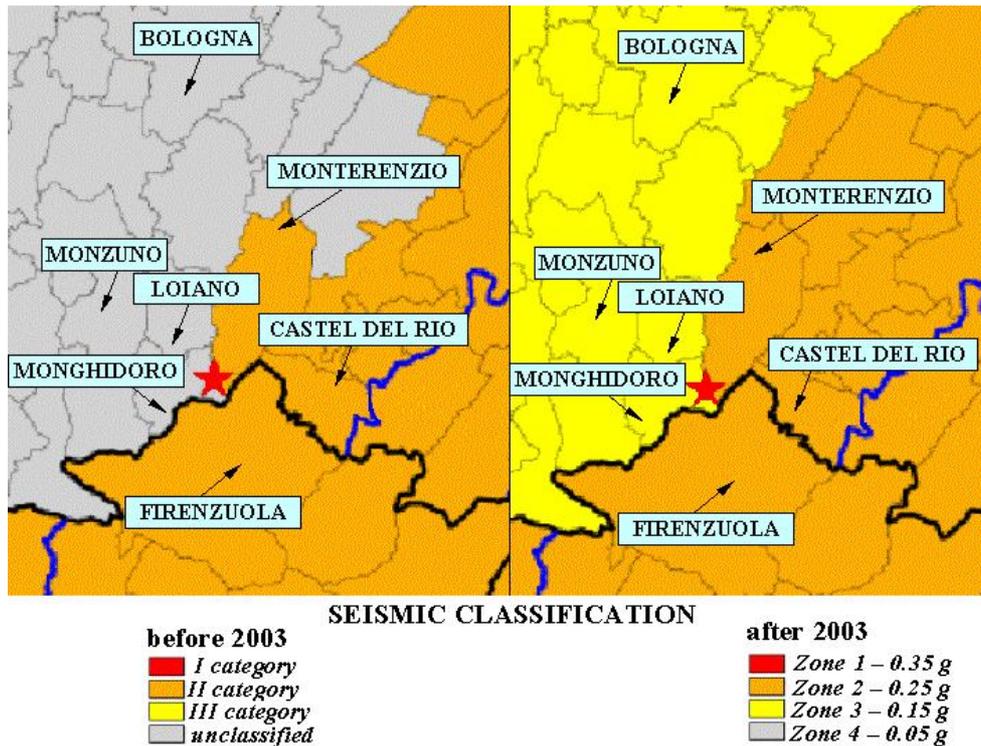
The Italian territory has been reclassified a few years ago [Presidente del Consiglio dei Ministri, 2003a]. About one half of the municipalities encircled by the MCS Intensity VII were not considered as seismic zones in the old classification (Fig. 2). The seismic classification relies upon the standard probabilistic approach [Cornell, 1968; Bender and Perkins, 1987] that is acceptable, as a general indication of the hazard in terms of probability of exceedance of an acceleration value, but that has been proven to be not fully satisfactory in several instances. Case studies indicate the limits of the currently used methodologies, deeply rooted in engineering practice, based on a probabilistic approach. The Probabilistic Seismic Hazard Analysis (PSHA) supplies indications that can be useful but are not sufficiently reliable to characterize seismic hazard: recent examples Kobe (17.1.1995), Bhuj (26.1.2001), Boumerdes (21.5.2003) and Bam (26.12.2003) events. The analysis of global seismicity shows that a single Gutenberg-Richter (GR) law is not universally valid. The multiscale seismicity model [Molchan et al., 1997] implies that the Gutenberg-Richter law can describe adequately only the set of earthquakes with dimensions that are small with respect to the elements of the zonation. This condition, fully satisfied in the study of global seismicity made by Gutenberg and Richter, has been violated in many subsequent investigations. Such a violation has given rise to the concept of Characteristic Earthquake (CE) in opposition to the Self-Organized Criticality (SOC) paradigm. In other words, the problem with PSHA is that its data are inadequate and its logic defective [e.g. Castanos and Lomnitz, 2002, Wang et al., 2003]. Furthermore for the protection of the cultural heritage, the concept of return period is of little value; in fact, such kind of patrimony, which must be handed down intact to posterity as far as possible, cannot be exposed to the roulette of the probabilistic approach.

Figure 2: Seismic classification

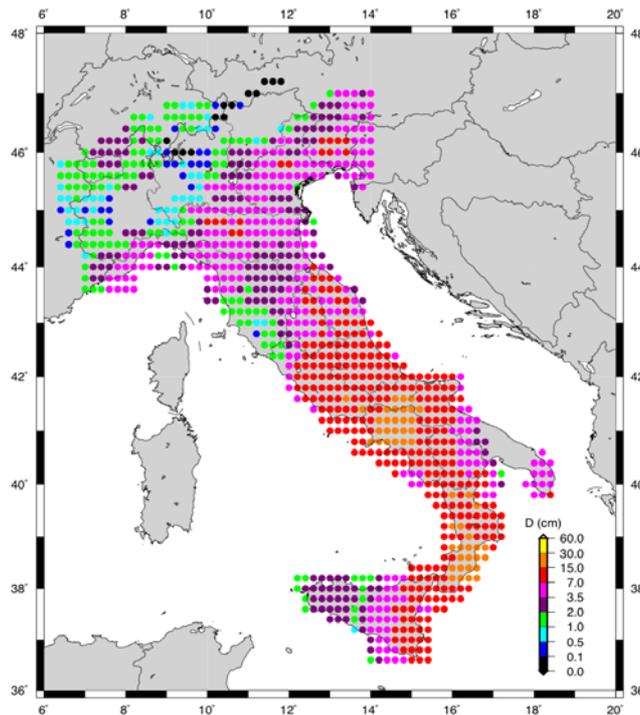
Figure 3: Horizontal Peak displacement (D) distribution at the national scale, obtained as a result of advanced deterministic zonation

The innovative deterministic procedure we have applied supplies realistic time histories from which it is possible to retrieve peak values for ground displacement (e.g. Fig. 3), velocity and design acceleration at bedrock level. The same can be done for earthquake scenarios. The procedure is particularly suitable for the best possible definition of the characteristics of the modern antiseismic devices to be used in the rehabilitation, since it allows to properly estimate the local soil effects, thus defining a very realistic seismic input. Should it be required the non-linear analysis of structures, realistic time series are available as well.

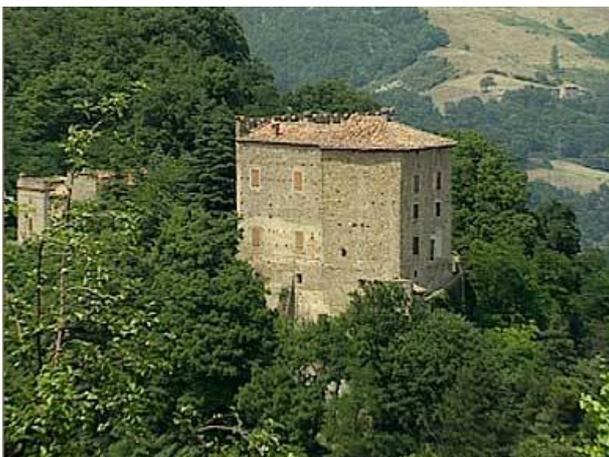
The Montorio Tower (Fig. 4) lays directly on the top of a sandstone rocky cliff, overhanging on three sides and anciently suitable for defensive purposes. This kind of topographic position can emphasize seismic shaking and the geological configuration is particularly exposed to landslides and atmospheric erosion; in fact, significant damage is documented after the 1869 (Vergato) seismic event and several retaining interventions were necessary since the beginning of the XX century.

Figure 4: The Montorio Tower

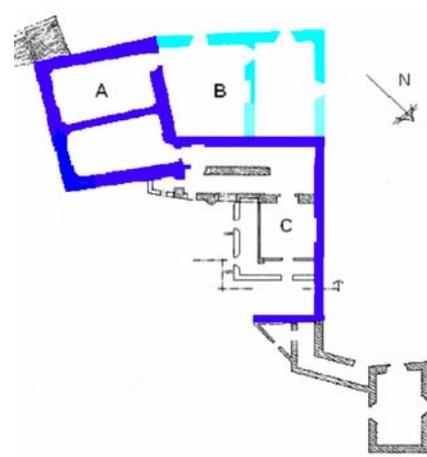
Figure 5: Chronological growth

The whole architectonic complex grew around an original XII-XIII century nucleus, identified by the tower itself, the defense wall and the shelter inner court (Fig. 5, part A). The enlargement B (two vaulted rooms) belongs to the XVI century and the sectors C were added in the 1700 first decades. The monument, a relevant example of genuine defense architecture, has been protected by the Ministry of

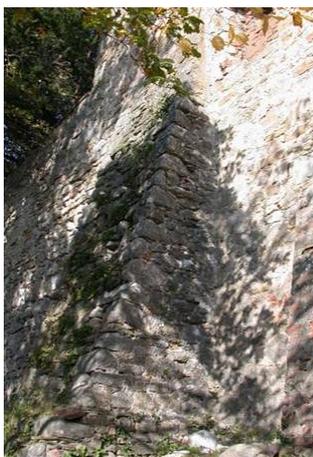
Cultural Heritage since 1910. If the tower presence is certified by the first known cadastral documents (1235), historical considerations make suppose the existence of a Longobard fortification system in the Bolognese Appennines area before the X century. In order to stiff the building, two S-W buttresses (Fig. 6) were realized in 1570-80, while the E corner strengthening was completed during 1900, together with other minor modifications. Furthermore, after the above told 1869 Vergato earthquake damage, the tower was lowered of one level in 1870.

Figure 6: S-W buttress

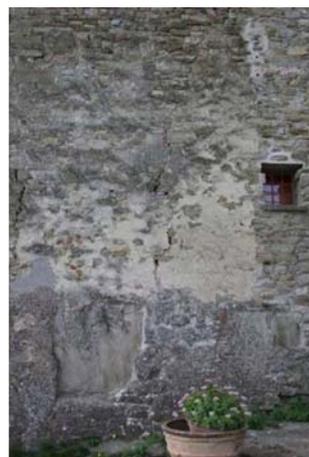
The Tower is a five-level construction (cellar, raised level, mezzanine, first floor and garret), with a typical two-roomed space divided by a central wall. External dimensions in plan are about 10.6 x 9.3 m and foundations lay directly on the rock (Fig. 7). The vertical walls (made by local sandstone and river pebbles) generally show regular horizontal stone-lines and bigger squared elements on the corners (Fig. 8), but somewhere the masonry fabric is inhomogeneous and presents discontinuity due to the subsequent additions (Figs. 9-10); the thickness is about 1 m; pronounced tapering with height is evident and an out of plumb has been measured in the S-E front. The horizontal floors (Fig. 12) are mainly made by single or double wooden truss frames, covered by a light layer on pressed sand or debris. In correspondence of the first level, three steel ties have been found. The sixteenth-century addition (cellar, two floors and garret) leans against the N-W tower front and the shelter inner court wall, but the lack of transversal connections is evident. The stone-masonry (similar to the tower's one) reveals minor thickness (0.6-0.7 m) and, externally, consistent out of plumbs. The raised floor rooms are covered by pavilion vaults and the cellar (Fig. 11) shows an interesting barrel vault (a one-leaf brick top with reinforcing vertical brick lines and a background arch). Generally, the old roofs are made by light double wooden frames, including top truss, midst pitch trusses, sloping joists, wooden layer and tiles. Even if string-courses are absent, longitudinal wooden trusses are located at their place, leaning directly on the top of the perimeter walls, with the aim to distribute the static loads. In correspondence of the transversal walls, diagonal struts support the longitudinal roof frame. Moreover, the covering structure elements, which can be responsible of pushing effects, show an overall deterioration and often marked inflexions (Fig. 12).

Figure 7: Wall on sandstone

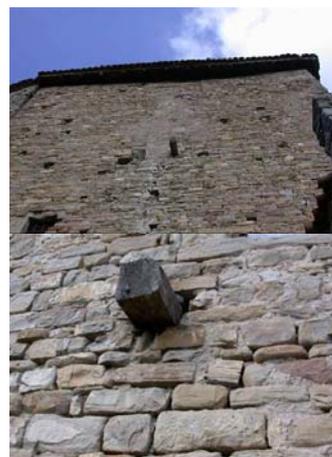
Figure 8: Vertical walls

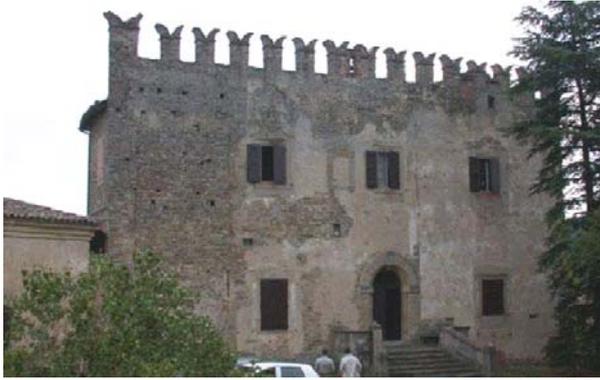
Figure 9: The Montorio Tower façade

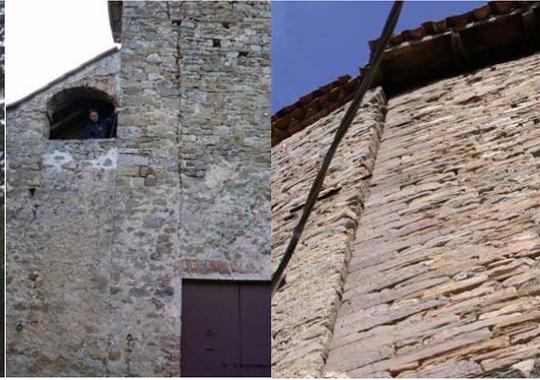
Figure 10: Structural discontinuity

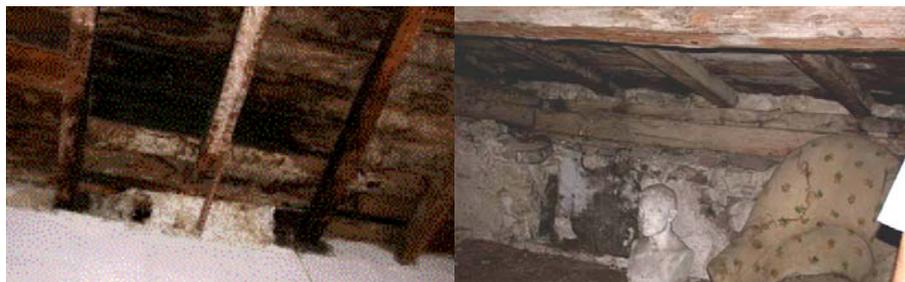
Figure 12: floors (left) and roofs (right)

All the floors will be generally provided by adequate stiffness, implementing the wooden trusses and replacing the deteriorated ones, with a particular attention to the anchoring system to the vertical walls (Fig. 14 right). The top stone-masonry, bearing the roof, will be completely reconstructed in a traditional way, due to its very degraded conditions. At the same time, a steel string-course will be provided, in order to connect the garret floor, stiffened as best as possible, and avoid pushing effects. The roof primary wooden trusses will be kept and reinforced, while the secondary ones, almost rotten, must be replaced. Finally, the cover existing tiles will be integrated with new ones.

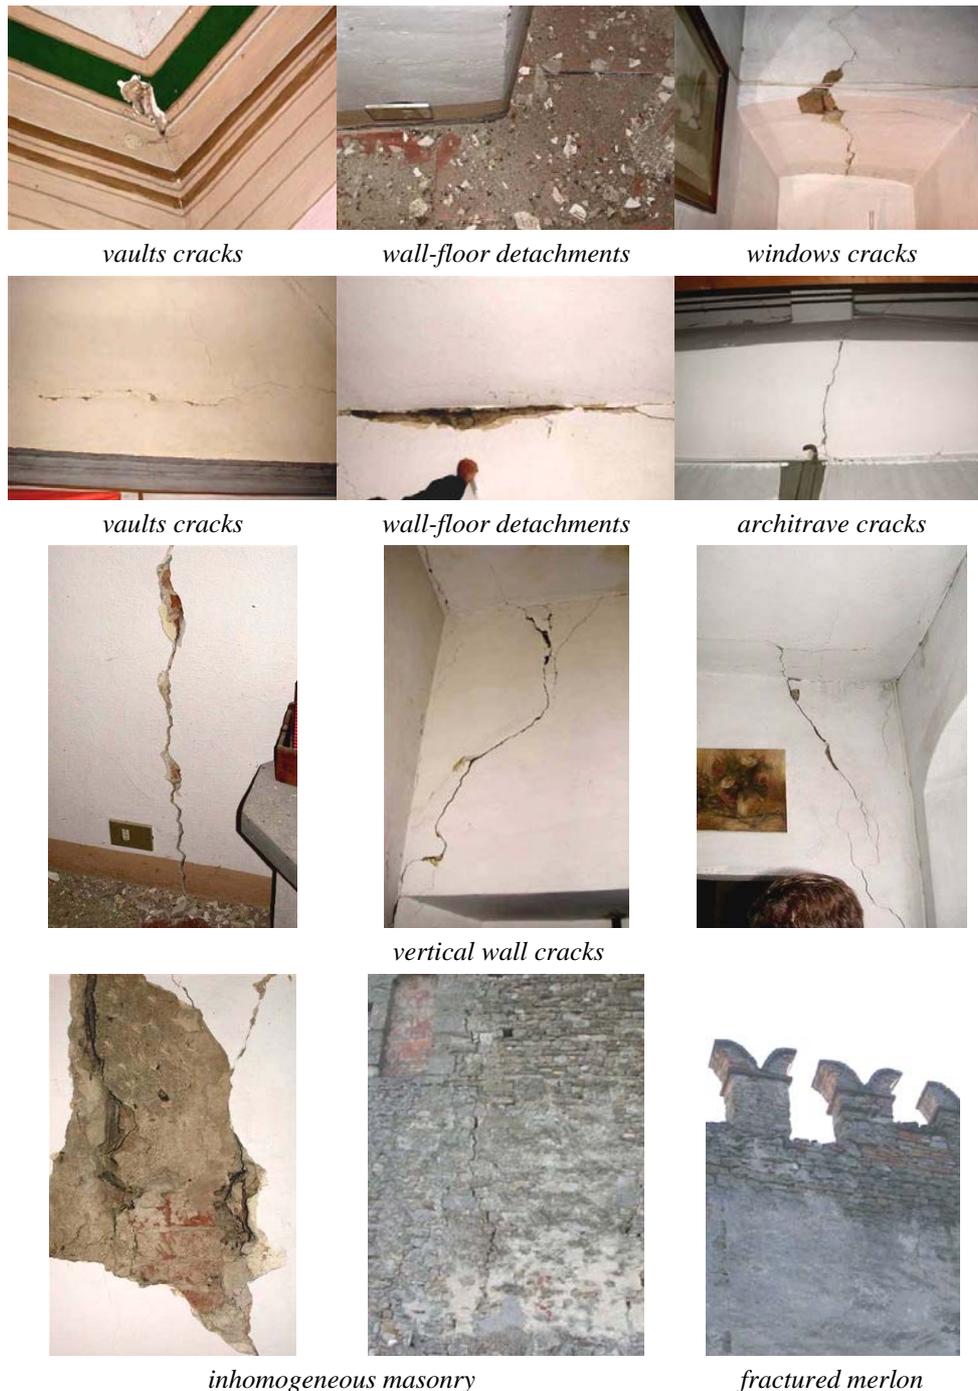
Most of the earthquake damage patterns are due to the following reasons (Fig. 13): lack of connections between different structural elements; ineffectiveness or absence of horizontal steel ties; presence of inhomogeneous masonry sectors (closed openings, niches, etc.); adoption of vulnerable construction typologies (one-leaf masonry vaults, floors with low stiffness, etc.); evidence of static defects existing before the seismic event (out of plumbs, detachments, previous cracks, etc.); generally deteriorated conditions due to scarce maintenance. In any case, the earthquake has been surely responsible of significant outwards overturning of the walls (first-mode mechanism due to out-of-plane dynamic forces).

Figure 13: Principal earthquake damage patterns

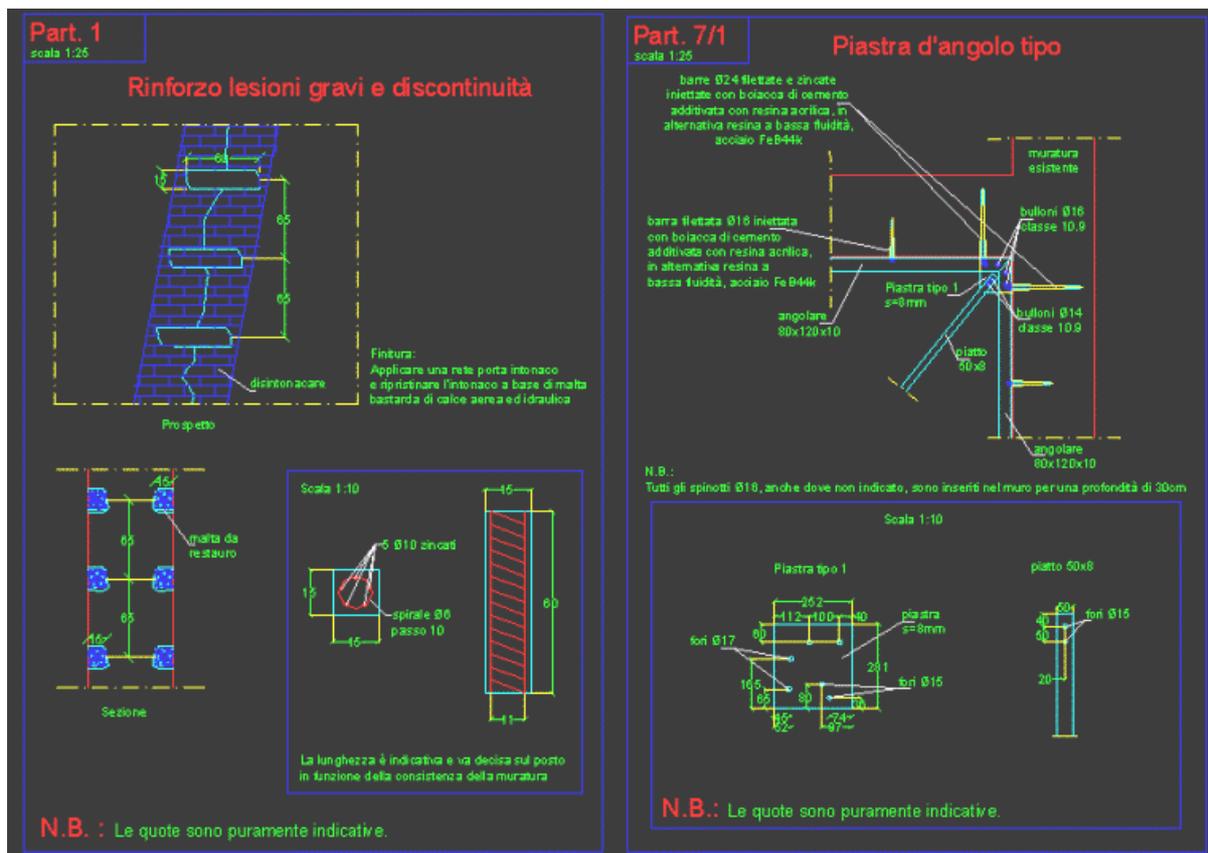
Figure 14: some intervention details

Firstly, a widespread introduction of steel ties at each level (in both the horizontal directions) is foreseen, with the aim to improve the structural box behavior and stop the overturning danger; in fact, this remedy is very powerful, as demonstrated by several shaking table tests on steel tied stone-masonry prototypes [Antonucci 2005]. A second aspect regards the punctual heavy cracks stitching by the insertion in the masonry of a series of galvanized iron bars (Fig. 14 left) astride the lesion and then plunged in compatible mortar, in order to keep the reading of the crack still visible; generalized mortar injections will be avoided; in case of widespread cracks - the most sited above the windows - only localized injections of compatible mortar will be carried out. The vaults will be repaired and thickened, if necessary, by layers of thin bricks, because the rotation at springings will be blocked by the above said steel ties.
