Source Security Program in the Philippines: A Lost Source Search Experience

Abstract. The Philippine Nuclear Research Institute (PNRI), the national agency in the licensing & regulations of radioactive materials in the country, is strengthening its capabilities in the security of radioactive sources. Part of this program is the PNRI's participation in the Regional Security of Radioactive Sources (RSRS) Project of the Australian Nuclear Science & Technology Organization (ANSTO). The project has provided equipment & methods training, assistance in the development of PNRI's own training program and support for actual orphan source search activities. On May 2007, a source search for the two lost Cs-137 level gauges of a steel manufacturing company was conducted by the PNRI and ANSTO. The source search are the a) development of instrument and source search training for the team, the National Training Workshop on Orphan Source Searches which was organized and conducted as a result of train-the-trainers fellowship under the RSRS project and b) planning and implementation of the lost source search activity. The conduct of the actual search on warehouses, product yard, canals, dust storage

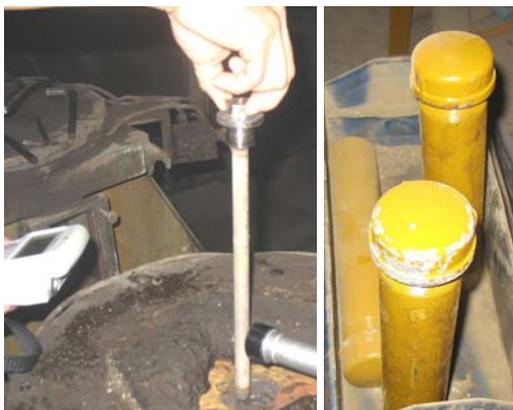
The two lost sources are Cs-137 pellets which are contained in rods that are used as gamma ray mould level controller for molten steel. The rod measures about 12 inches (1ft) and is encapsulated in a stainless steel container. Figure 1 shows the rod source and assembly drawing. A more detailed data on the source and the corresponding radiological impact assessment is as follows:

Figure 1. The Cs-137 rod source used in mould level controllers and the canister that contains them. To the right is the assembly drawing of the source.

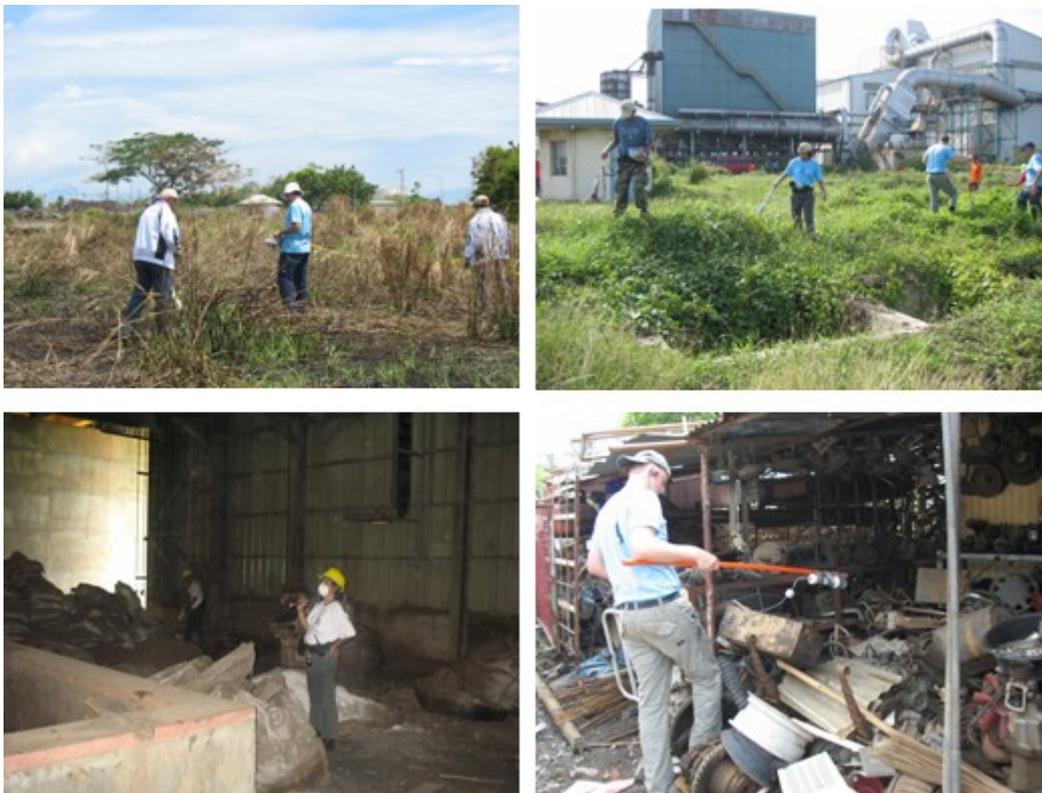
Figure 4. Source search activities at the steel plant compound

Generally, sand, bricks and sacks of objects containing naturally occurring radioactive materials such as Thorium was found in the search areas. The materials are used as casts and bricks in steel manufacturing so that they are generally present in the grounds, drainage and steel making building. Figure 4 shows some of the source search activities
