# Environmental assessment of submarine power cables

Daniel ISUST†, Juan D. MARTÍNEZ†, Amaya ARTECHE‡, Carmen DEL RIO‡ and Virginia MADINA‡

† Grupo General Cable Sistemas, S.A., 08560-Manlleu (Barcelona), Spain

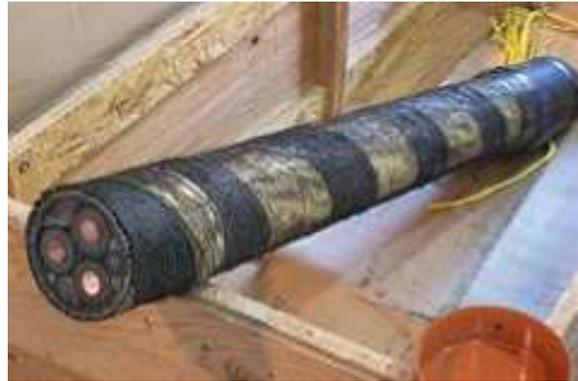
This system consists of a three-core cable designed for wet electrical conduction with conductor element surface of 300 mm<sup>2</sup>, Fig. 1. In this system, both leachability and ecotoxicity studies were performed for the complete and systematic evaluation of their potential environmental impact.

Figure 1: Three-core cable (System 1).

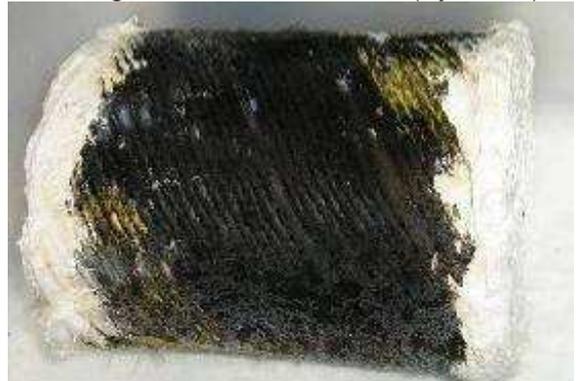
a. Undamaged cable: A sealing with polyurethane was performed onto the two cross sections of the specimen to simulate this situation, Fig. 2.

Figure 2: Sealed three-core cable specimen (System 1-Scenario a).

Fig. 7 shows the appearance of the damaged tested sample after the leaching test, whereas Fig. 2 gives the appearance of the undamaged cable after this test.

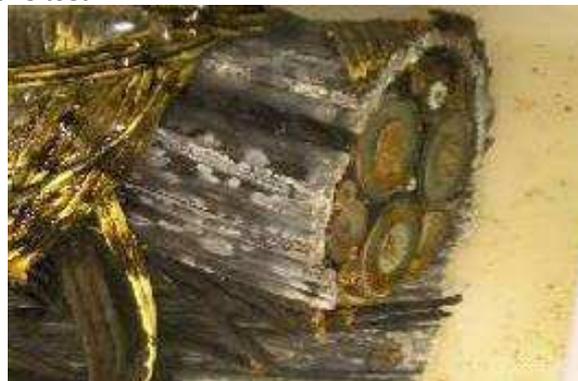
Figure 7: Final appearance of damaged three-core cable after leaching test.

In case of system 2 the external high density polyethylene (HDPE) jacket was partially removed in order to expose the metallic sheath to the seawater environment (see Fig. 7). This fact contributes to accelerate the migration of copper and aluminum due to corrosion phenomena. The ends of these single-core cable samples were sealed with polyurethane. Thus, metals in the eluate can be only attributable to the migration from the metallic shield.

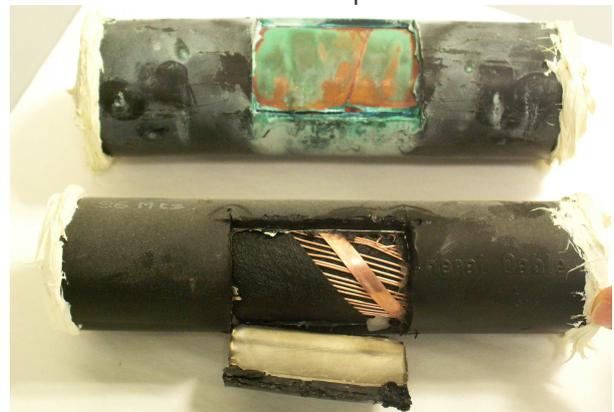
Fig. 15 shows the appearance of tested single-core specimens after the leaching tests. Results were quite different in both cables. Significant corrosion damage with greenish corrosion products generation was observed in the exposed area of the helicoidally copper tape, whereas the copper wires coupled with aluminium were almost uncorroded. For this latter case white voluminous corrosion products from the aluminium tape were observed. This behaviour is mainly attributed to a galvanic effect. Aluminium is more electronegative, this is the anode when coupled with copper. Thus copper is protected, whereas the corrosion rate of aluminium is promoted.

Figure 15: Final appearance of single-core cable with helicoidally copper tape (top) and single-core cable with aluminium sheet + copper wires (bottom).
