Evaluation Of Hanford Single-Shell Waste Tanks Suspected Of Water Intrusion - 14196

Evaluation Of Hanford Single-Shell Waste Tanks Suspected Of Water Intrusion – 14196

ABSTRACT

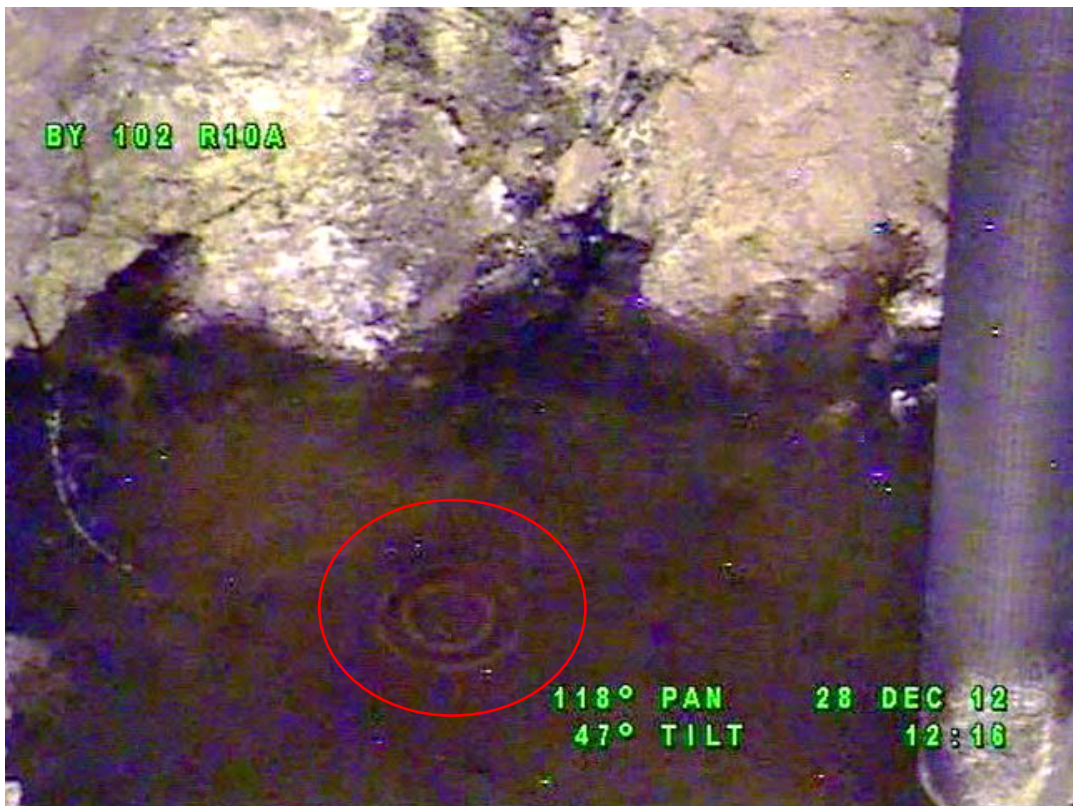
Active intrusion droplets were observed in tank BY-102 originating from the Riser 3 pit drain. There was an average of 26.5 droplets per minute observed during the video, and the droplets caused ripples in the liquid pool as shown in Figure 2. This liquid pool covered 2% of the total waste surface (Figure 3). The Enraf plummet was located on the salt surface; however, the Enraf plummet wire was lying over a broken piece of pipe that shows signs of wear caused by the wire rubbing against it. The LOW was surrounded by saltcake.

Fig. 2. Tank BY-102 ripples in liquid pool.

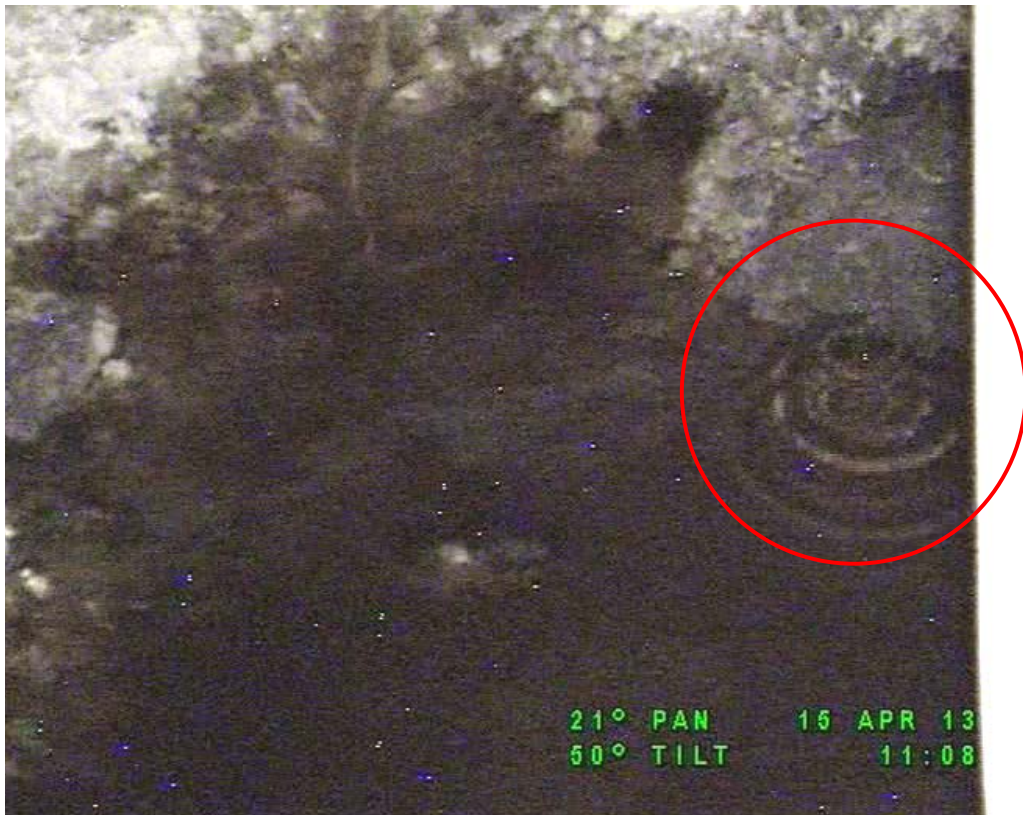
In tank SX-106, an active intrusion was observed coming from the vapor header connection. The exhauster had been removed from the SX tank farm, but the buried vapor header connecting the 15 SX tanks drains to SX-106. During the video, water droplets fell from the header connection at a rate of approximately 57 droplets per minute, and the droplets created ripples in the liquid pool, as shown in Figure 4. The waste surface was a solid salt surface with a long liquid pool extending from the vapor header connection to the Riser 2 temperature probe as shown in Figure 5. The Enraf plummet was resting on an irregular surface, and the LOW could not be seen from the video camera location.

Fig. 4. Tank SX-106 liquid pool ripples.
