NONDESTRUCTIVE EXAMINATION TECHNIQUES ON CANDU FUEL ELEMENTS

G. GHEORGHE, I. MAN

Institute for Nuclear Research, Pitesti, Romania, gabriela.gheorghe@nuclear.ro

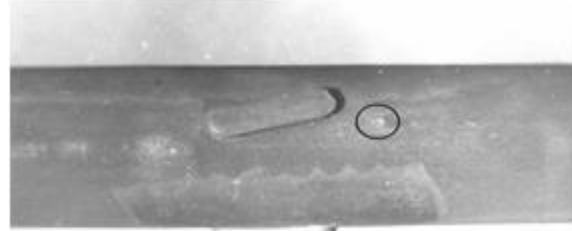
**Figure 3**

Visual inspection revealed the existence, all over the sheath, of fine, non-adherent and dark gray deposits, except the areas between the spacers and those between spacers and central skate, where the sheath has a shiny metallic look. Above the right spacer a little lack of material was observed due to a localized corrosion process. It has a circular form, has 0.7 mm in diameter and is at 2.6 mm from the spacer and 139.6 mm from the marked end. This detail is shown in **Figure 3**.

The galvanic corrosion primed by the thermocouple and sheath contact

The deposits were removed from the surface of the sheath prior to its visual examination. We observed in this way that the thermally affected zones are darker than the rest of the sheath, indicating a lower oxidation state. The position and the appearance of detected defect lead to the conclusion that it is the result of a galvanic corrosion process primed by the contact of the thermocouple with the sheath, the sheath's wall being not penetrated.

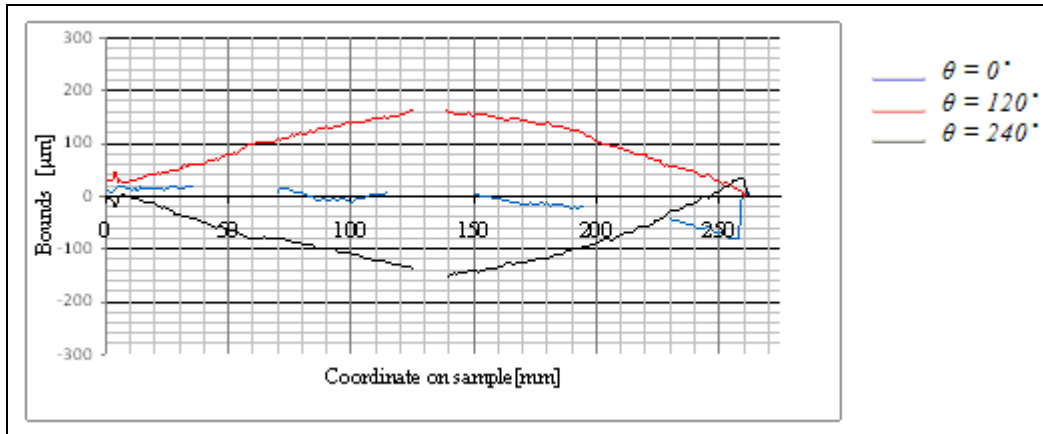
The arrow was measured at the same time as the diameter, being determined by the semi-difference of the values measured between those two displacement transducers which are a differential transformer type with mobile core, being disposed in opposite sides of the fuel element. They come in contact with it through the touch probes which are directly related to the cores. The fuel element moves vertically, step by step, between those two touch probes, diametrically opposed. Measurement accuracy is ± 5 μm . The arrow profile (bending) of the fuel element was also obtained. The length is measured by moving the fuel element from the "origin Z" vertically in front of the periscope until its central crosshair overlaps with the inferior stopper shoulder first and then with the superior stopper shoulder [3]. The value of each Z displacement is displayed by the indexer on the control command panel, and the difference between them is the length of the fuel element. The results of the measurements are shown in **Figure 4** and **Figure 5** and highlight the fact that the fuel element has suffered bending of the sheath.

Figure 5 Bending profiles on three longitudinal directions

On dimensional control, irradiation-induced changes were observed, resulting in wrinkling of the sheath in the interface zones of the pellets. The average diameter increase is 0.35%, the highest growth was recorded in the direction 0° , the corresponding diameter increase being 0.46%. The representation by superposition of the diametrical profiles on those three longitudinal directions (0° , 120° and 240°) has revealed that the cladding of the fuel element suffered a cambering process. It was found that the maximum camber occurred for a vertical coordinate of 261 mm and has a value of 167 μm . The fuel element bent, the maximal arrow being of 162 μm for a vertical coordinate of 125 mm.

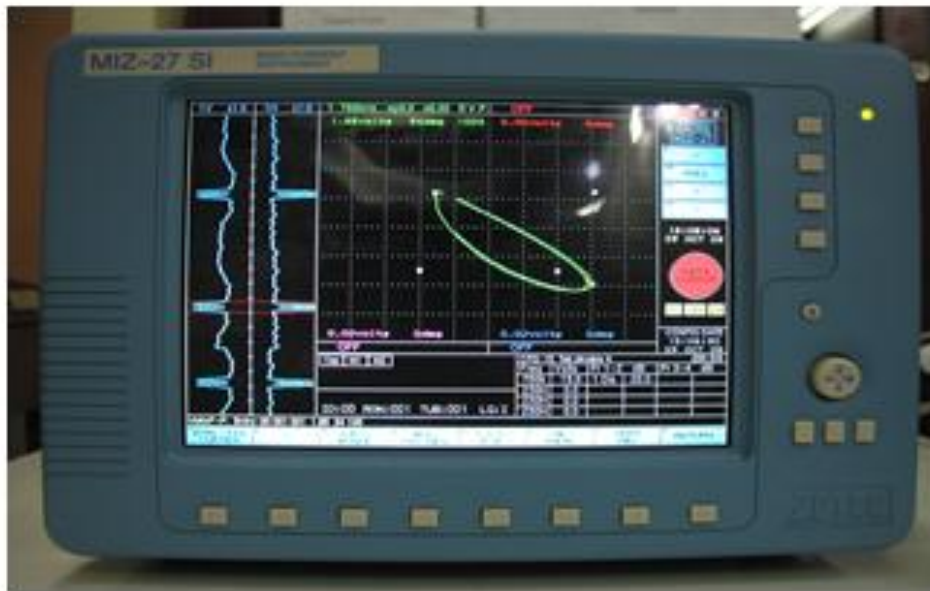
Figure 6 Front panel MIZ-27SI

- Universal test machine (**Figure 1**);
- Control/command panel of the machine;
- Eddy current flaw detection instrument (**Figure 6**);
- Measurement console (**Figure 7**);
- Differential probe.

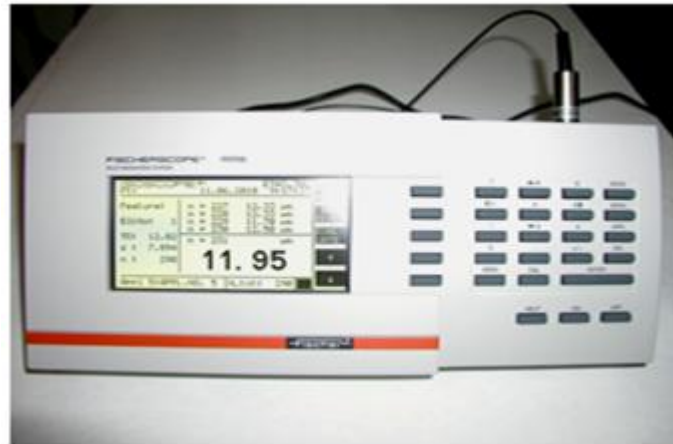
Figure 10 Device used to measure the thickness of the oxide

- Universal test machine (**Figure 1**);
- Control/command panel of the machine;
- Device for measuring the thickness of the oxide layer (**Figure 10**);
- Measurement console (**Figure 11**);
- Measuring probe.

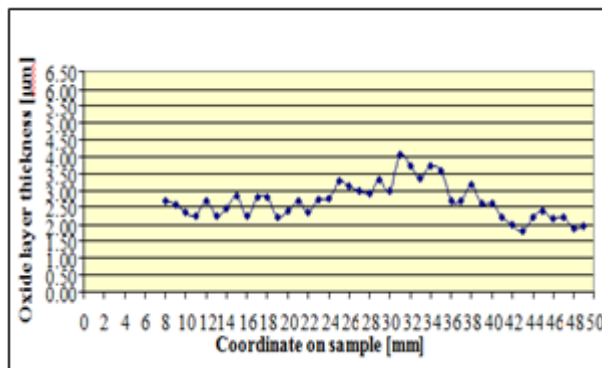
zircaloy-4 oxidized by autoclaving. The tube was scanned longitudinally on three generators, oriented equidistant, at 120° between any two successive ones. A scanning on circumference was also performed on the tube, at 8 mm from the unmarked end (**Figure 15**). The measurement results were confirmed by measuring the oxide thickness of the cross-section of the tube, using an optical microscope (**Figure 16**).

Figure 14 Longitudinal scan at $\theta=240^\circ$
