ORNL/RASA- 95/4

Radiological Verification Survey Results at 3 Peck Ave., Pequannock, New Jersey (PJ002V)

Date issued —May 1995

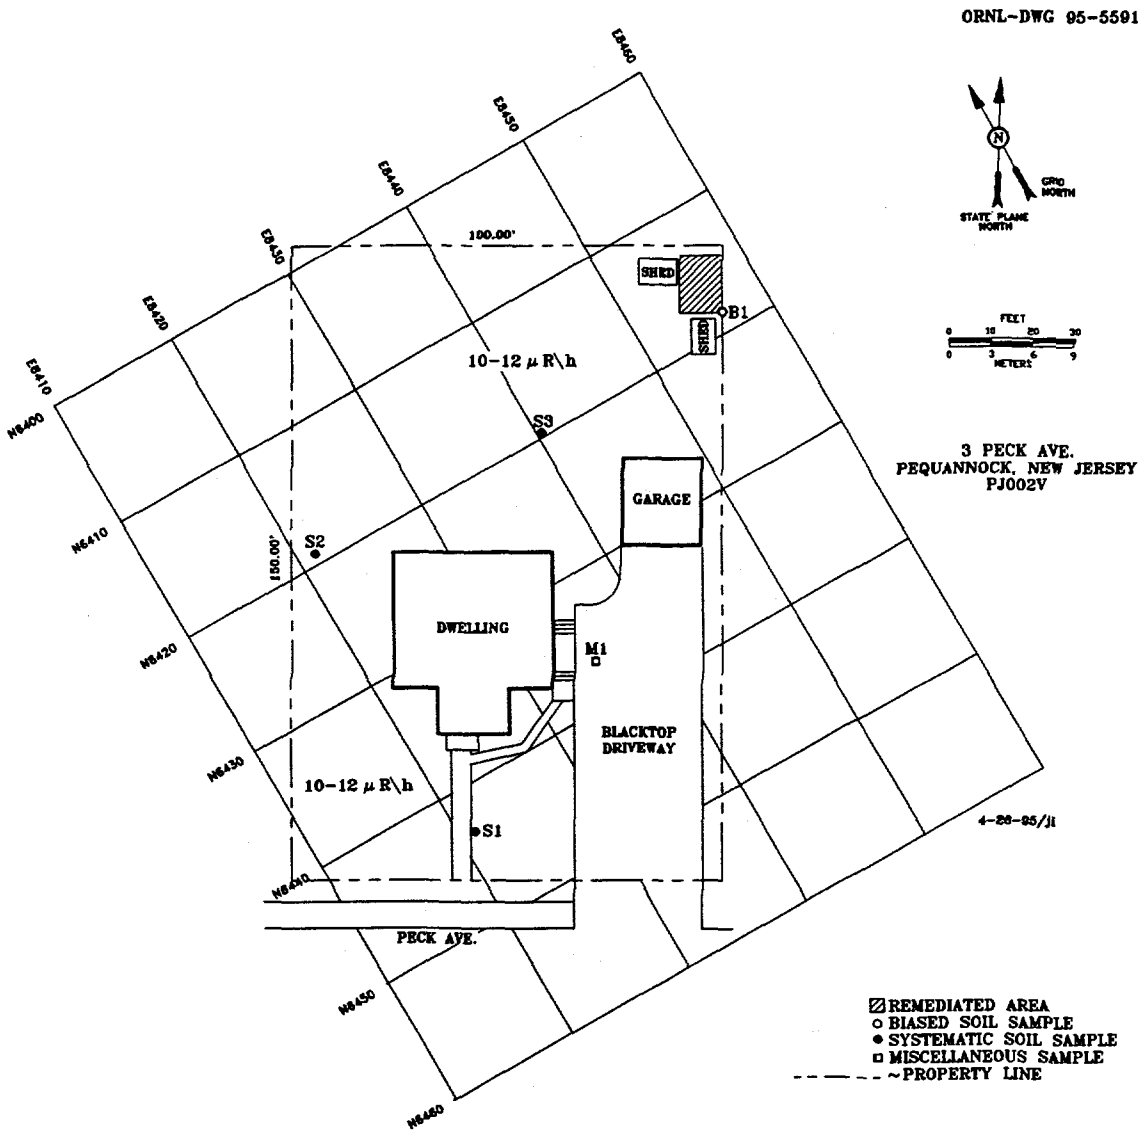
Surface (0-15 cm, or 0 to 6 in) and subsurface (15-45 cm, or 6 to 18 in) soil and miscellaneous samples were collected at various locations over the property. A confirmatory sample was taken from the remediated area between the two sheds in the northeast corner of the property. This is referred to as a biased sample and is labeled B1. Miscellaneous samples were taken from the asphalt driveway (M1A, B, and C) where slightly elevated gamma levels had been identified. Systematic samples (S1-S3) were taken at random irrespective of gamma exposure rates. Locations of the samples are shown in Fig. 2, and results of the analysis are shown in Table 1.

Gamma measurements at one meter from the surface ranged from 10 to 12 μR/h as shown in Fig. 2. Gamma measurements generally ranged from 11 to 12 μR/h at the surface in the grassy areas of the front and back yards, and 21 μR/h at the surface of the remediated area between the two sheds in the far northeast corner of the lot. An elevated level up to 30 μR/h was measured on contact with the asphalt driveway. All of these measurements are comparable to the natural background levels for this area.

Fig. 2. Diagram of the property at 3 Peck Ave., Pequannock, New Jersey showing soil sampling locations and gamma measurements.
